# Agenda Item #1

## Application 2025-36-CA

13 N Warren Street

Demolish existing contributing structure

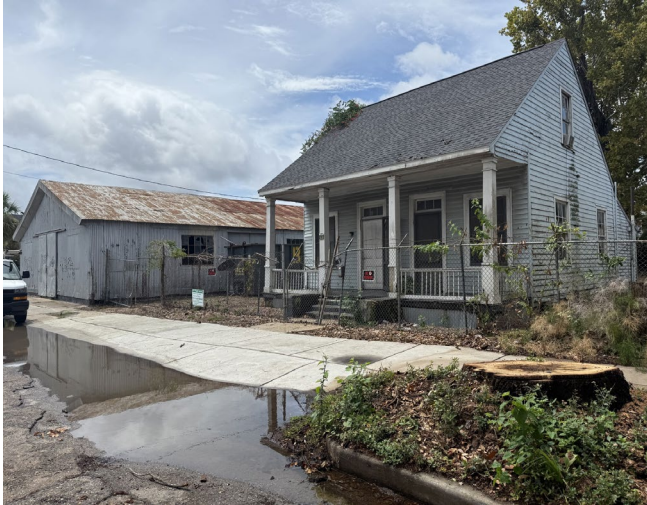
1. View of property, looking SW

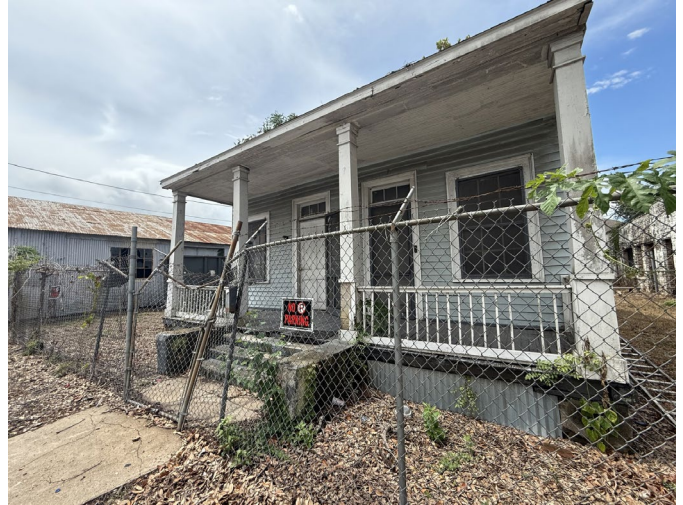
2. View of east façade, looking SW

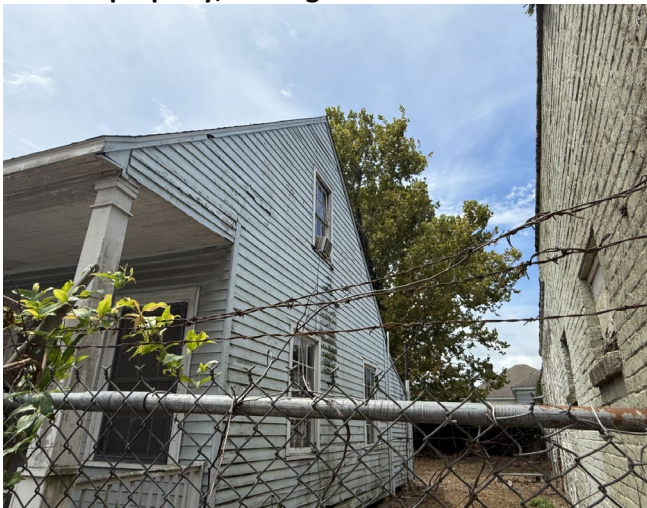
3. View of north elevation, looking SW

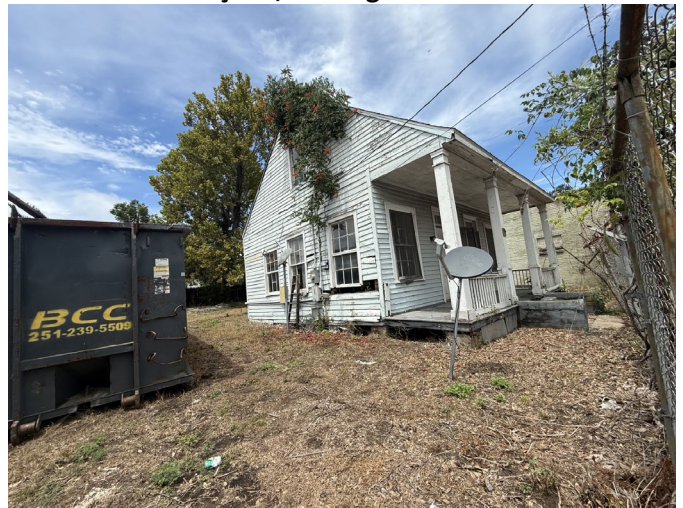
4. View of south elevation, looking Nw

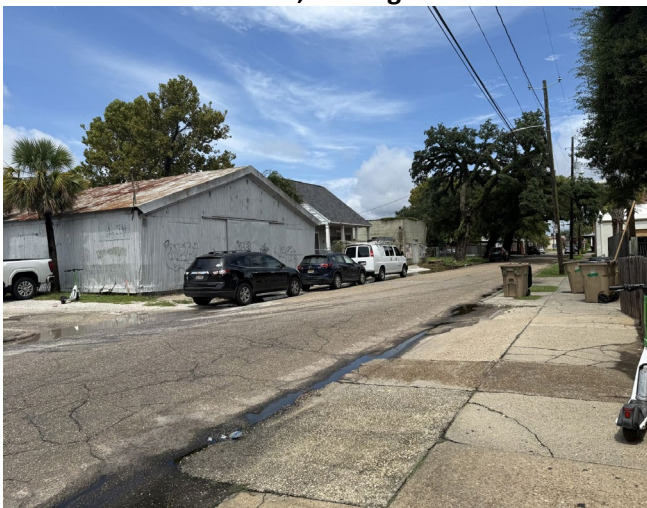
4. View of streetscape, looking NW

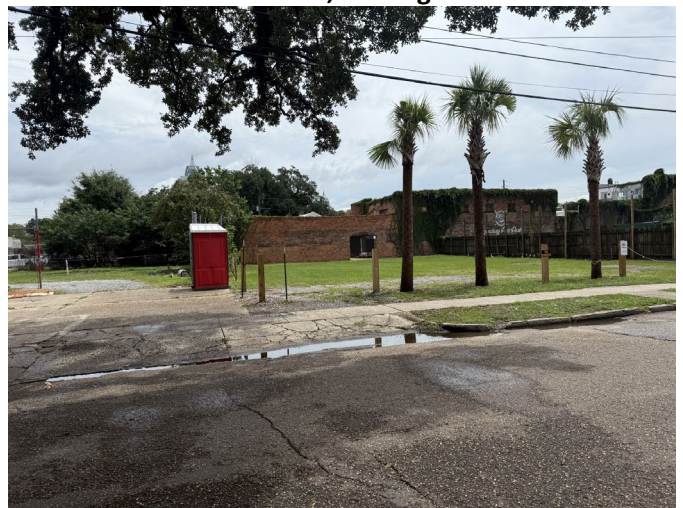
5. View of property across the street, looking E

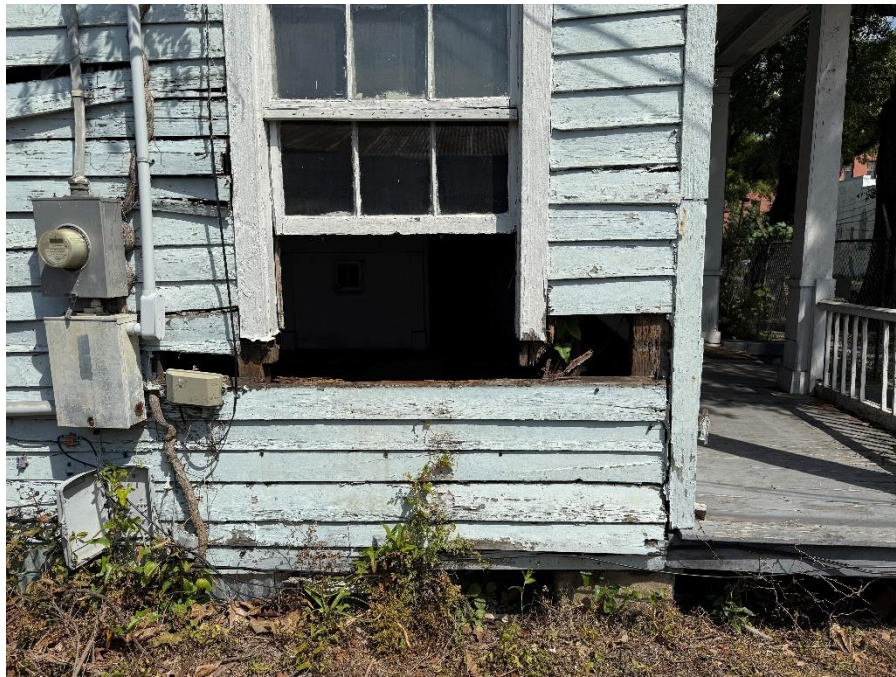
Photo Number: 1	Location: South Exterior of Structure
Date Taken: 04-29-25	Comments: Deteriorated exterior siding and bottom of window framing
Camera Facing: North

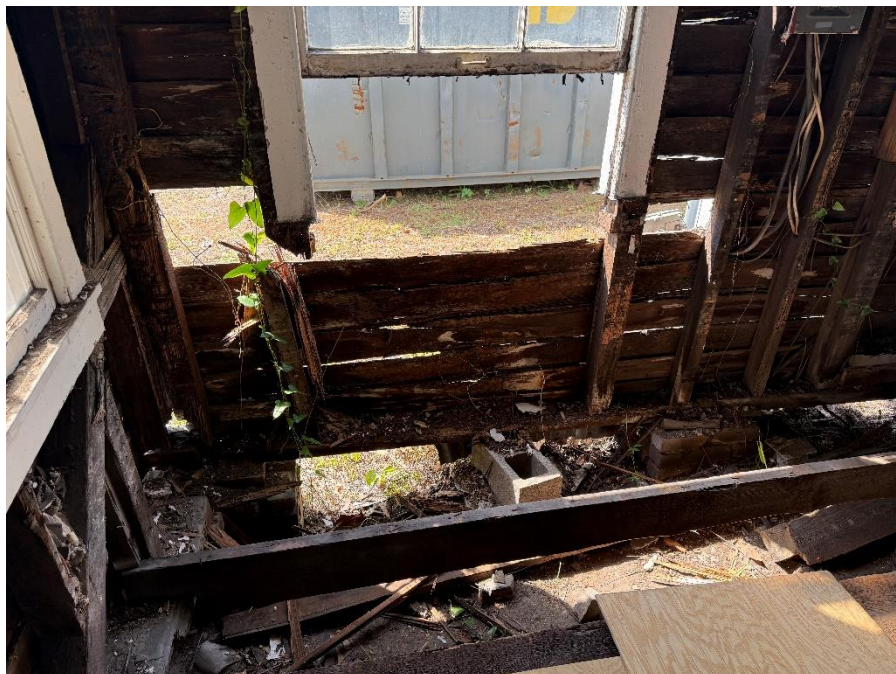
Photo Number: 2	Location: South Interior of Structure
Date Taken: 04-29-25	Comments: Deteriorated floor joists and foundation sills. Missing window, window framing, and sections of studs.
Camera Facing: South

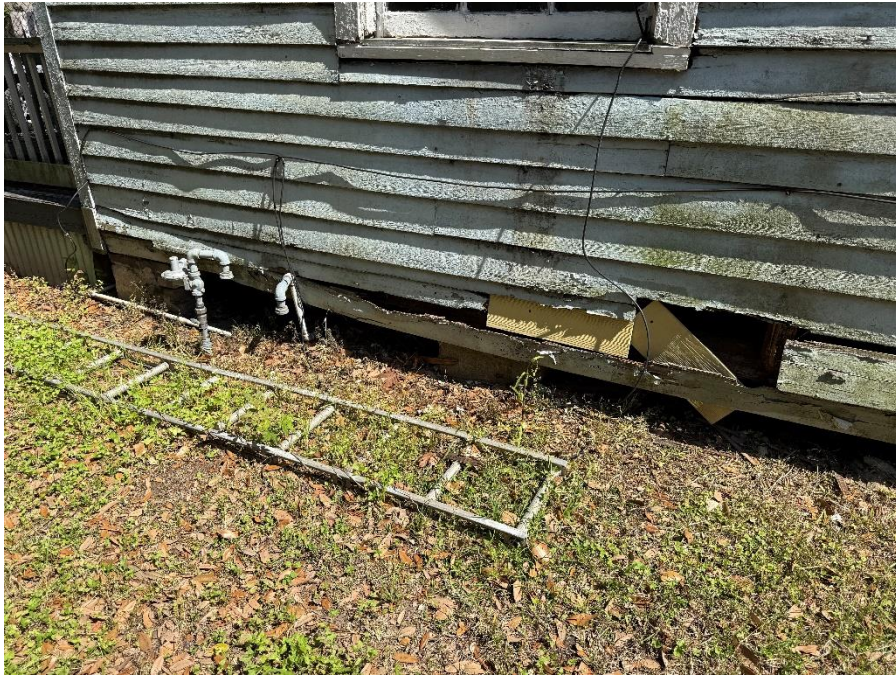
Photo Number: 3	Location: North Exterior of Structure
Date Taken: 04-29-25	Comments: Deteriorated foundation sills and siding
Camera Facing: Southeast

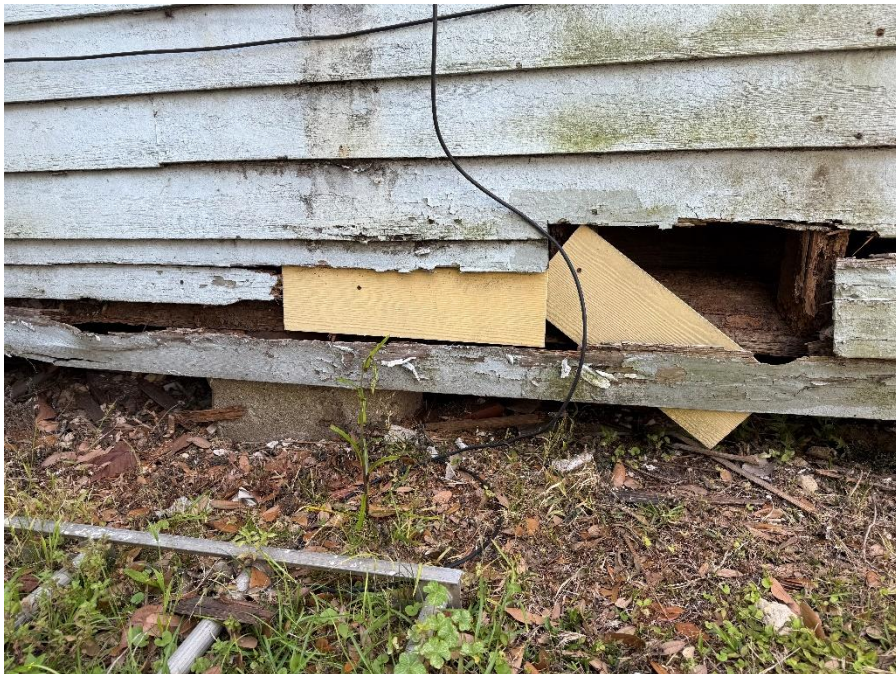
Photo Number: 4	Location: North Exterior of Structure
Date Taken: 04-29-25	Comments: Deteriorated foundation sills and siding
Camera Facing: Southeast

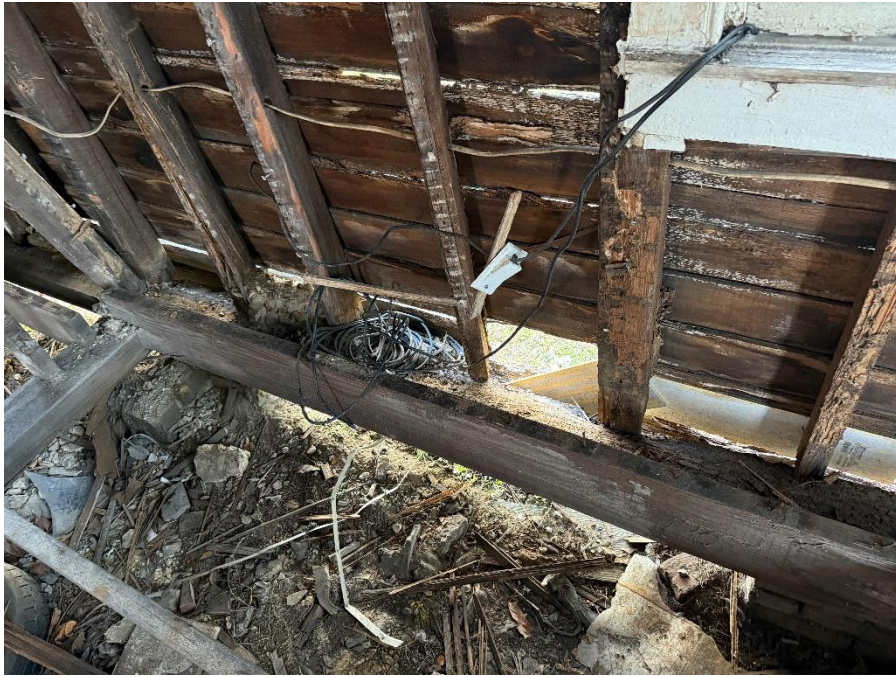
Photo Number: 5	Location: North Interior of Structure
Date Taken: 04-29-25	Comments: Deteriorated foundation sills, siding, studs and floor joists missing
Camera Facing: Northwest

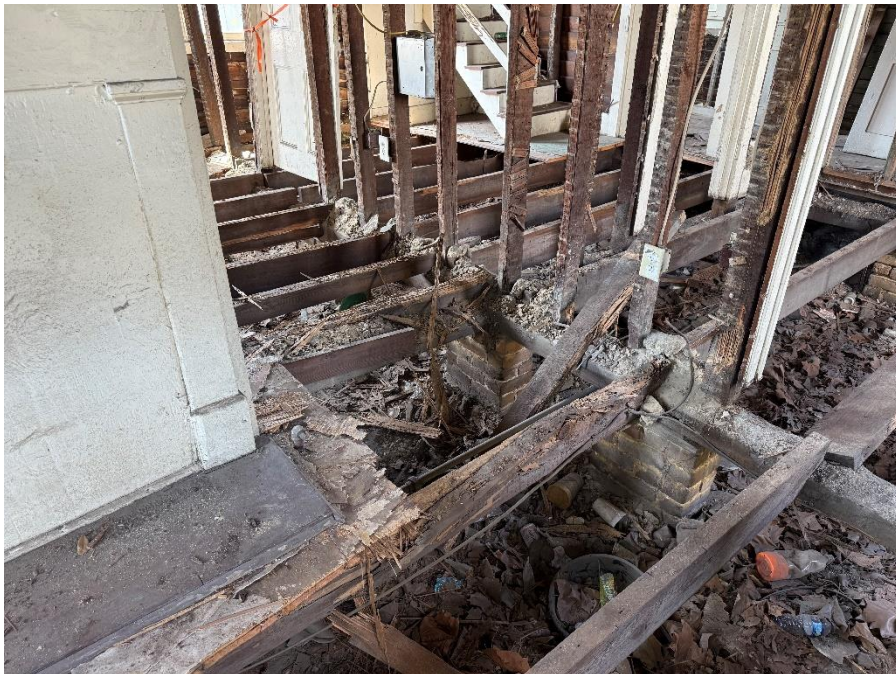
Photo Number: 6	Location: Central Interior of Structure
Date Taken: 04-29-25	Comments: Deteriorated floor beams, floor joists and load bearing stud walls
Camera Facing: Southwest

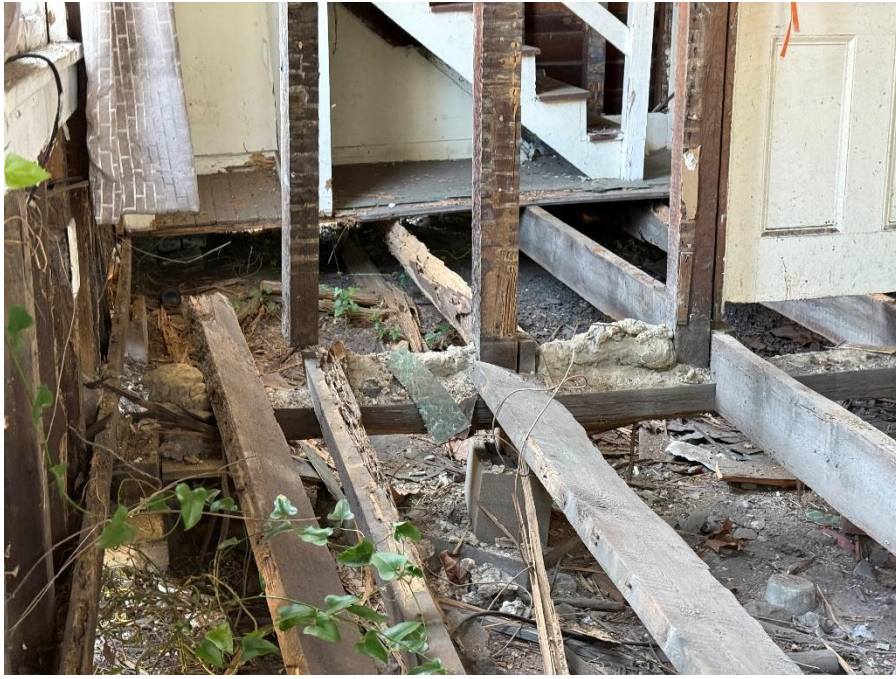
Photo Number: 7	Location: West Interior of Structure
Date Taken: 04-29-25	Comments: Deteriorated floor beams, missing floor joists, Foundation damage
Camera Facing: West

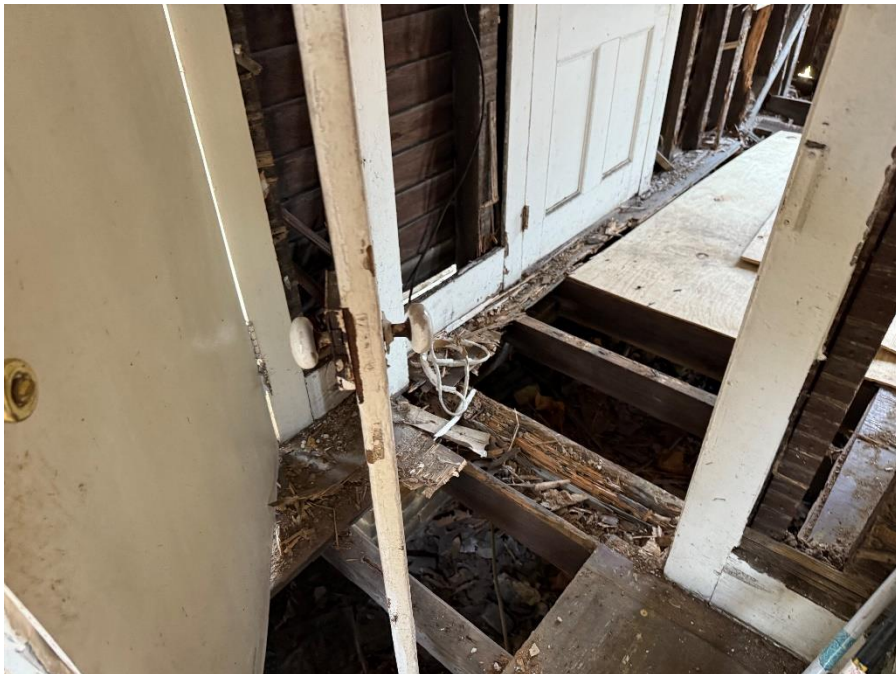
Photo Number: 8	Location: East Interior of Structure
Date Taken: 04-29-25	Comments: Deteriorated floor beams, foundation damage will not allow doors to shut
Camera Facing: Southeast

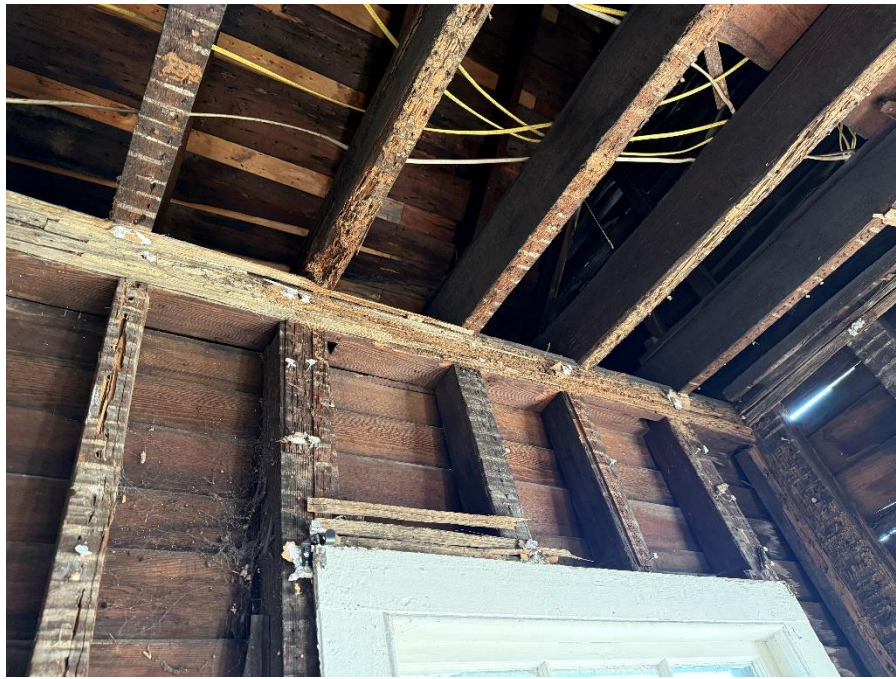
Photo Number: 9	Location: East Interior of Structure
Date Taken: 04-29-25	Comments: Rafter failure due to deterioration of rafter, exterior wall top plate and exterior wall studs
Camera Facing: Southeast

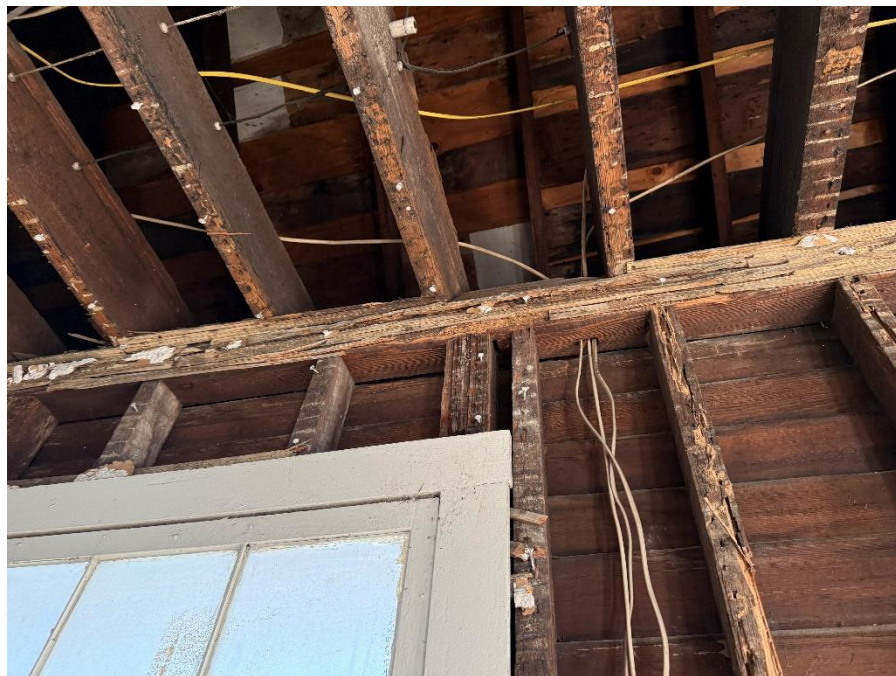
Photo Number: 10	Location: East Interior of Structure
Date Taken: 04-29-25	Comments: Rafter failure due to deterioration of rafter, exterior wall top plate and exterior wall studs
Camera Facing: Northeast
