Agenda Item #10

Application 2025-56-CA

959 Church Street

Remove 2 historic chimneys

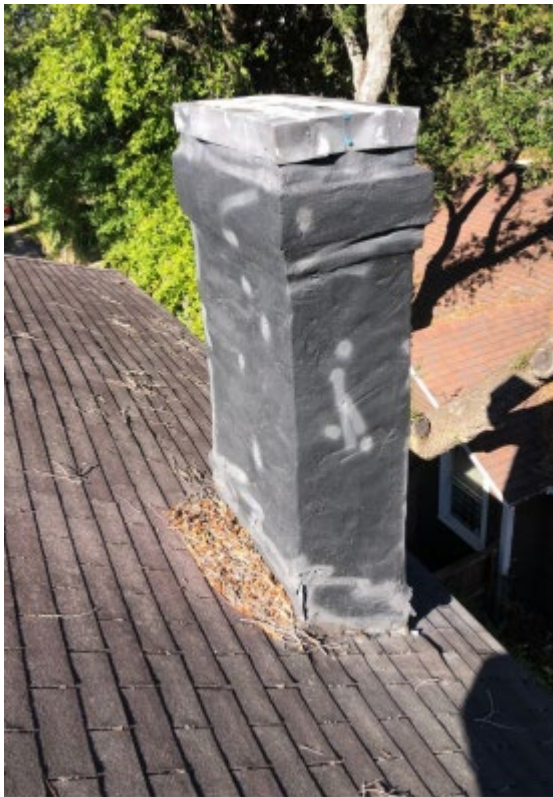
5. Chimney 1 on east elevation

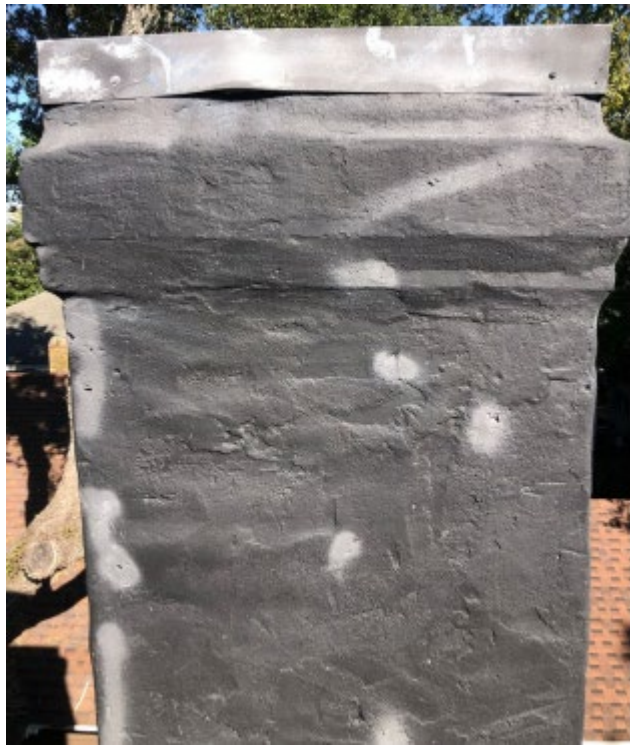
6. Closer view of chimney 1 and the cap that was installed and the concrete that was applied.

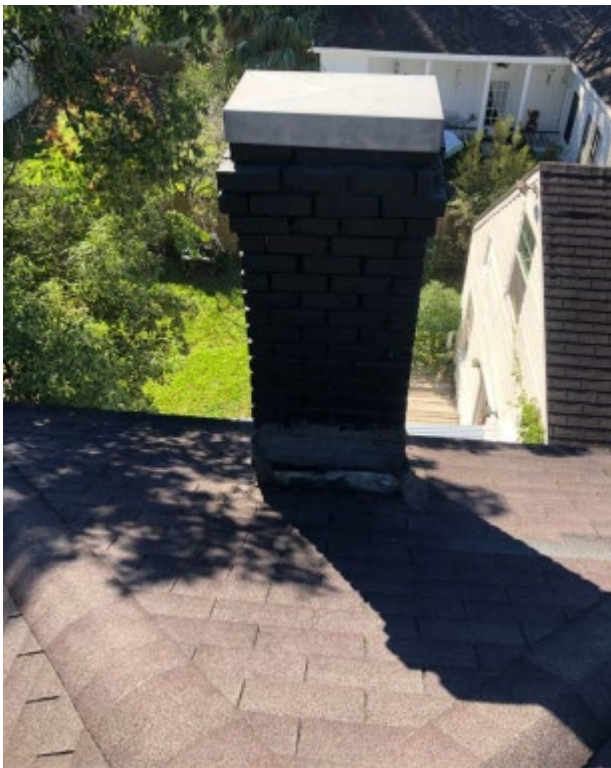
7. Chimney 2 on west elevation

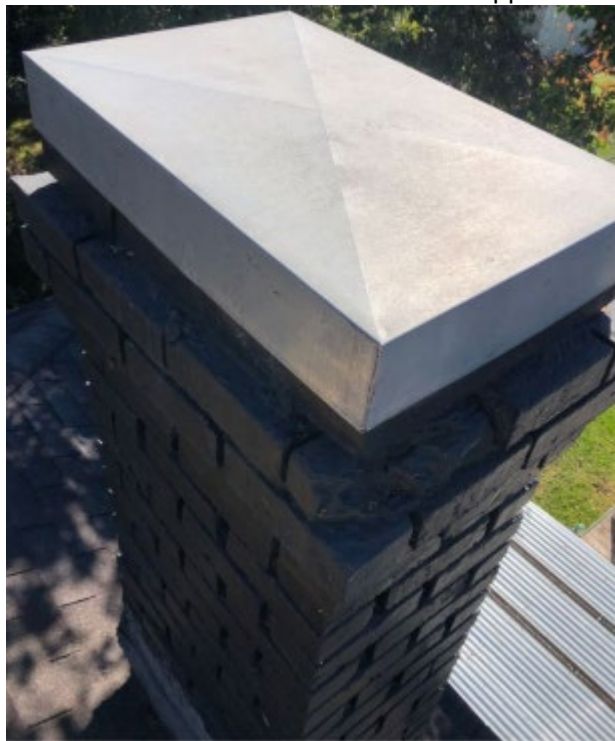
8. Closer view of chimney 2 and the cap that was installed.

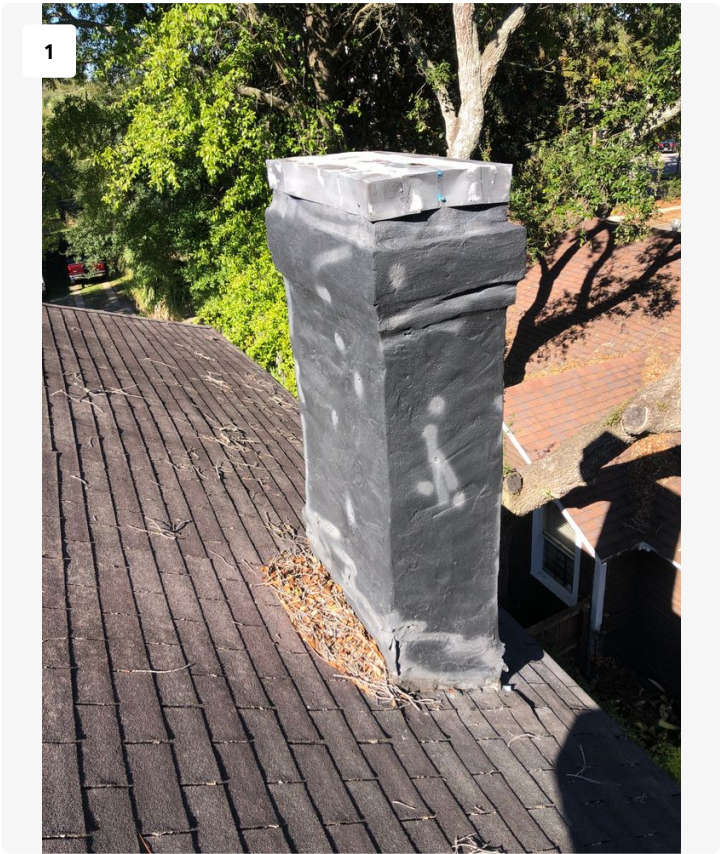
Chimney is in very bad shape and needs to be removed below the roofline.

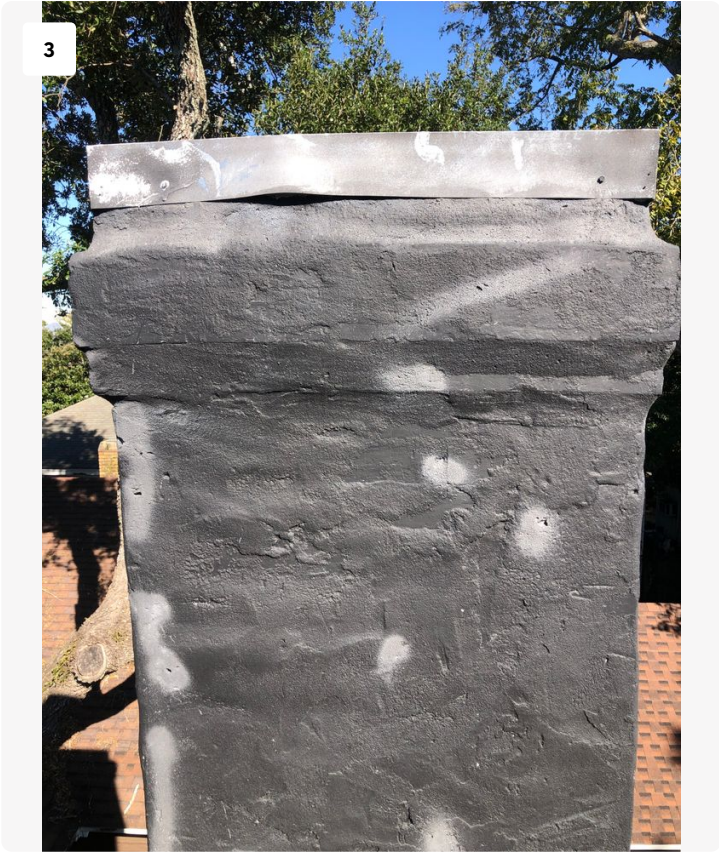
Chimney is permanently capped and no longer in use.

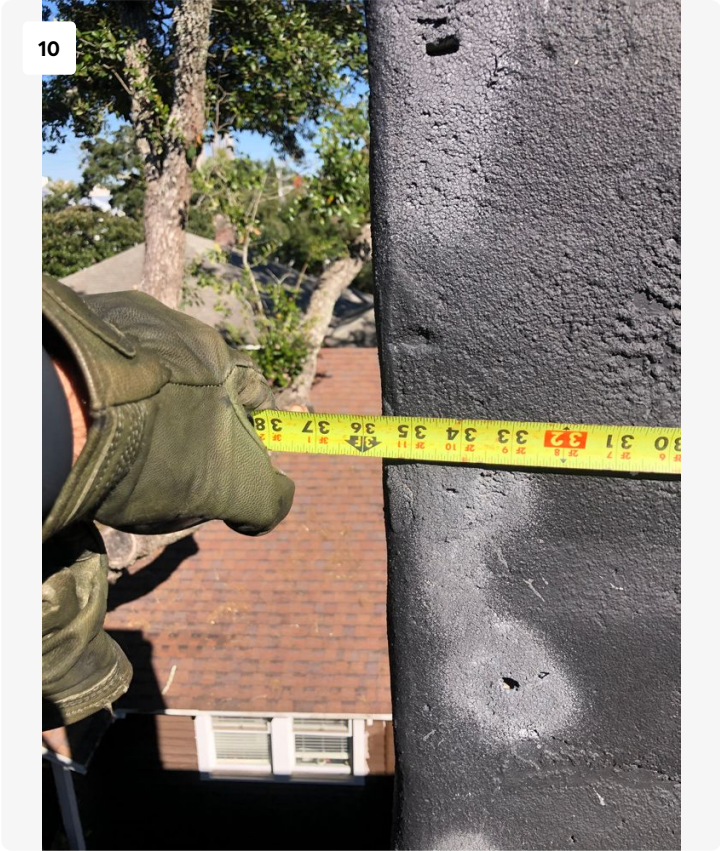
Any chimney over 30" requires a cricket during a reroof. We cannot install a cricket and fasten it securely to this chimney without further damaged occurring.

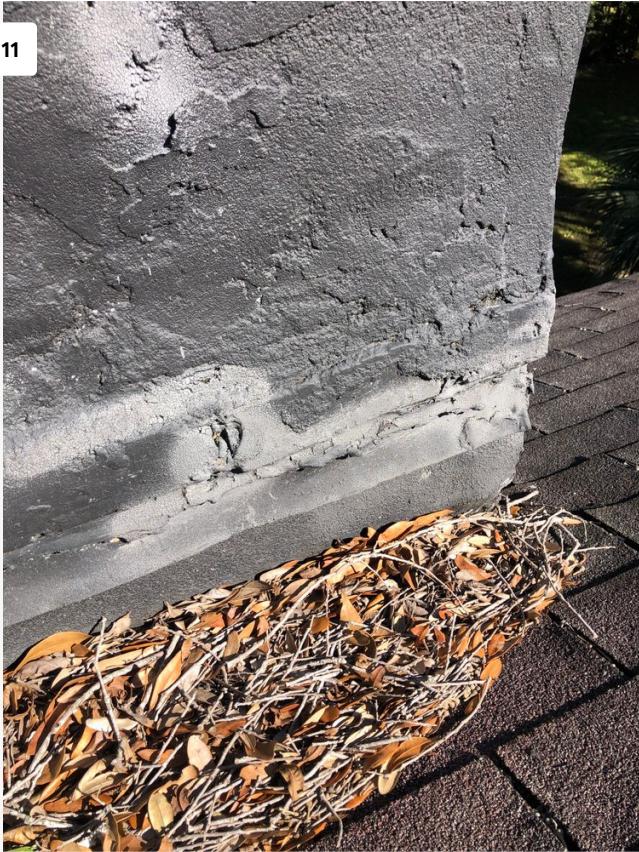
This chimney was previously fully coated in a layer of some sort of concrete. It is not consistent or smooth and has holes throughout. It is compromised.

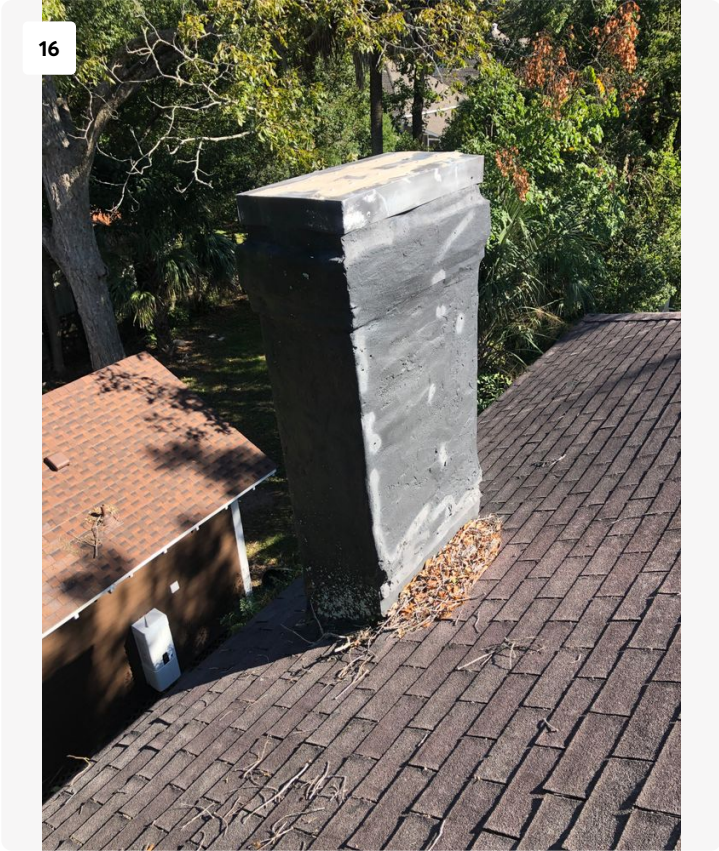
This chimney is permanently capped and serves no purpose also.

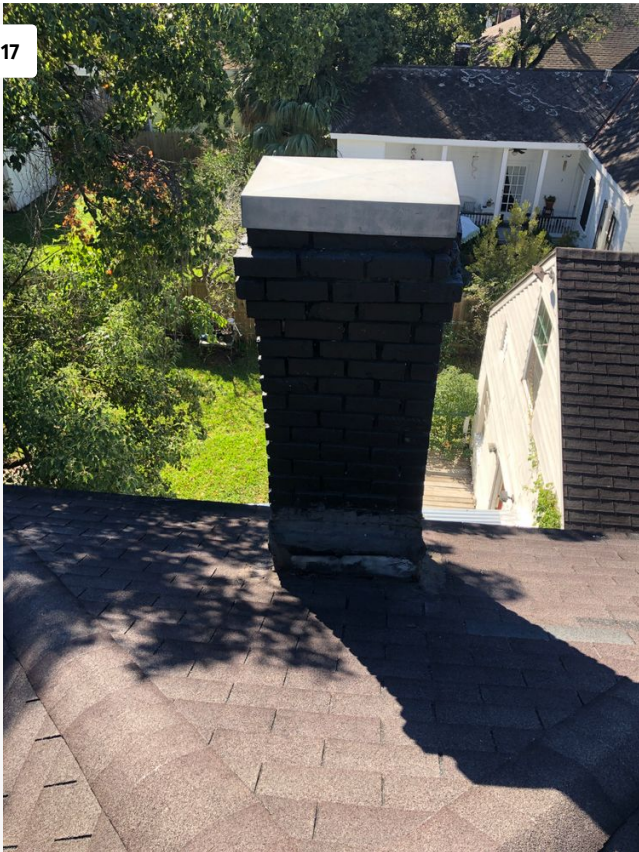
Chimney is in bad shape and needs to be removed below the roofline.

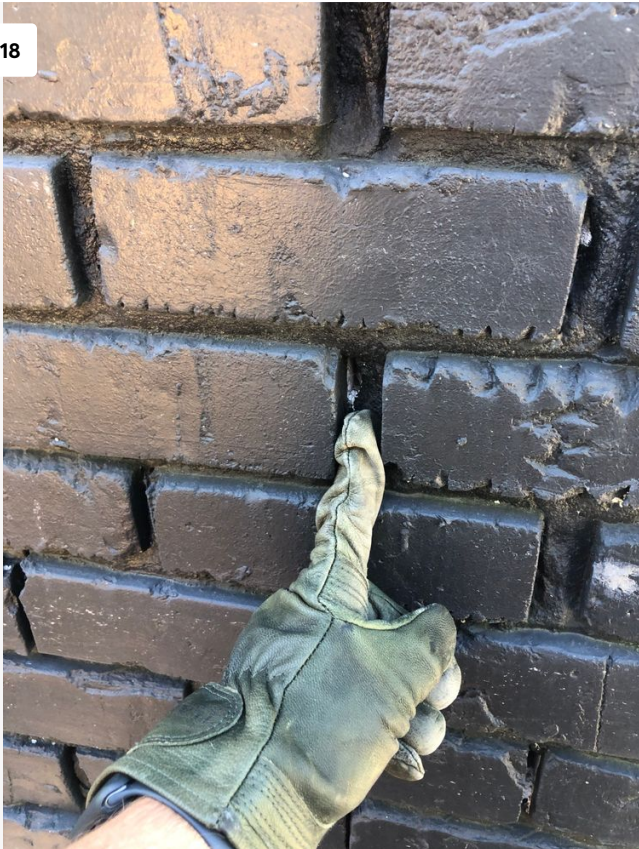
The grooves are too deep to properly cut in and set the flashing while maintaining a leak free roof.

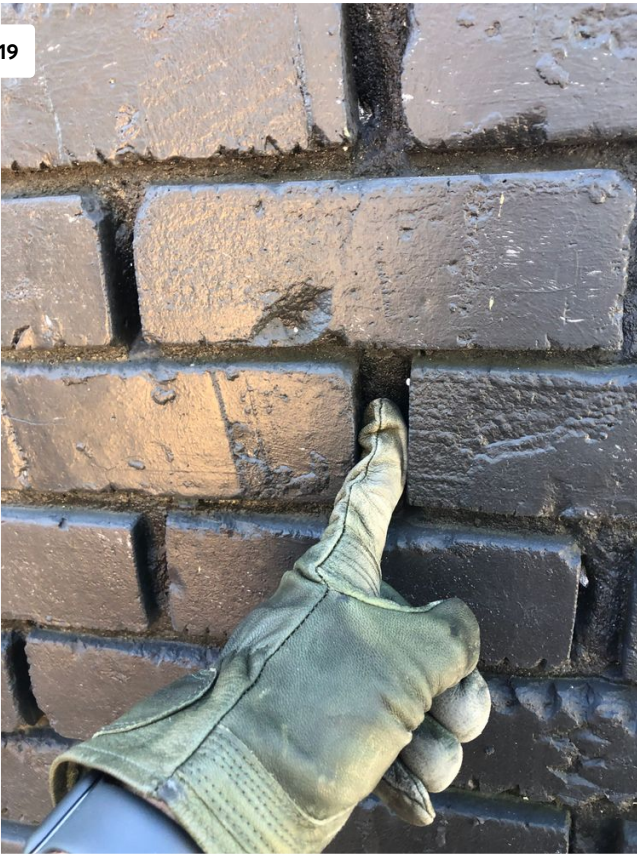
The mortar grooves are extremely deep. In order to set in flashing we use a diamond blade to cut and set flashing in. We would cut right through the chimney with the grooves this deep and the flashing would not set and seal.

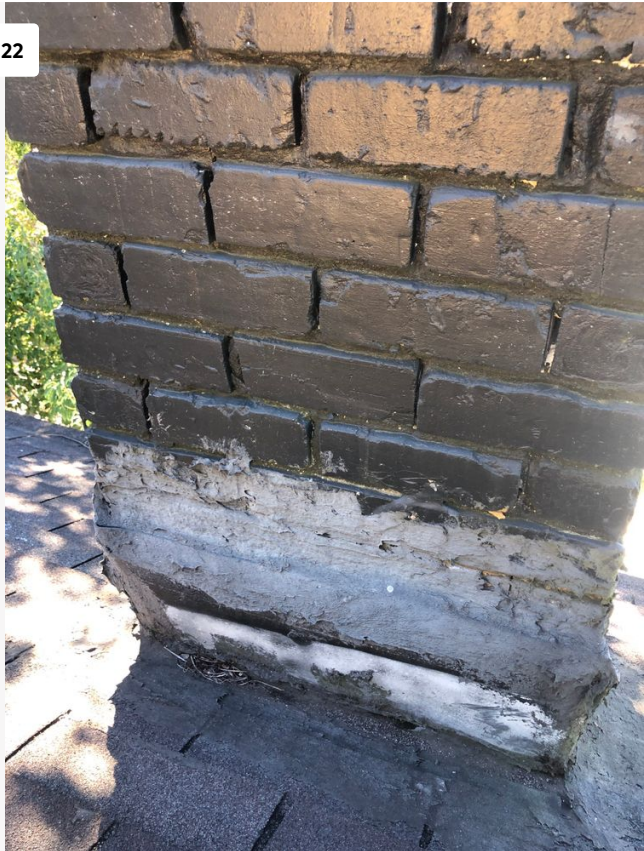
The previous extensive failed repairs show me it is not able to be repaired and properly flashed.

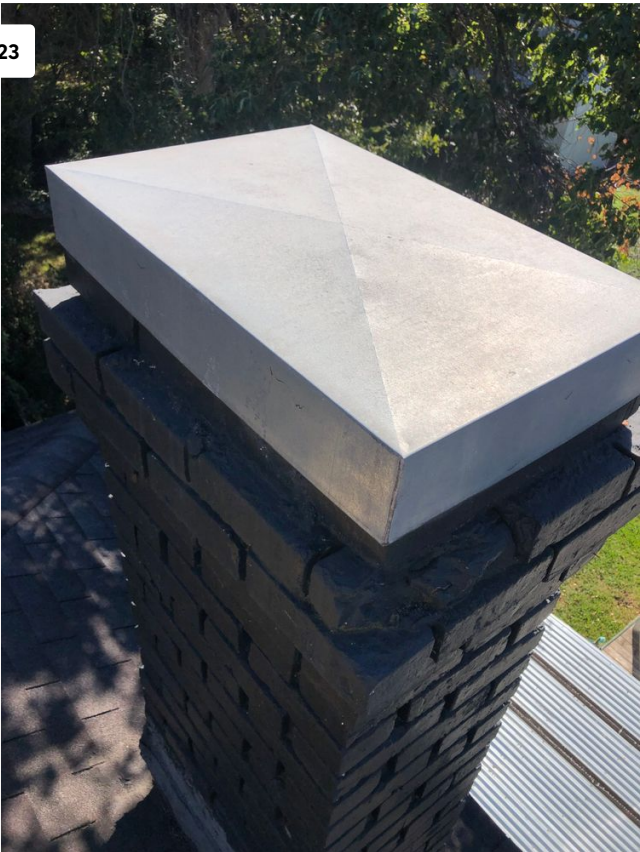
The chimney is completely capped and not in use. It serves no purpose.
