## Agenda Item #7

### Certified Record 2026-61-CA

109-111 S. Conception Street

Replace 26 existing wood windows with fully operable, single-pane wood replica windows to match the existing

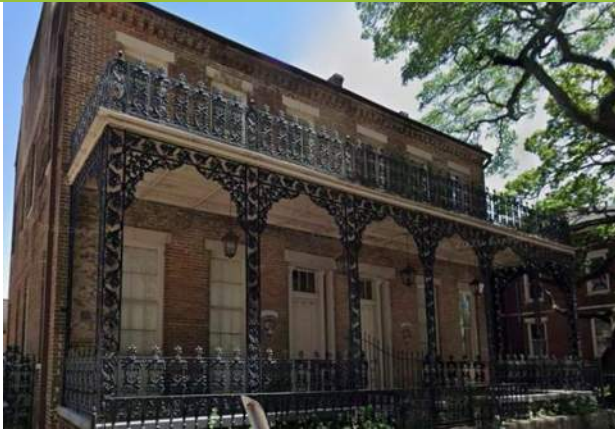
1. West façade, looking SE

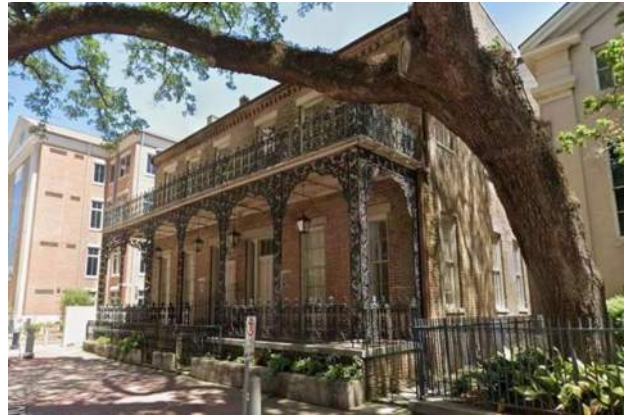
2. West façade and south elevation, looking NE

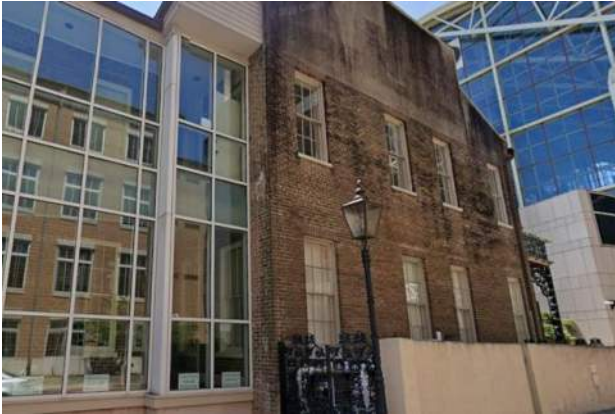
Windows on the north elevation are in the worst condition. This is common on the north sides of buildings, where limited sun exposure creates damp conditions that accelerate wood rot and deterioration. Most windowsills on the north elevation have already been replaced due to rot. Rot is common at most horizontal rails. The upper check rails have mostly failed and would require replacement. The bottom rails show signs of rot. Some of these might repaired using epoxy, but many have been previously repaired and would require replacement. Rot is also common at the vertical stiles where they attach to the lower rails. Muntins also show signs of rot where they insert into the sash, especially at the lower rails. The window labeled 2L (north side, second floor, second from the west end) is so deteriorated that the lower half of the bottom sash fell away when the window was opened to assess its condition. This window is boarded with plywood to prevent water intrusion.

3. North elevation, looking SW

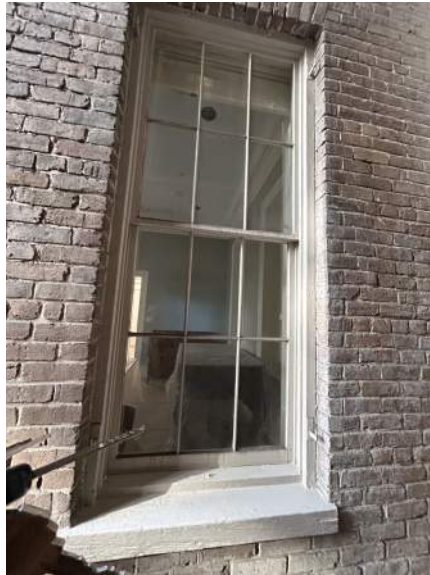
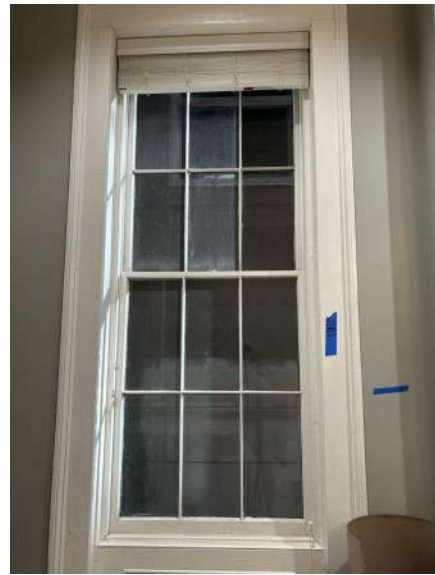
Window 1A

| Window Component | Description of Issue/Problem |
|---|---|
| Jambs | Deteriorating of jamb close to sill |
| Exterior trim & stops | Deteriorating of brick mould close to sill |

| Lowest rail | Separating sash joints, failure at mulls |
| Muntins & mullions | Water behind glazing - long term damage |
| Meeting rails (double- and single-hung) | Failure at check rail |

1A: (Fair) Deterioration of brick mould and jamb at sill area. Upper sash has failure at horizontal check rail, mullions are unstable, and glazing has failed and deteriorated allowing water intrusion. Lower sash has failure at bottom rail, mullions are unstable, and glazing has failed and deteriorated allowing water intrusion.

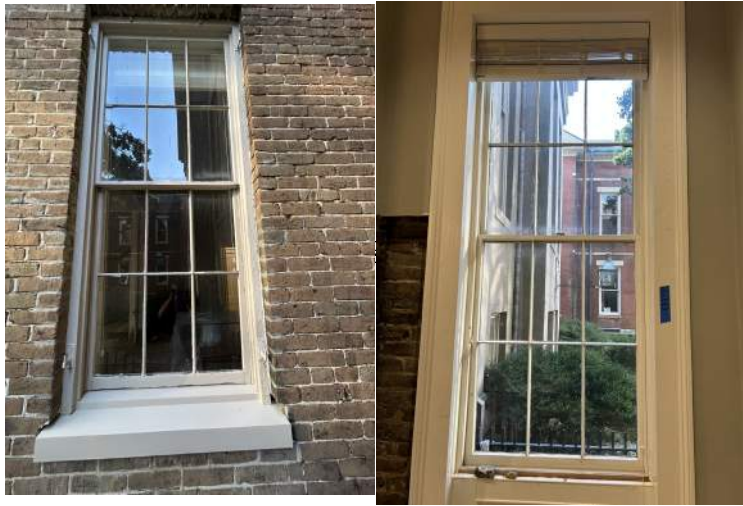
Window 1B

| Window Component | Description of Issue/Problem |
|---|---|
| Sill | Ext sill replaced due to rot |
| Jambs | Brick mould and jamb deteriorated at sill |

| Muntins & mullions | Mullions unstable causing glazing failures |
| Meeting rails (double- and single-hung) | Failure at horizontal check rail at upper sash |
| Glazing putty & gaskets | Failed, causing water intrusion |

| Weatherstripping | Missing |

1B: (Poor) Deterioration of brick mould and jamb at sill area. Timber sill rotted and replaced – requires repointing of grout to prevent water intrusion. Upper sash has failure at horizontal check rail, mullions are unstable, and glazing has failed and deteriorated allowing water intrusion. Lower sash has failure at bottom rail - rotting wood components, mullions are unstable, and glazing has failed and deteriorated allowing water intrusion.

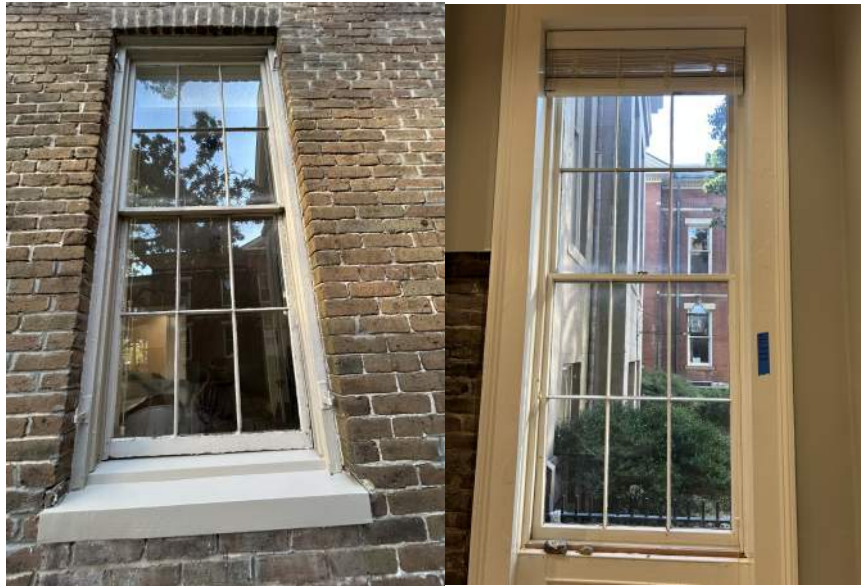
Window 1C

| Window Component | Description of Issue/Problem |
|---|---|
| Sill | Ext sill replaced due to rot |
| Jambs | Brick mould and jamb deteriorated at sill |

| Other rails & stiles | Upper sash failure at horizontal check rail |
| Muntins & mullions | Unstable and causing glazing failures |
| Glazing putty & gaskets | Failed |

| Weatherstripping | Missing |

1C: (Poor) Deterioration of brick mould and jamb at sill area. Timber sill rotted and replaced – requires repointing of grout to prevent water intrusion. Upper sash has failure at horizontal check rail, mullions are unstable, and glazing has failed and deteriorated allowing water intrusion. Lower sash has failure at bottom rail - rotting wood components, mullions are unstable, and glazing has failed and deteriorated allowing water intrusion.

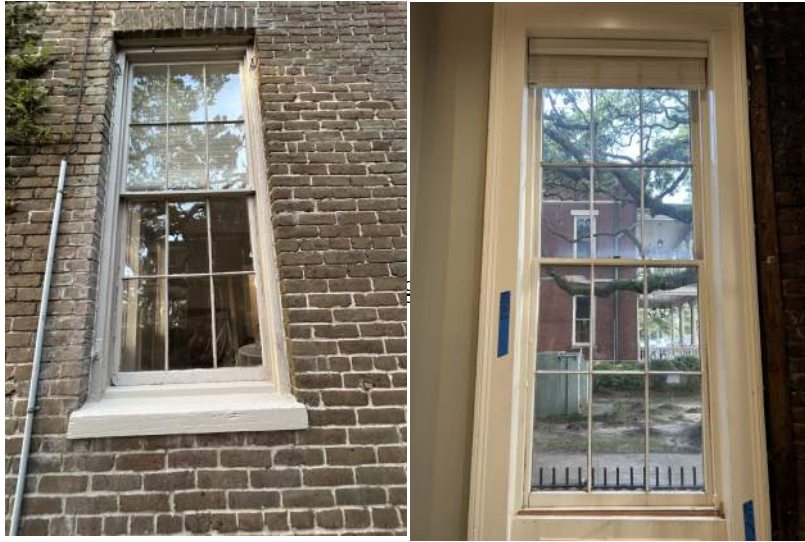
Window 1D

| Window Component | Description of Issue/Problem |
|---|---|
| Jambs | Brick mould and jamb deteriorated at sill |

| Other rails & stiles | Failure at horizontal check rail upper sash |
| Muntins & mullions | Unstable and causing glazing failures |
| Glazing putty & gaskets | Failed |

| Weatherstripping | Missing |

1D: (Poor) Deterioration of brick mould and jamb at sill area. Upper sash has failure at horizontal check rail, mullions are unstable, and glazing has failed and deteriorated allowing water intrusion. Lower sash has failure at bottom rail - rotting wood components, rotting stiles mullions are unstable, and glazing has failed and deteriorated allowing water intrusion.

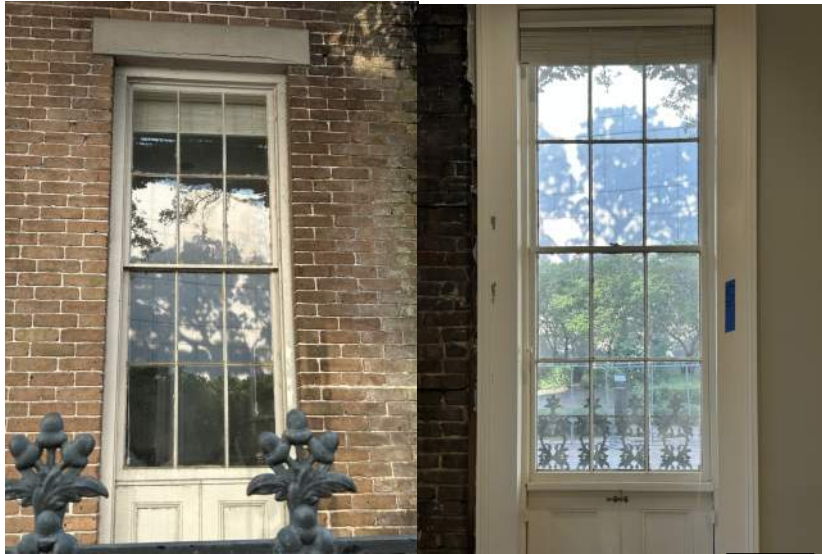
Window 1E

| Lowest rail | Failure at lowest rail of bottom sash |
| Other rails & stiles | Failure of check rail upper sash |
| Glazing putty & gaskets | Glazing failure upper and lower sash |

| Weatherstripping | Missing |

1E: (Poor) Glazing failure on upper and lower sash, failure at the check rail of the upper sash, failure at the lower rail on the lower sash.

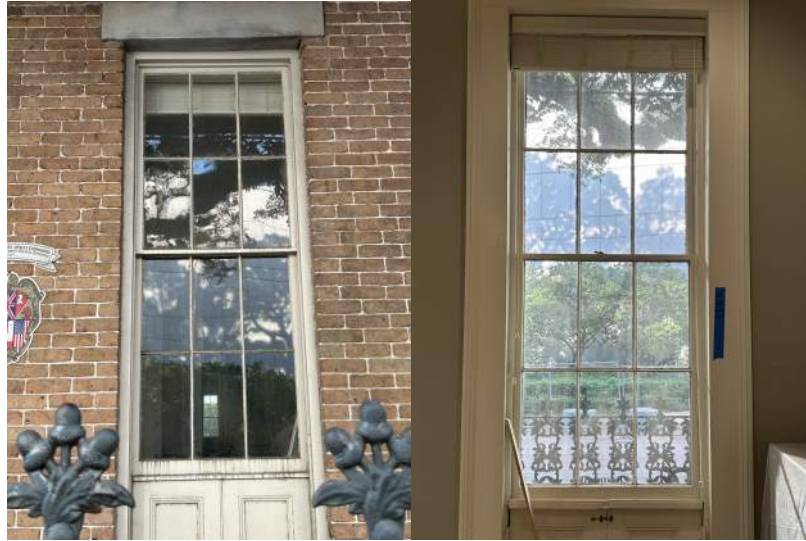
Window 1F

| Lowest rail | Failure at lowest rail of bottom sash |
| Other rails & stiles | Failure of check rail upper sash |
| Glazing putty & gaskets | Glazing failure upper and lower sash |

| Weatherstripping | Missing |

1F: (Poor) Glazing failure on upper and lower sash, failure at the check rail of the upper sash, failure at the lower rail on the lower sash.

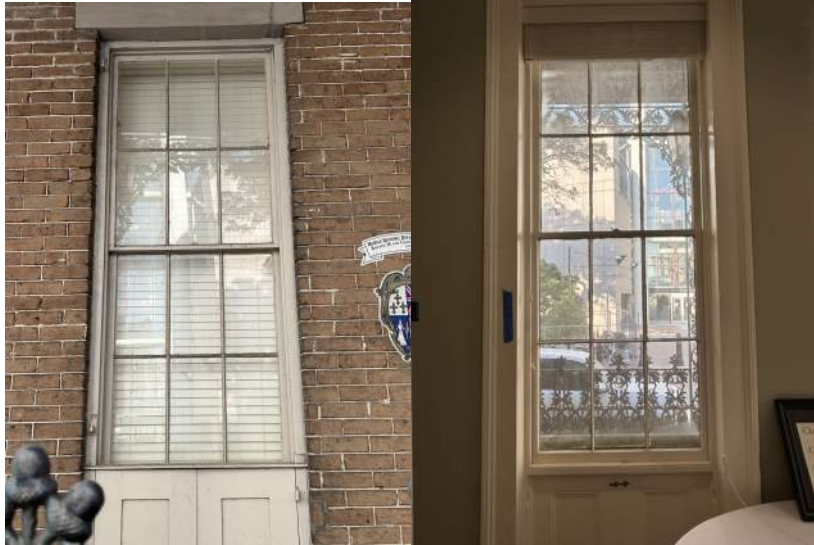
Window 11

| Lowest rail | Failure at lowest rail of bottom sash |
| Other rails & stiles | Failure of check rail upper sash |
| Glazing putty & gaskets | Glazing failure upper and lower sash |

| Weatherstripping | Missing |

1I: (Poor) Glazing failure on upper and lower sash, failure at the check rail of the upper sash, failure at the lower rail on the lower sash.

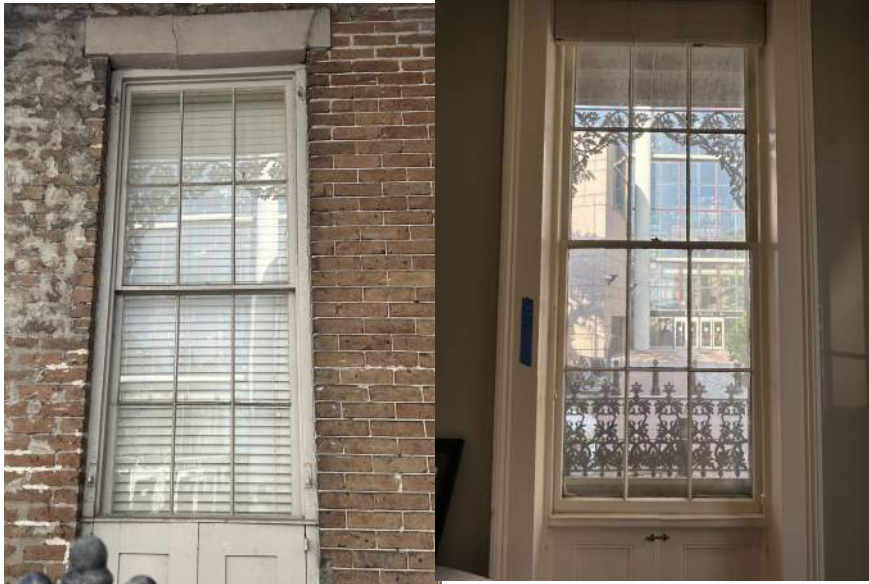
Window 1J

| Lowest rail | Failure at lowest rail of bottom sash |
| Other rails & stiles | Failure of check rail upper sash |
| Glazing putty & gaskets | Glazing failure upper and lower sash |

| Weatherstripping | Missing |

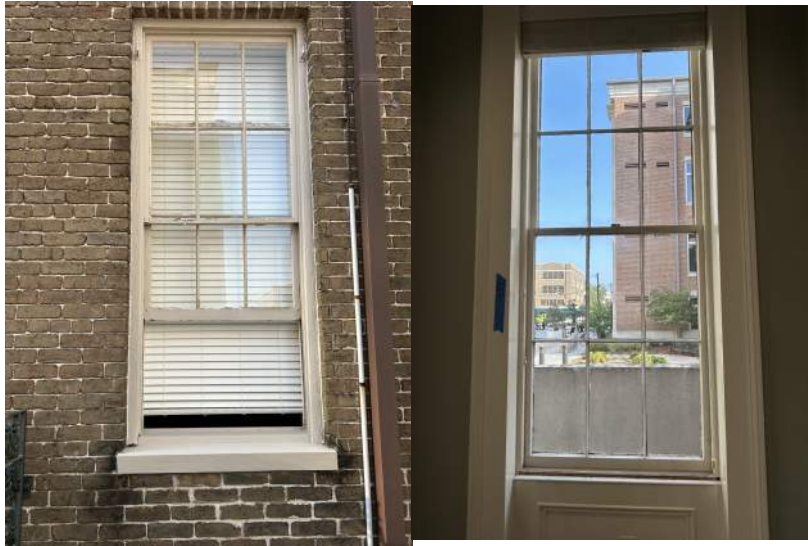
Window 1K

| Window Component | Description of Issue/Problem |
|---|---|
| Sill | Ext sill replaced due to rot |
| Jambs | Brick mould and jamb deteriorated at sill |

| Muntins & mullions | Mullions unstable causing glazing failures |
| Meeting rails (double- and single-hung) | Failure at horizontal check rail upper sash |
| Glazing putty & gaskets | Failed, causing water intrusion |

| Weatherstripping | Missing |

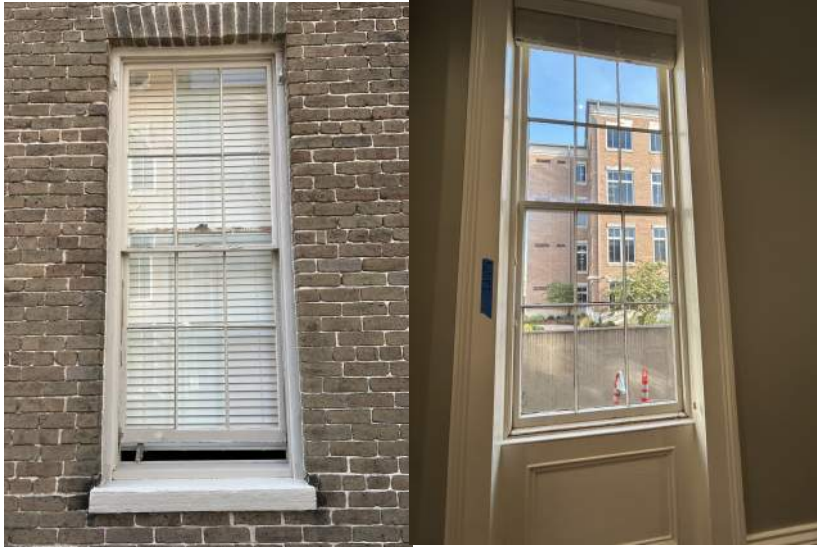
Window 1L

| Window Component | Description of Issue/Problem |
|---|---|
| Jambs | Brick mould and jamb deteriorated at sill |

| Other rails & stiles | Failure vertical stiles upper sash |
| Muntins & mullions | Mullions unstable causing glazing failures |
| Meeting rails (double- and single-hung) | Failure at horizontal check rail upper sash |
| Glazing putty & gaskets | Failed, causing water intrusion |

| Weatherstripping | Missing |

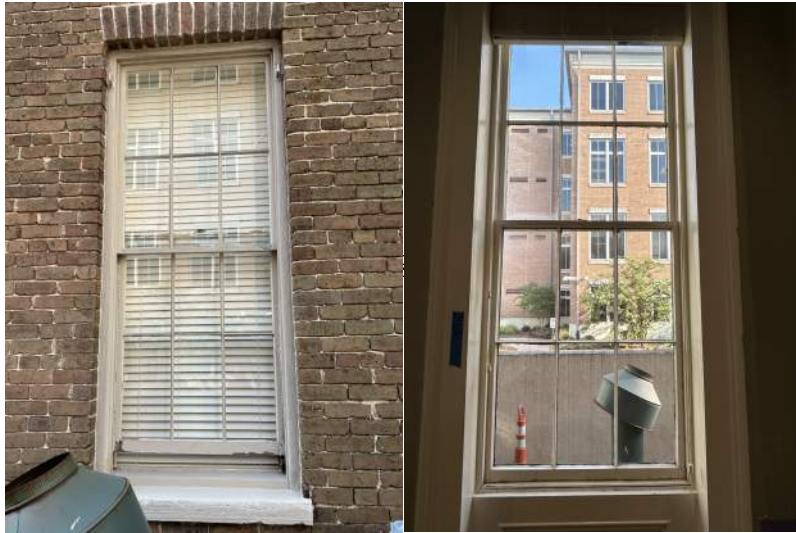
Window 1M

| Window Component | Description of Issue/Problem |
|---|---|
| Jambs | Brick mould and jamb deteriorated at sill |

| Other rails & stiles | Failure vertical stiles upper sash |
| Muntins & mullions | Mullions unstable causing glazing failures |
| Meeting rails (double- and single-hung) | Failure at horizontal check rail upper sash |
| Glazing putty & gaskets | Failed, causing water intrusion |

| Weatherstripping | Missing |

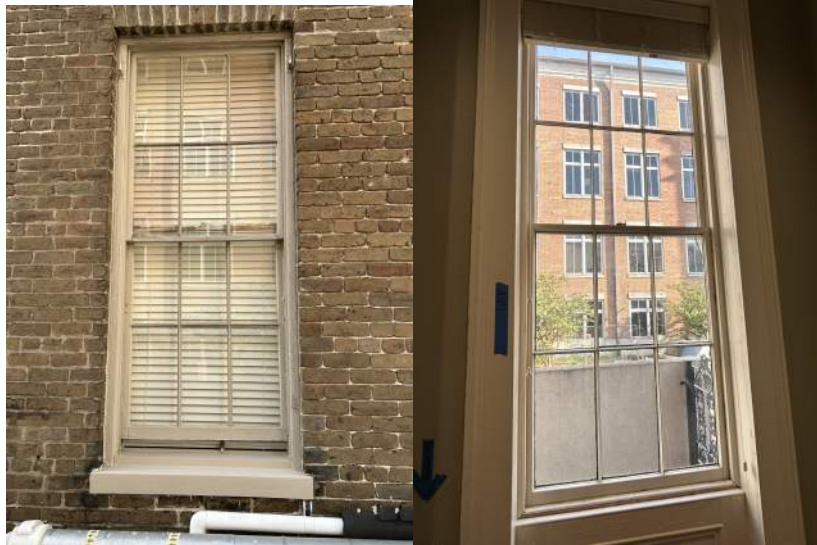
Window 1N

| Window Component | Description of Issue/Problem |
|---|---|
| Sill | Ext sill replaced due to rot |
| Jams | Brick mould and jamb deteriorated at sill |

| Other rails & stiles | Failure vertical stiles upper sash |
| Muntins & mullions | Mullions unstable causing glazing failures |
| Meeting rails (double- and single-hung) | Failure at horizontal check rail upper sash |
| Glazing putty & gaskets | Failed, causing water intrusion |

| Weatherstripping | Missing |

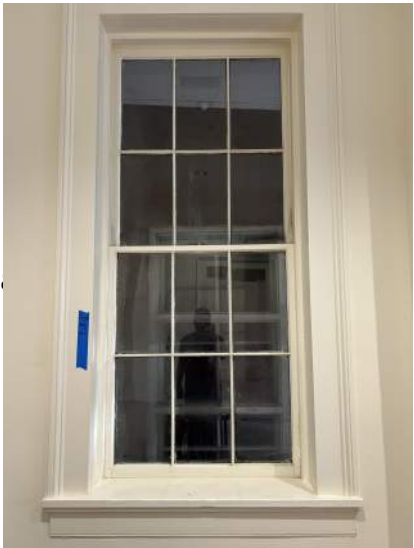
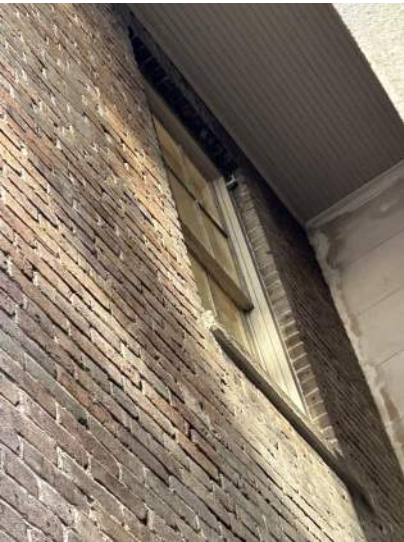
Window 2A

| Window Component | Description of Issue/Problem |
|---|---|
| Jambs | Brick mould and jamb deteriorated at sill |

| Other rails & stiles | Failure at horizontal check rail upper sash |
| Muntins & mullions | Unstable and causing glazing failures |
| Glazing putty & gaskets | Failed |

| Shutter | Missing |

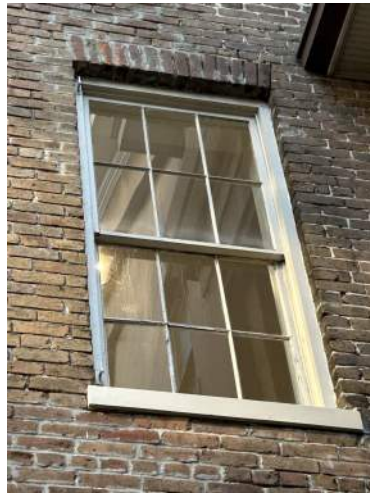
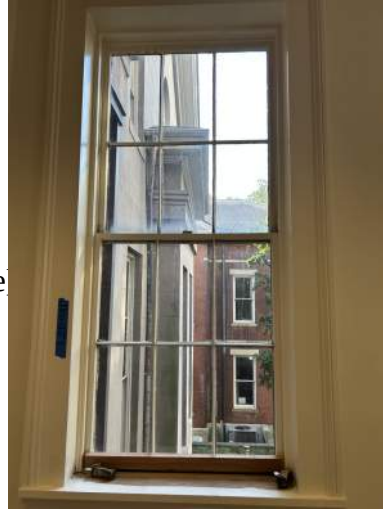
Window 2B

| Window Component | Description of Issue/Problem |
|---|---|
| Sill | Ext sill replaced due to rot |
| Jambs | Brick mould and jamb deteriorated at sill |

| Muntins & mullions | Mullions unstable causing glazing failures |
| Meeting rails (double- and single-hung) | Failure at horizontal check rail upper sash |
| Glazing putty & gaskets | Failed, causing water intrusion |

| Weatherstripping | Missing |

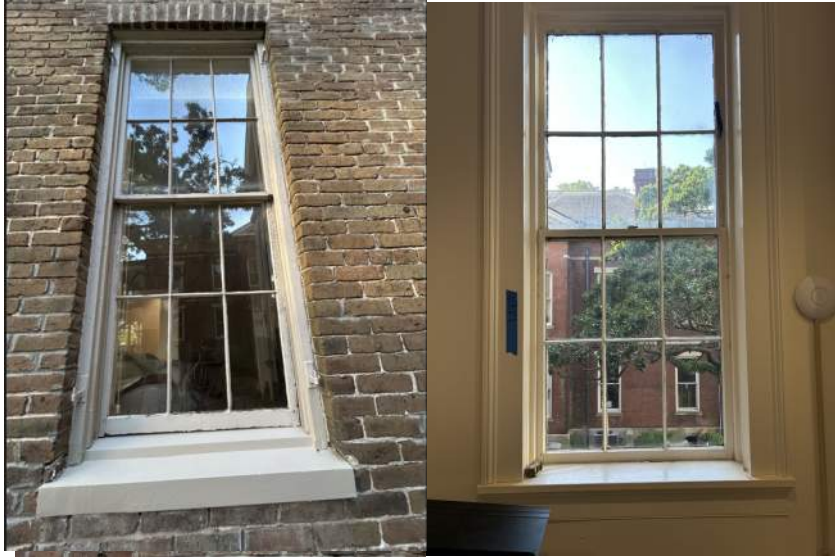
Window 2C

| Window Component | Description of Issue/Problem |
|---|---|
| Sill | Ext sill replaced due to rot |
| Jambs | Brick mould and jamb deteriorated at sill |

| Muntins & mullions | Mullions unstable causing glazing failures |
| Meeting rails (double- and single-hung) | Failure at horizontal check rail upper sash |
| Glazing putty & gaskets | Failed, causing water intrusion |

| Weatherstripping | Missing |

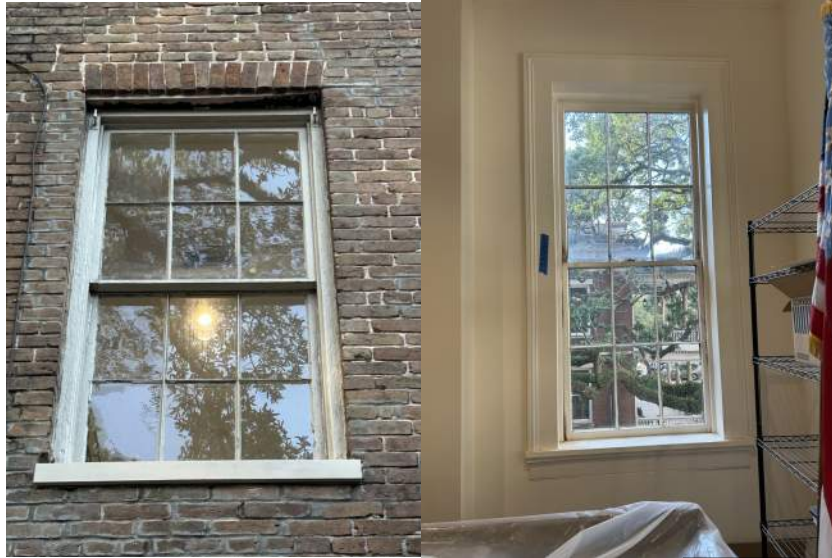
Window 2D

| Window Component | Description of Issue/Problem |
|---|---|
| Sill | Ext sill replaced due to rot |
| Jambs | Brick mould and jamb deteriorated at sill |

| Muntins & mullions | Mullions unstable causing glazing failures |
| Meeting rails (double- and single-hung) | Failure at horizontal check rail upper sash |
| Glazing putty & gaskets | Failed, causing water intrusion |

| Weatherstripping | Missing |

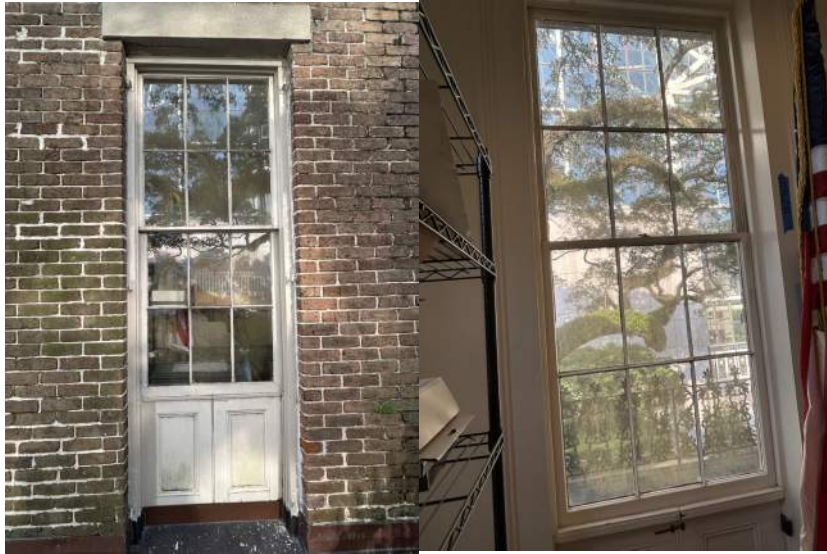
Window 2E

| Window Component | Description of Issue/Problem |
|---|---|
| Muntins & mullions | Mullions unstable causing glazing failures |
| Meeting rails (double- and single-hung) | Failure at horizontal check rail upper sash |
| Glazing putty & gaskets | Failed, causing water intrusion |
| Weatherstripping | Missing |

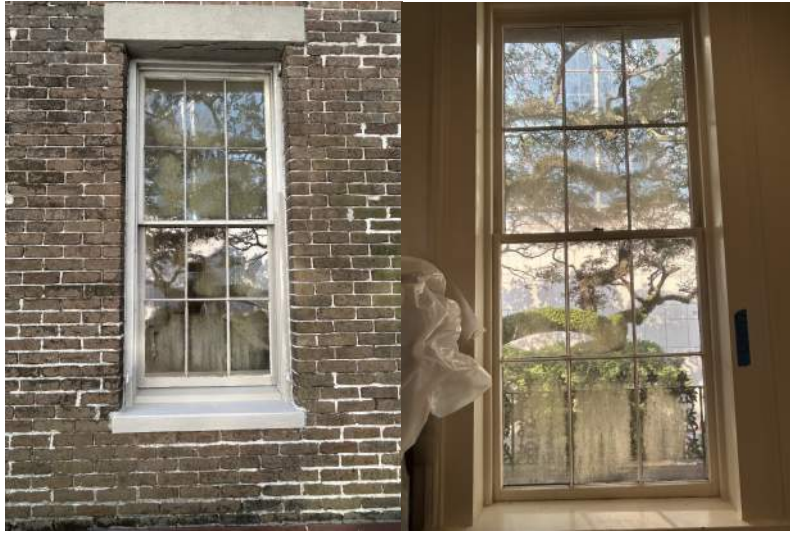
Window 2F

| Window Component | Description of Issue/Problem |
|---|---|
| Sill | Ext sill replaced due to rot |
| Jambs | Brick mould and jamb deteriorated at sill |

| Muntins & mullions | Mullions unstable causing glazing failures |
| Meeting rails (double- and single-hung) | Failure at horizontal check rail upper sash |
| Glazing putty & gaskets | Failed, causing water intrusion |

| Weatherstripping | Missing |

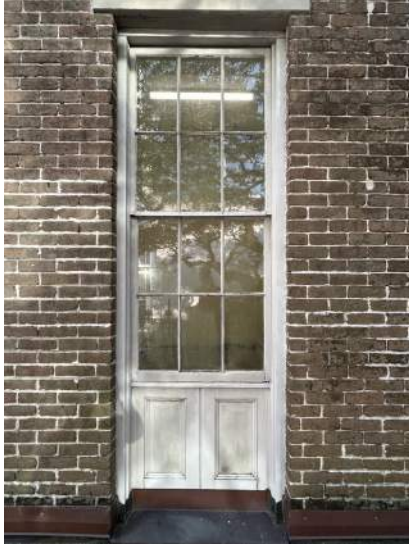
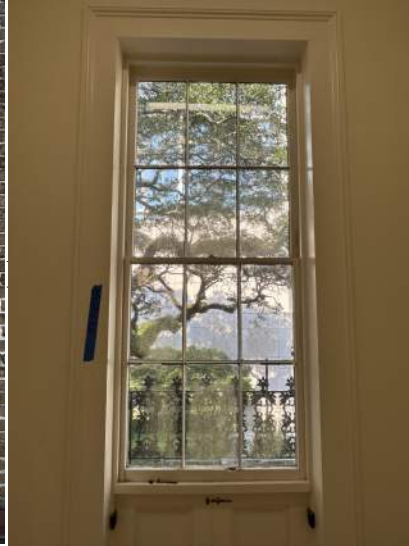
Window 2G

| Window Component | Description of Issue/Problem |
|---|---|
| Jambs | Brick mould and jamb deteriorated at sill due to long term water intrusion |
| Muntins & mullions | Mullions unstable causing glazing failures |
| Meeting rails (double- and single-hung) | Failure at horizontal check rail upper sash |
| Glazing putty & gaskets | Failed, causing water intrusion |
| Weatherstripping | Missing |

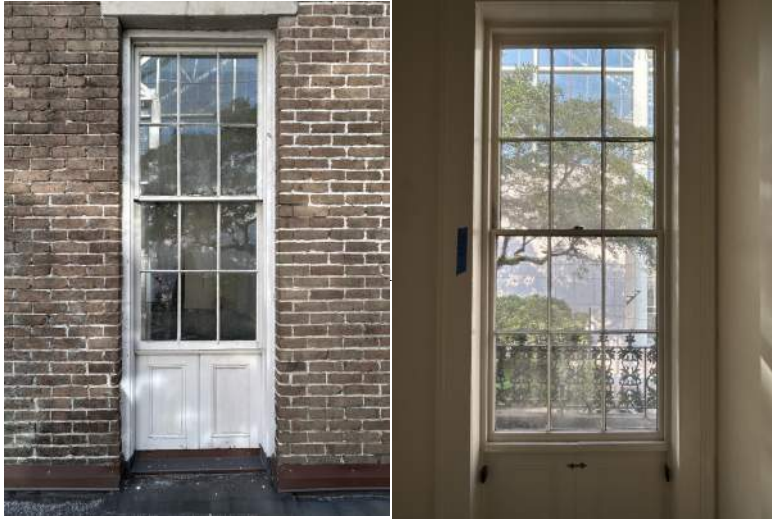
Window 2H

| Window Component | Description of Issue/Problem |
|---|---|
| Jambs | Brick mould and jamb deteriorated at sill due to long term water intrusion |
| Muntins & mullions | Mullions unstable causing glazing failures |
| Meeting rails (double- and single-hung) | Failure at horizontal check rail upper sash |
| Glazing putty & gaskets | Failed, causing water intrusion |
| Weatherstripping | Missing |

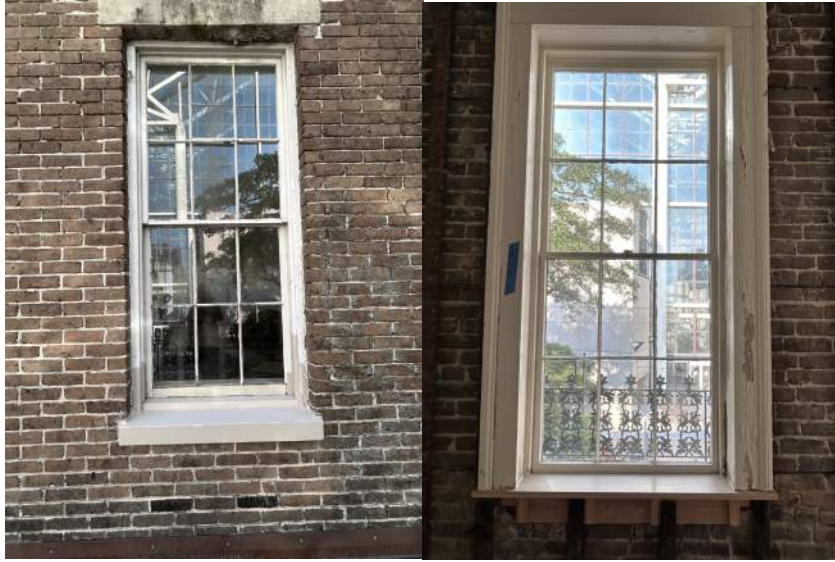
Window 21

| Window Component | Description of Issue/Problem |
|---|---|
| Sill | Ext sill replaced due to rot |
| Jambs | Brick mould and jamb deteriorated at sill |

| Muntins & mullions | Mullions unstable causing glazing failures |
| Meeting rails (double- and single-hung) | Failure at horizontal check rail upper sash |
| Glazing putty & gaskets | Failed, causing water intrusion. Glazing falling out |

| Weatherstripping | Missing |

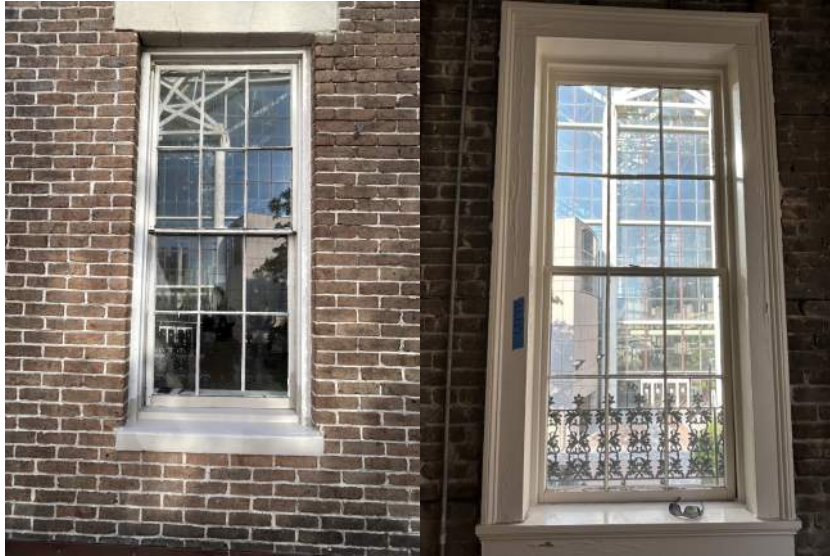
Window 2J

| Window Component | Description of Issue/Problem |
|---|---|
| Sill | Ext sill replaced due to rot |
| Jambs | Brick mould and jamb deteriorated at sill |
| Interior wall surface | Removed due to water intrusion. Waiting to replace until windows addressed |

| Muntins & mullions | Mullions unstable causing glazing failures |
| Meeting rails (double- and single-hung) | Failure at horizontal check rail upper sash |
| Glazing putty & gaskets | Failed, causing water intrusion |

| Weatherstripping | Missing |

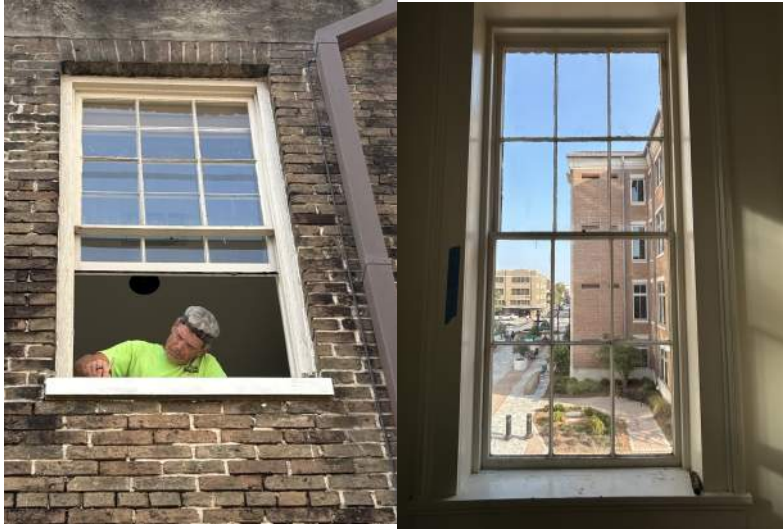
Window 2K

| Window Component | Description of Issue/Problem |
|---|---|
| Sill | Ext sill replaced due to rot |
| Jambs | Brick mould and jamb deteriorated at sill |

| Muntins & mullions | Mullions unstable causing glazing failures |
| Meeting rails (double- and single-hung) | Failure at horizontal check rail upper sash |
| Glazing putty & gaskets | Failed, causing water intrusion. Glazing falling out |

| Weatherstripping | Missing |

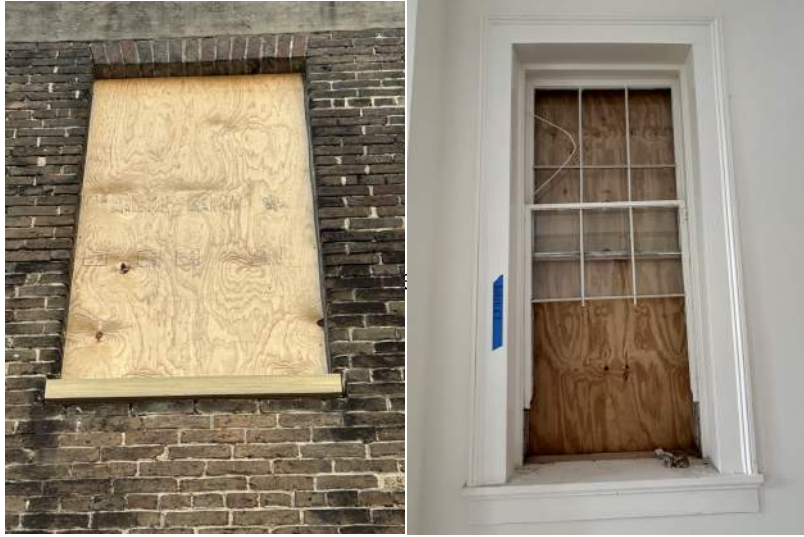
Window 2L

| Window Component | Description of Issue/Problem |
|---|---|
| Sill | Ext sill replaced due to rot |
| Jambs | Brick mould and jamb deteriorated at sill |

| Muntins & mullions | Mullions unstable causing glazing failures |
| Meeting rails (double- and single-hung) | Failure at horizontal check rail upper sash |
| Glazing putty & gaskets | Failed, causing water intrusion. Glazing falling out |

| Weatherstripping | Missing |

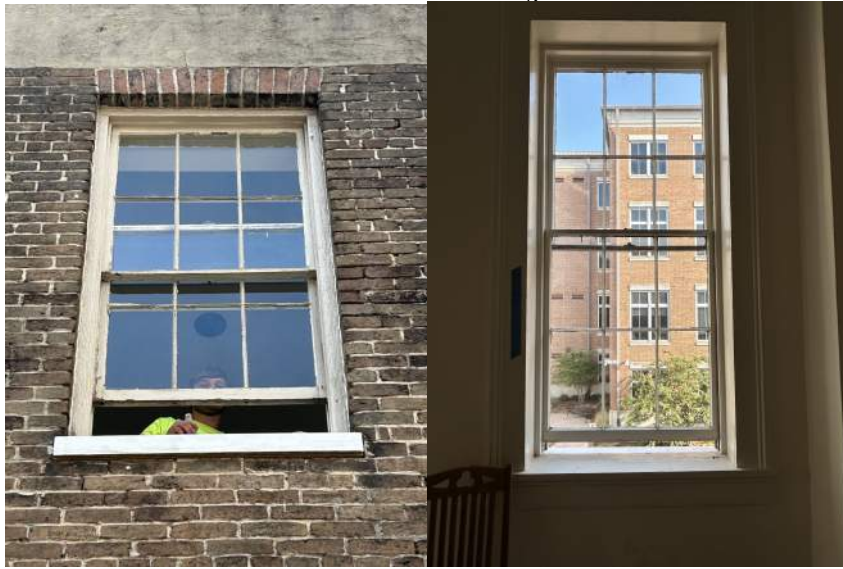
Window 2M

| Window Component | Description of Issue/Problem |
|---|---|
| Sill | Ext sill replaced due to rot |
| Jambs | Brick mould and jamb deteriorated at sill |

| Muntins & mullions | Mullions unstable causing glazing failures |
| Meeting rails (double- and single-hung) | Failure at horizontal check rail upper sash |
| Glazing putty & gaskets | Failed, causing water intrusion. Glazing falling out |

| Weatherstripping | Missing |

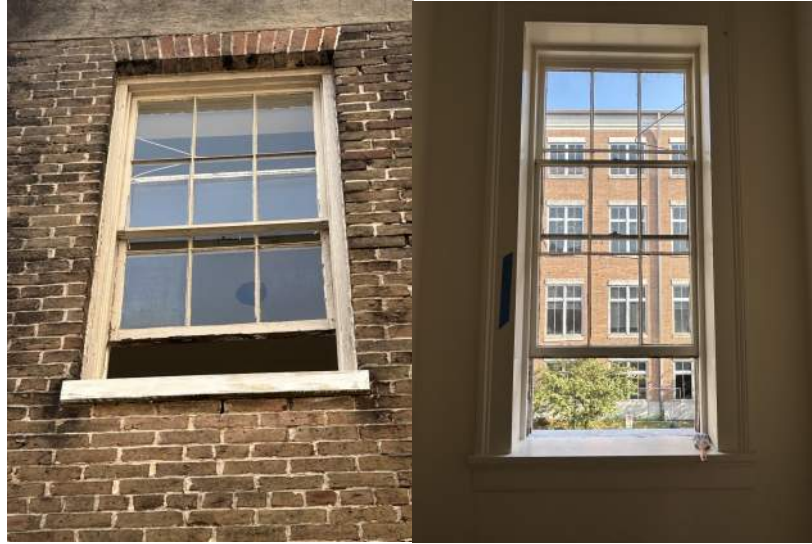
Window 2N

| Window Component | Description of Issue/Problem |
|---|---|
| Sill | Ext sill replaced due to rot |
| Jambs | Brick mould and jamb deteriorated at sill |

| Muntins & mullions | Mullions unstable causing glazing failures |
| Meeting rails (double- and single-hung) | Failure at horizontal check rail upper sash |
| Glazing putty & gaskets | Failed, causing water intrusion. Glazing falling out |

| Weatherstripping | Missing |

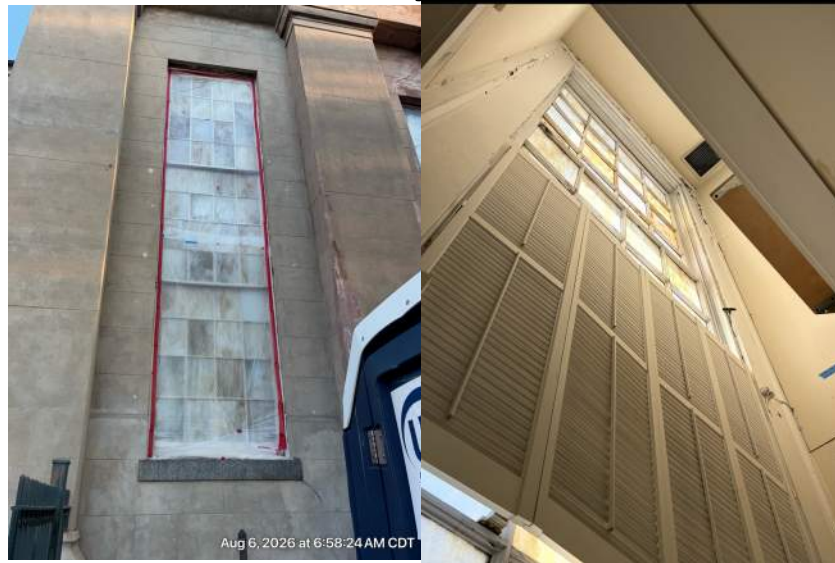
Sacristy Window

| Window Component | Description of Issue/Problem |
|---|---|
| Interior trim & stops | Interior trim is completely rotten, as is the framing holding the window in place. All will have to be replaced |

| Lowest rail | Termite and water intrusion damage to all rails, all stiles, and all mullions |
