Agenda Item #1

Application 2025-30-CA

1159 Old Shell Road

After-the-fact window and column replacement on façade; Paint applied to brick porch wall

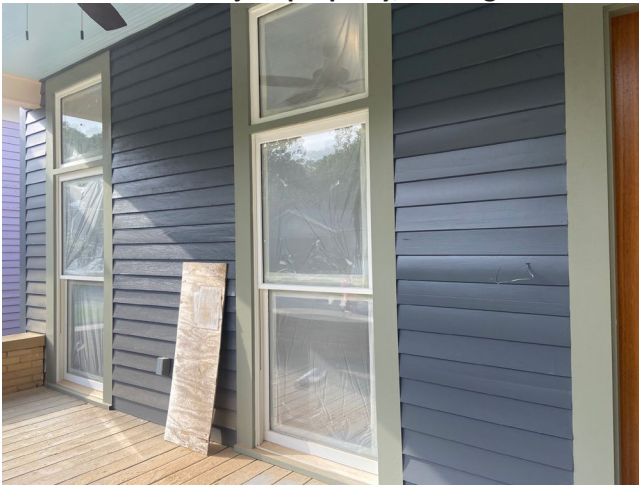
The replacement window arrangement installed in each of the box head window openings consists of a wood one-over-one window below a lintel board, with a fixed single-light window above. This is an inappropriate alternative to the full-length window previously extant in these openings and considerably alters the stylistic expression of the façade.

3. Detail of replacement windows on façade

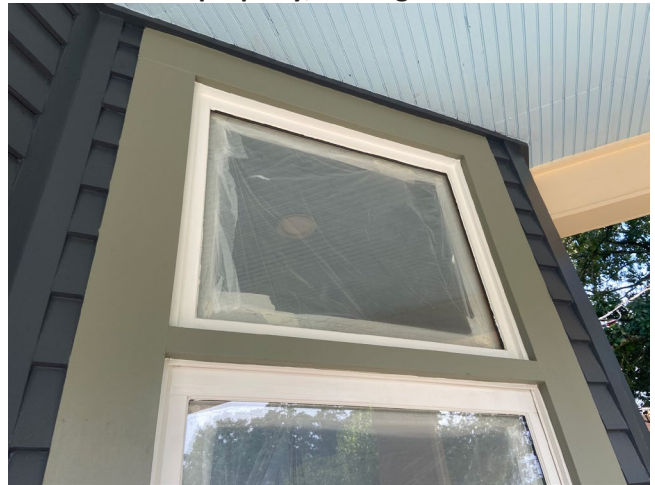
4. Detail of replacement window on façade

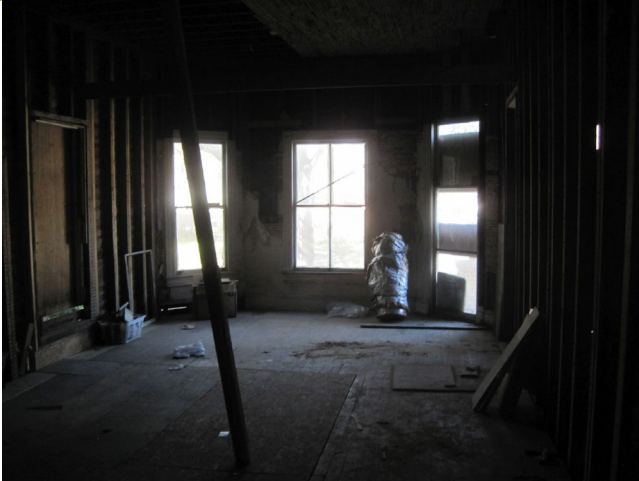
7. Interior view of bay window sashes in place (May 2024)

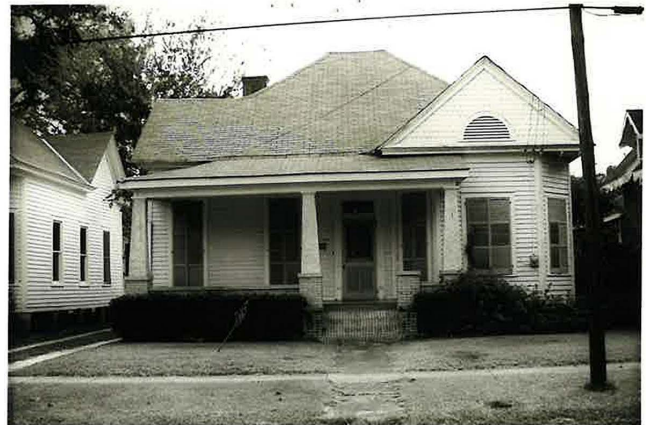
The current replacement columns lack the dimensionality provided by the taper and the paneling seen on the original columns in historic photographs. The use of Hardie board, though not congruent with what was submitted by the applicant, is a suitable replacement material as noted in guideline 5.19 above; however, the flatter profile of the replacement columns produces an overall look of inferior craftsmanship and does not appropriately convey the craftsman styling of the historic porch. (5.3, 5.4, 5.6)

8. Historic survey photo showing craftsman porch and columns.

- After discussion with HD Staff, the applicant agreed to taper the porch columns.
- A letter from Oakleigh Woodworks was submitted to Staff providing a condition assessment of the three full-length windows original to the façade.

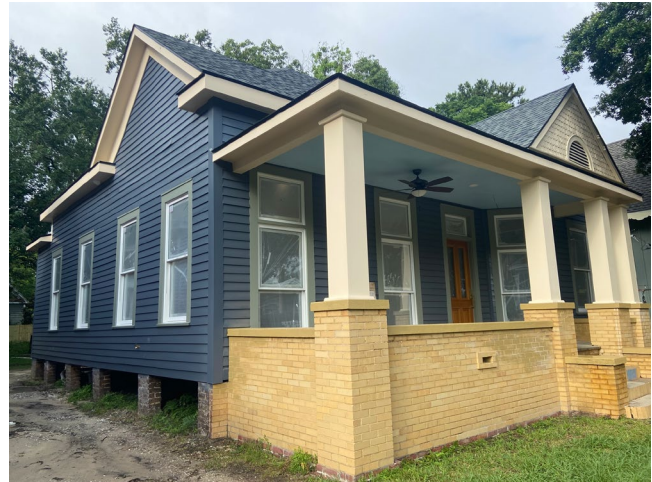
The previously existing wood one-over-one windows on the east and west elevations were proposed and approved to be repaired, according to the submitted plans and approved scope of work (SOW). They have been replaced with wood one-over-one windows that fit the existing openings. The material, dimensions and light configuration are in keeping with the original, with a flatter profile.

10. View of east elevation replacement windows.

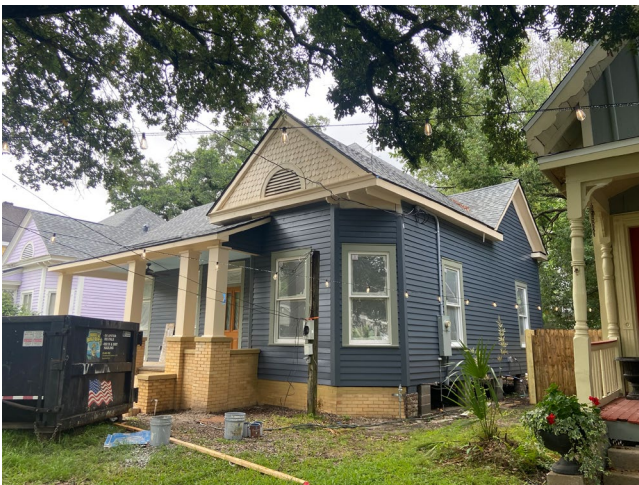
11. View of west elevation replacement windows.

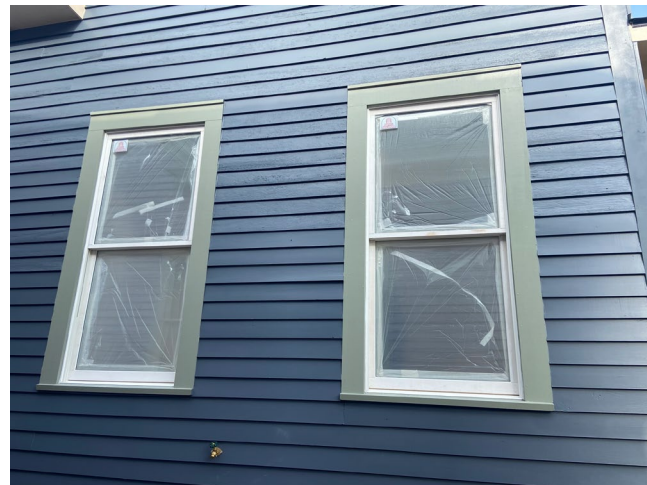
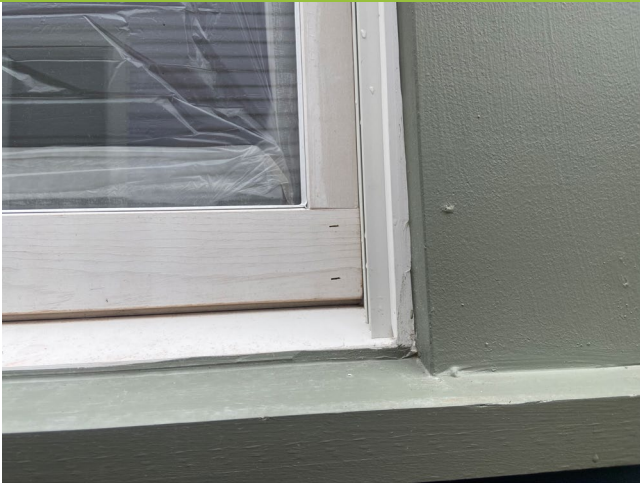
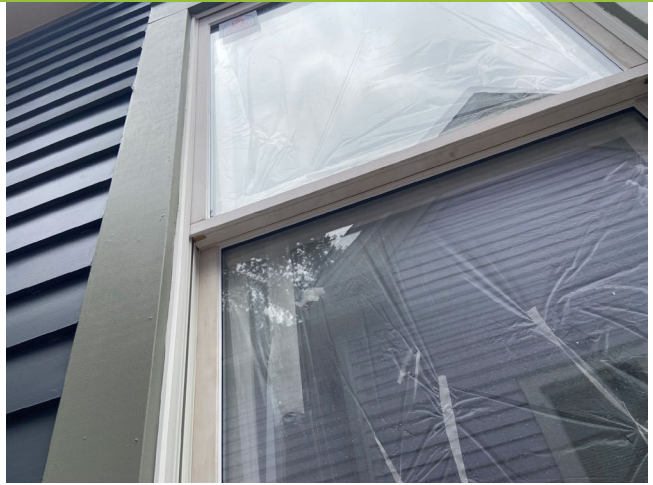
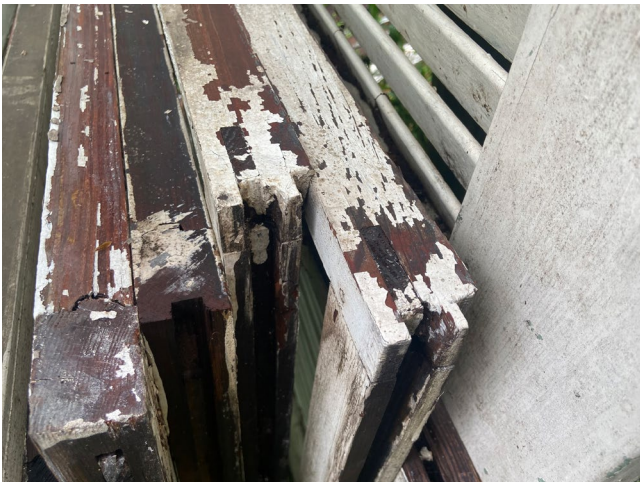
12. Detail of replacement one-over-one windows.

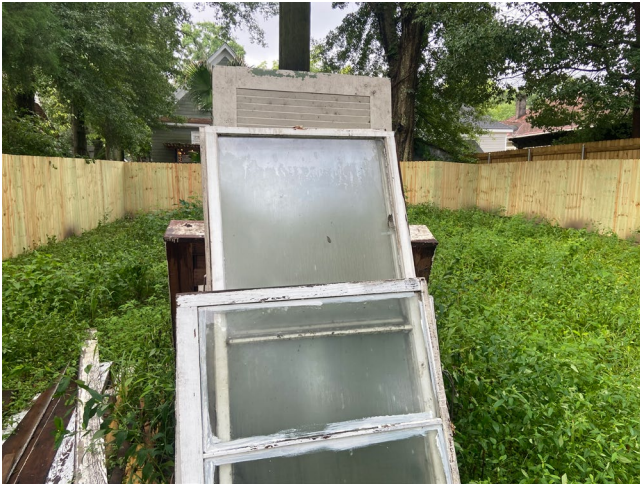
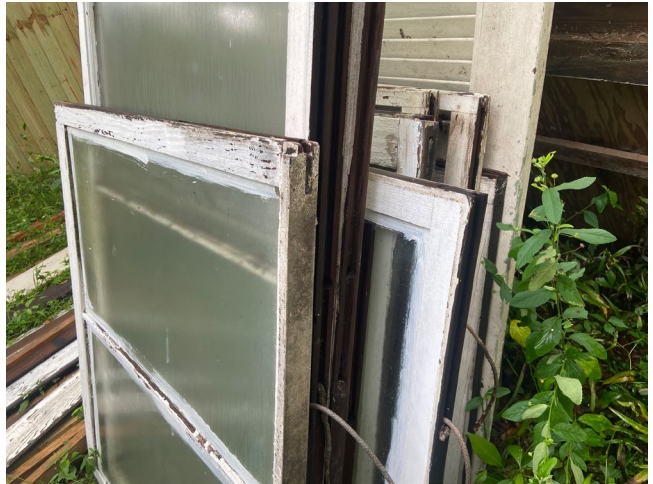
During the site visit, historic windows were found on the property. These windows appear to be the original box head windows removed from the façade, and potentially those from the bay window as well. The windows seem to be in good repairable condition. Also discovered was a dumpster containing removed trim.

15. Removed historic windows

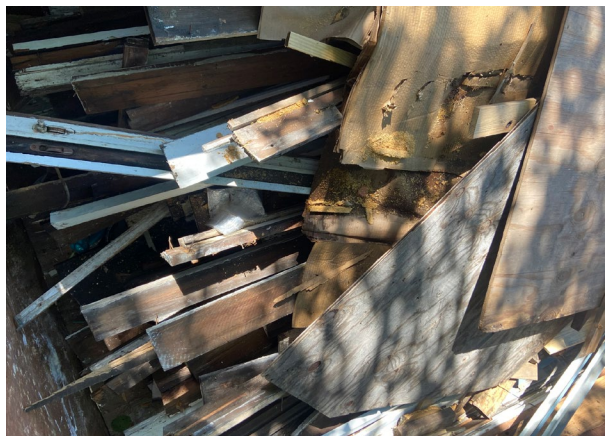
18. Removed trim
