Agenda Item #2 Application 2025-28-CA

273 Park Terrace

Window replacement

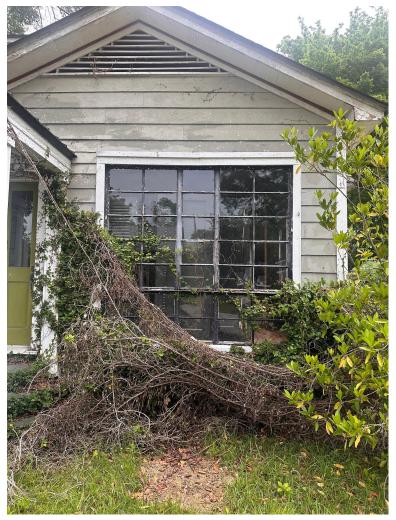
Front Right Windows— will be replaced with the below windows to provide identical look.

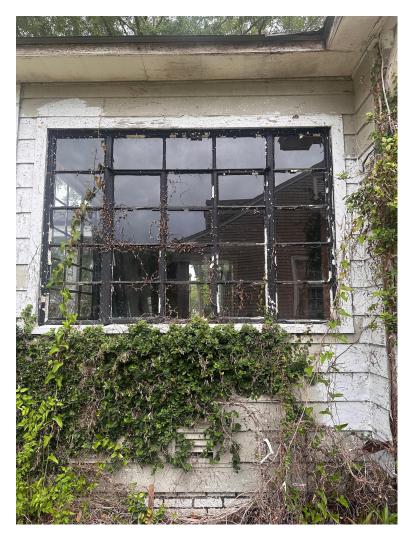
Left Side window— replace with below window to replicate look

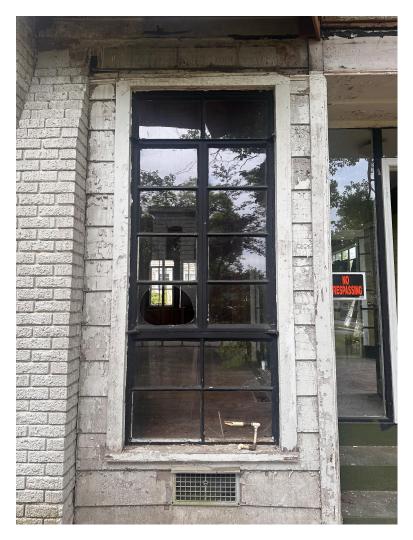
Left Side Window— will be replaced with the below custom window to provide exact look.

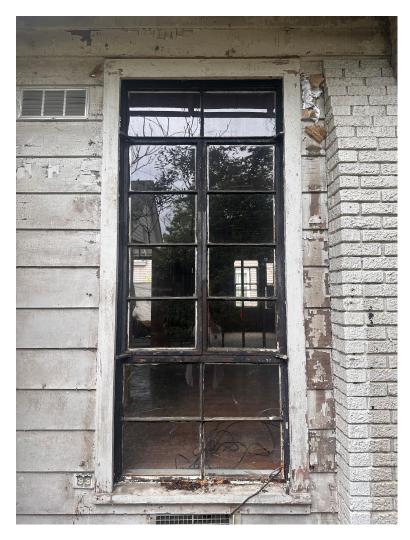
Left Side Window— will be replaced with the below custom window to provide exact look.

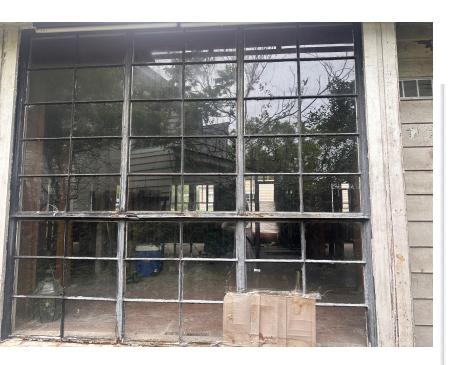
Left Dining Window— will be replaced with the below custom window to provide exact look.

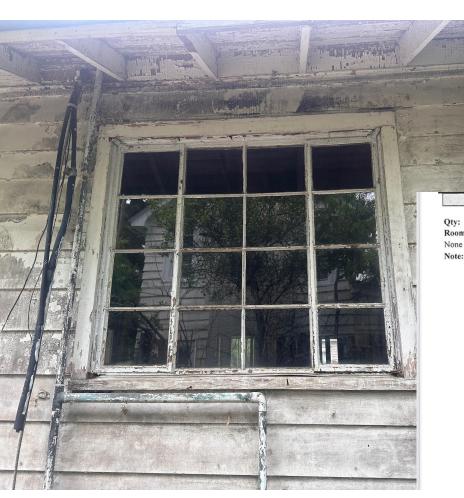
Left Kitchen Window— will be replaced with the below custom window to provide exact look.

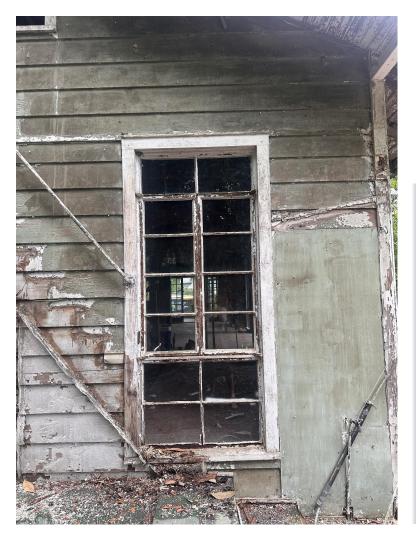
Back Window— will be replaced with the below custom window to provide exact look.

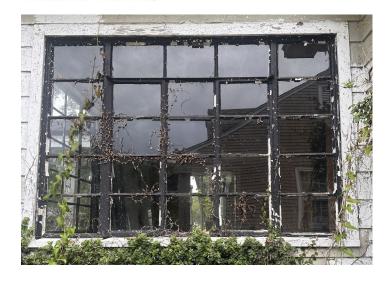
South Elevation

Window Component	Description of Issue/Problem
FRAME	
Sill	The wooden sill has water damage and rot in many places.
Jambs	The exterior trim has many areas of complete corrosion that would make it nearly impossible to remove while ensuring it remains intact to restore.
Exterior trim & stops	The interior trim has lots of rust and some corrosion occurring
Interior trim & stops	Plaster– Damaged with water intrusion causing cracking/moisture issues
Interior wall surface

SASH	These windows are stationary and do not have moveable sashes
Lowest rail	A large amount of corroded material along the lowest rail of the 5x5 sash
Other rails & stiles	
Muntins & mullions	Many areas of corrosion present throughout the unit
Meeting rails (double- and single-hung)	
Glazing putty & gaskets

FUNCTION	These windows are stationary and do not have function, they are one unit with no movement
Handles	
Movement mechanics	
Locks	
"Square"	
Weatherstripping

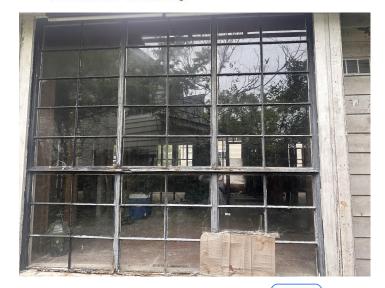
North Elevation

Window Component	Description of Issue/Problem
FRAME	
Sill	The wooden sill has severe water damage and rot, complete deterioration in many spots.
Jambs	
Exterior trim & stops	Rust and corrosion present throughout beyond repair
Interior trim & stops	Rust and corrosion present throughout
Interior wall surface	Plaster– Damaged with water intrusion causing cracking/moisture issues

SASH	
Lowest rail	The entire bottom rail is completely corroded and deteriorated.
Other rails & stiles	Major areas of rust and corrosion along other rails. Major bow between bottom 3 units and top
Muntins & mullions	Some major and other minor areas of rust and corrosion.
Meeting rails (double- and single-hung)	
Glazing putty & gaskets

FUNCTION	These windows are stationary and do not have the capability for movement.
Handles	
Movement mechanics	
Locks	
"Square"	
Weatherstripping

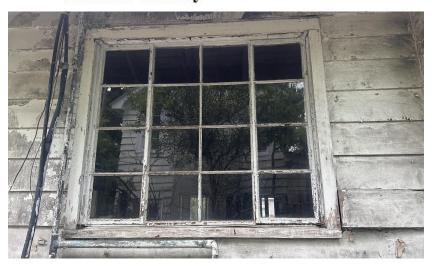
North Elevation

Window Component	Description of Issue/Problem
FRAME	•
Sill	The wooden sill has severe water damage and rot.
Jambs	
Exterior trim & stops	Rust and corrosion present throughout beyond repair
Interior trim & stops	Rust and corrosion present throughout
Interior wall surface	Plaster– Damaged with water intrusion causing cracking/moisture issues

SASH	
Lowest rail	Rust and corrosion present across the lowest rail beyond repair.
Other rails & stiles	
Muntins & mullions	Some major and other minor areas of rust and corrosion.
Meeting rails (double- and single-hung)	
Glazing putty & gaskets

FUNCTION	These windows are stationary and do not have the capability for movement.
Handles	
Movement mechanics	
Locks	
"Square"	
Weatherstripping
