# Agenda Item #1

## Application 2025-33-CA

61 N. Reed Avenue

Replace six porch columns with fiberglass columns.  
Rebuild three double bases.

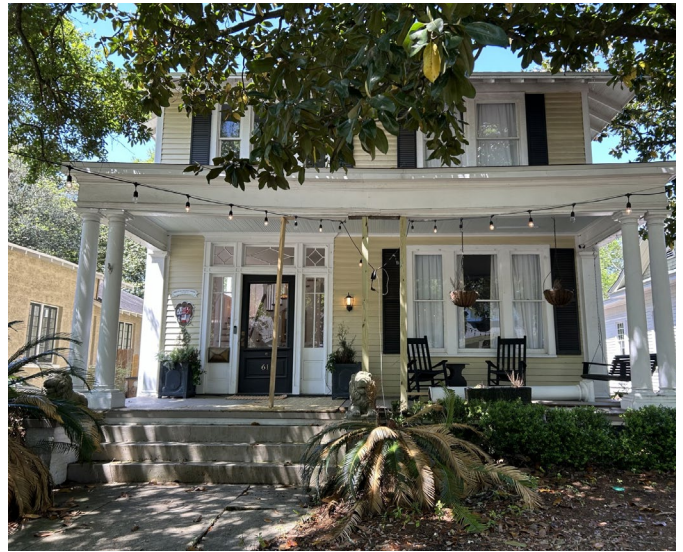
**2. Location of removed columns, looking E**

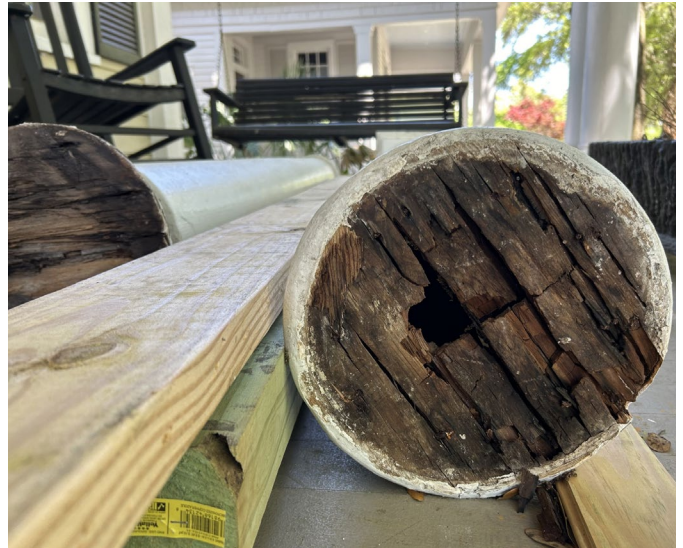
The applicant received a COA in February 2025 to replace the larger wood base on which the center paired columns rest. When the columns were removed to carry out the base replacement, significant deterioration was discovered near the base of the columns. In April 2025, the applicant applied to replace the two (2) deteriorated wood columns with fiberglass columns. The staff report and meeting discussion deemed the columns beyond repair. A schematic of the proposed replacement column was submitted which closely matched the profile of the original columns, with a noted slight departure in molding detail at the capital and base. With agreement from the applicant, the Board gave conditional approval for the two replacement fiberglass columns, contingent on Staff approval of a resubmitted replacement column design that matched the original columns (and therefore the remaining four original wood columns) exactly. Over the following months, the applicant attempted to acquire an exact match, staying in touch with Staff. They ultimately discovered that fiberglass columns could not be reproduced to a 100% match to the original design. Additionally, ordering wood columns to be milled identically to the original are extremely cost prohibitive to the owner. The subject application is an alternative solution: replacing all six (6) columns with fiberglass replacements in the previous submitted design which would result in six matching replacement columns that express a very similar profile to the original but are not an exact match. The applicant has determined that this option is much more financially feasible than ordering two duplicate wood columns. Although not identical, the submitted design is an appropriate profile which is consistent with the classical expression of the structure and would minimally impact the stylistic details of the front porch, given the proposal of wholesale replacement.

**4. Detail of deteriorated column 1**

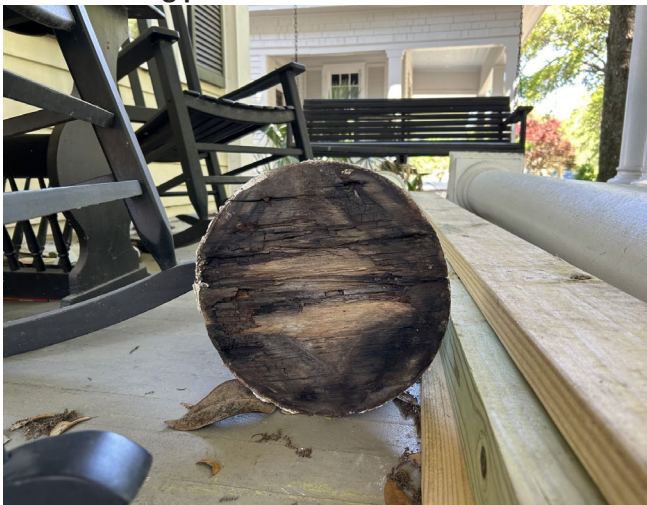
**5. Detail of deteriorated column 2**
