Agenda Item #2

Application 2024-06-CA

113 Parker Street

Remove existing knee wall around porch.
Replace existing columns.

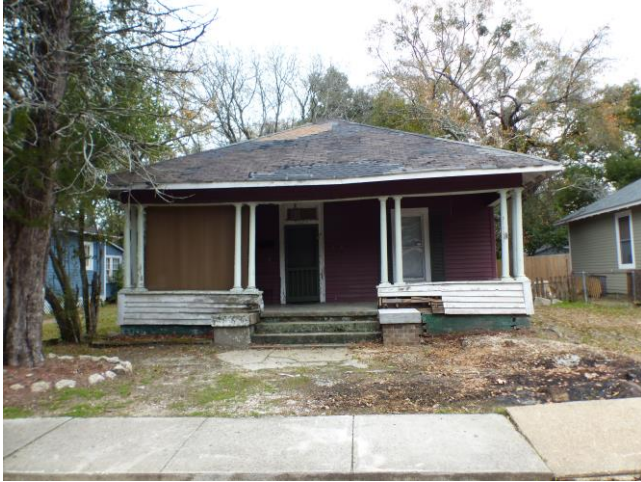
1. West elevation (façade), looking east

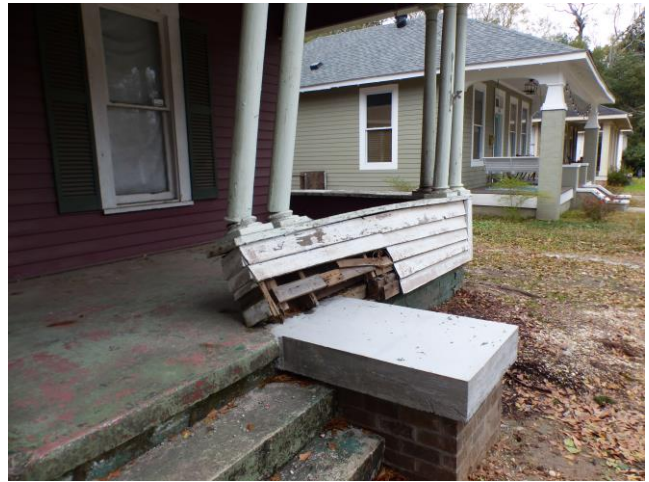
The clapboard knee wall was originally a shingled to match the shingled skirt around the house. At some later date, the shingles at the knee wall were replaced by clapboards. The *Guidelines* recommend that original building materials be preserved. Any deterioration should be removed only when beyond reasonable repair, and replacement materials should match in material, profile, and dimension. (5.4, 5.6) The *Guidelines* further recommend that porch repairs maintain the original character, calling for historic elements to match the original. (6.5, 6.6) The knee wall appears to be an original feature of the porch, and is a common element seen on Craftsman style bungalows. The same porch design with a knee wall is present at both 105 and 108 Parker Street. Although the existing knee wall is damaged and deteriorated in places, it does not appear to be beyond reasonable repair.

Like the knee wall, the style and placement of a structure's porch columns further define its character. The existing columns are rotten in places, and some have shifted or have come detached from their base. Although the grouped Tuscan Free Classic columns currently supporting the porch do not seem to be beyond repair, if replacement is undertaken, grouped battered columns may be considered as a more suitable alternative than the proposed simple, boxed columns. Grouping the columns would better preserve the historic design patterns of the porch. Installing a single box column in the place of existing paired columns would weaken the established aesthetic, both at this property and on the street. Likewise, pairs of boxed columns would not as efficiently visually communicate the intended expression. In addition to the precedent set at the subject property for grouped columns, this feature can be observed at 108 Parker. (6.5, 6.6)

2. Detail: damaged porch columns and knee wall, looking southeast

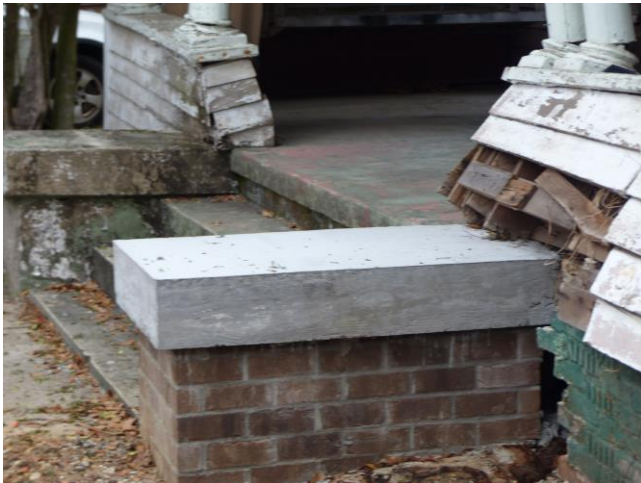
3. Detail: cheek walls, looking north

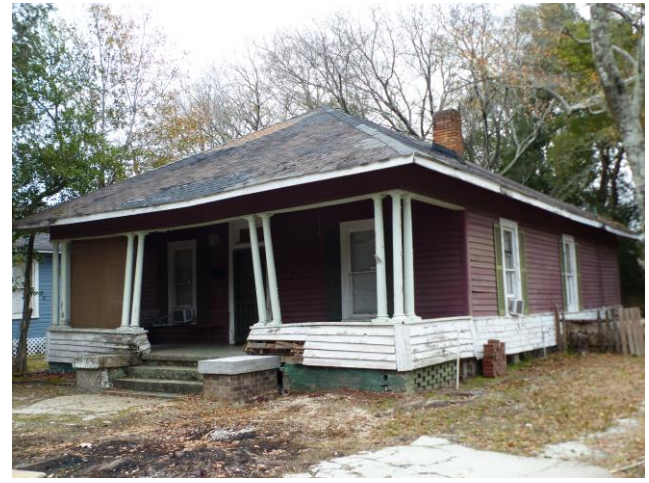
4. View of porch, looking northeast

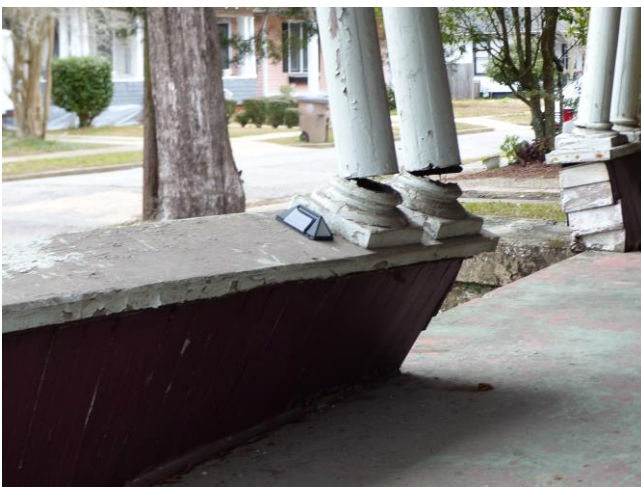
5. Detail: column bases, looking northwest

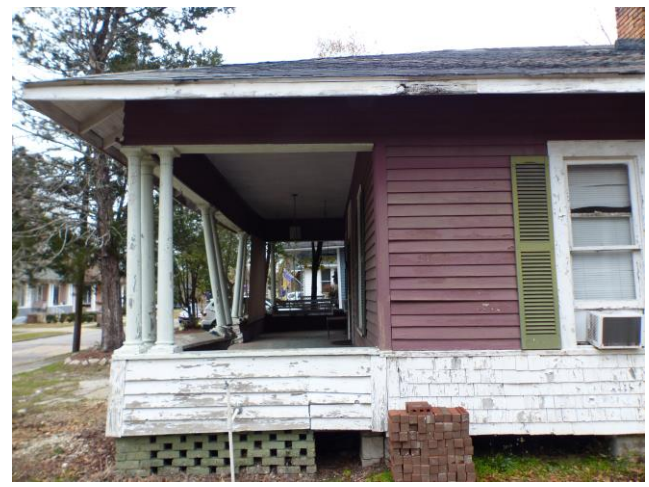
6. Side (south elevation), looking north
