Agenda Item #3

Application 2023-44-CA

1212 New St. Francis Street

1. After-the-fact: Replace all windows with vinyl sash windows
2. Replace/Install new siding.

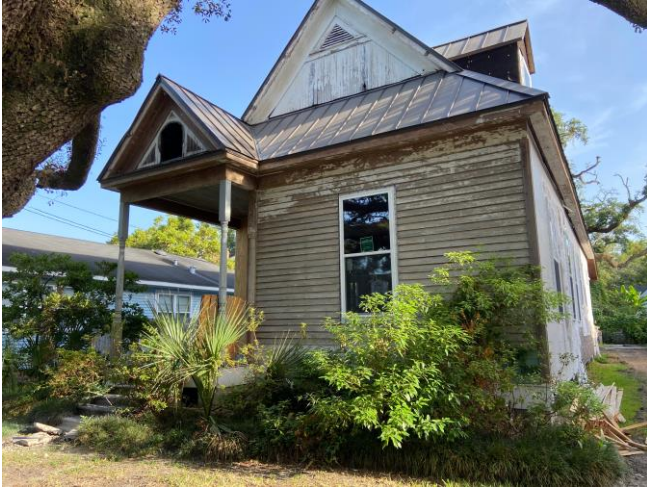
1. South (front) elevation

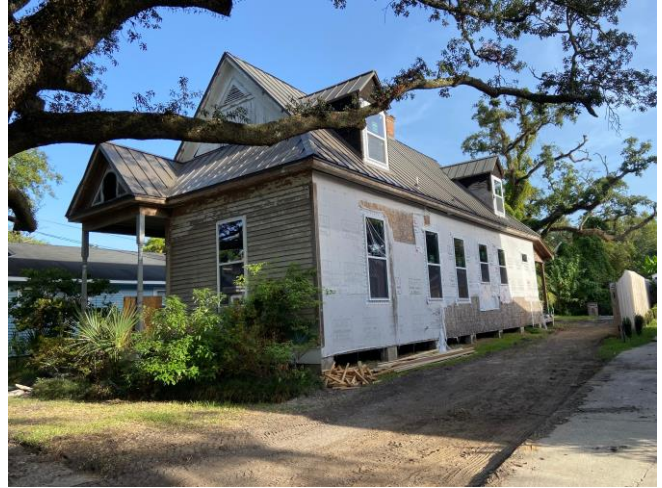
2. Southeast

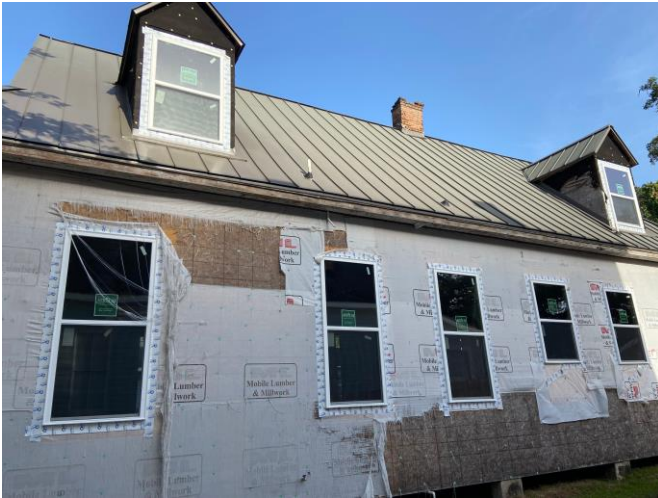
The one-over-one vinyl windows were recently installed in all extant window openings on the structure. Photos show that prior to installation, window openings on the east elevation were covered with plywood. Earlier photographic evidence reveals deterioration and empty window openings on this elevation with extant wood windows on the south (façade) and west elevations. According to the applicant, these extant windows were in an extreme deteriorated state, and although there was evidence of inferior efforts to maintain the windows, the windows were not salvageable. Historic Development Department records show that two-over-two wood windows with true divided lights were approved for installation in the gables on the east elevation; however, it is unclear if these windows were ever installed. If they were installed, satellite imagery reveals that they were no longer extant by 2011.

3. East elevation

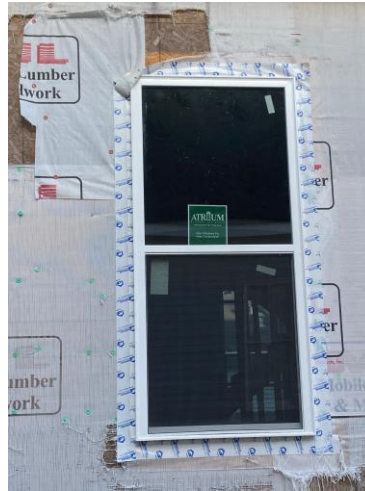
The *Guidelines* recommend that historic windows that are intact and in repairable condition be retained and repaired, and those that are not repairable be replaced with new windows that are consistent with the existing in location, framing, and light configuration. (5.20, 5.21) The one-over-one vinyl replacement windows are compatible with existing window openings, and although photographs demonstrate evidence of a previous two-over-two light configuration, the one-over-one configuration is appropriate to the design and style of the building. The *Guidelines* further note that vinyl is not an acceptable window material for contributing properties within Mobile's historic districts. (5.21)

4. Replacement window

1. Three (3) vinyl windows to be removed (one on the façade and the southernmost window on both the east and west elevations)
 - a. The removed windows are to be replaced with the wood two-over-two windows which are extant on the property.

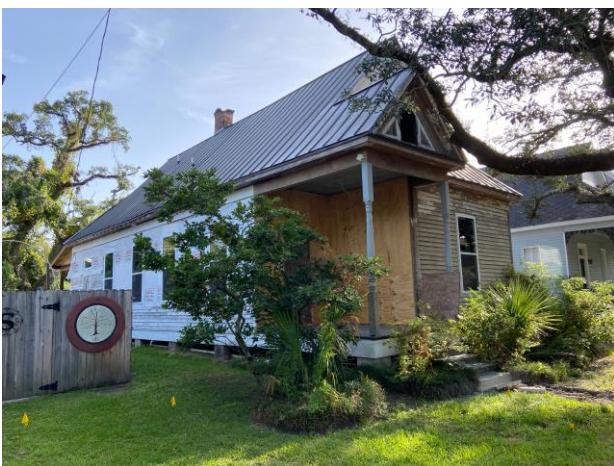
5. Southwest

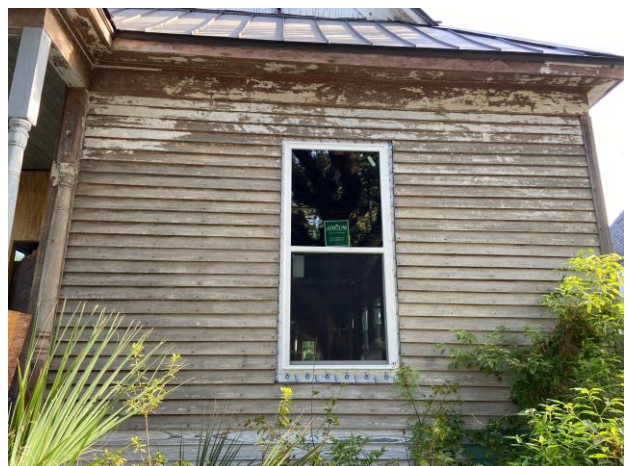
the consideration of green materials that imitate the original in profile and dimension, such as Hardie plank, as acceptable replacement materials providing they sustain the integrity of the building. (5.4, 5.7) The wood lap siding extant on west bay of the façade appears to be in good or repairable shape. New wood lap siding that matches the existing in profile and dimensions would be a fitting and compliant replacement material for the east bay under the porch and around the entry door. The non-primary elevations currently have minimal siding and could be re-clad in either new wood lap siding or an appropriate Hardie plank material.

6. South façade – east bay

- b. All windows will be trimmed to match original window dimensions, including a 1"x 4" on each side and a 1"x 6" on top with a trim piece above.
2. Wood lap siding matching the existing is to be installed on the façade.

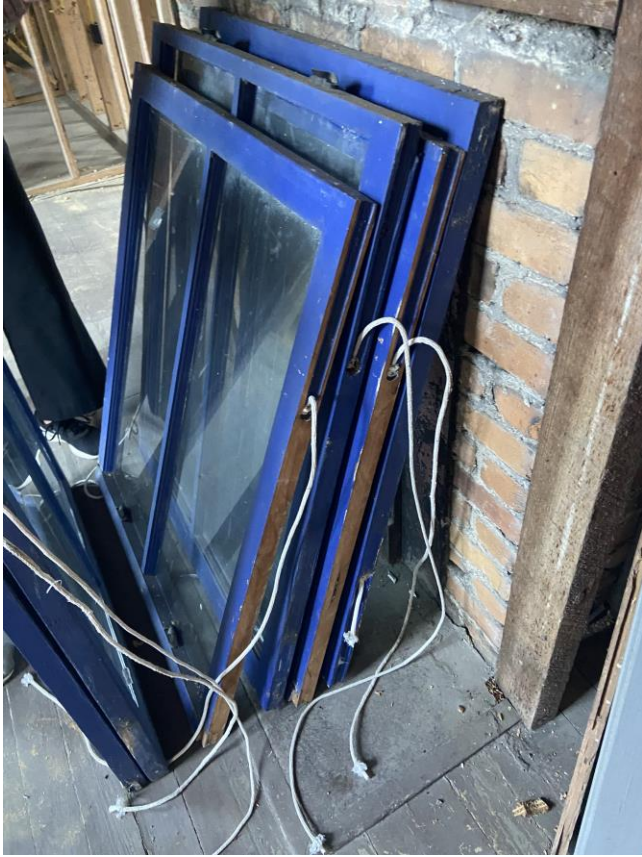
7. wood sashes extant on property
