# Agenda Item #3

## Application 2023-59-CA

154 S. Monterey Street

After-the-Fact: Replace windows on north, south, and west elevations with vinyl windows; replace windows on façade with aluminum-clad windows

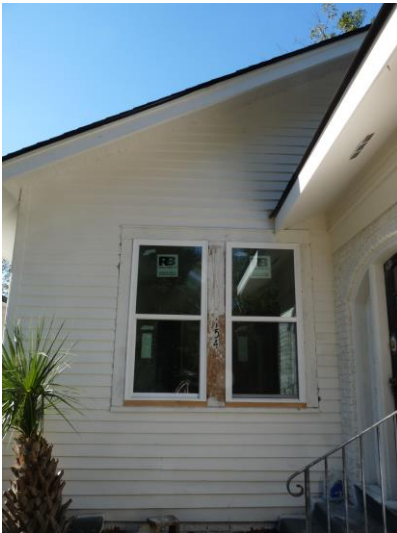
The one-over-one vinyl windows were recently installed in all extant window openings on the structure, with the exception of the arched window openings on the enclosed front porch. Photos show that prior to installation, the historic windows were wood with a Prairie style nine-over-one configuration. The *Guidelines* recommend that historic windows that are intact and in repairable condition be retained and repaired, and those that are not repairable be replaced with new windows that are consistent with the existing in location, framing, and light configuration. (5.20, 5.21) According to the applicant, prior to replacement, the historic wood windows were deemed unrepairable. Although the Prairie style nine-over-one configuration of the historic windows contributes significantly to the character of the historic bungalow, the one-over-one vinyl replacement windows are an acceptable configuration and are compatible with existing window openings with minor infill at the bottom. The *Guidelines* further note that vinyl is not an approved window material for contributing properties within Mobile's historic districts. (5.21) To mitigate this problem, the application seeks approval to replace the two vinyl windows which have been installed on the east façade with prairie-over-one aluminum clad windows. The applicant has provided sample drawings of the proposed windows. It is unclear if the samples provided would fit the historic window openings on the façade. It should be noted that the remaining vinyl windows, which are being proposed for retention, are not located on key character-defining walls such as the façade, whereas the two windows being proposed for replacement are located on the façade, which is a primary wall, thus character-defining. (5.22)

3. Facade windows

On December 13<sup>th</sup>, the applicant met with a Design Review Committee which consisted of members of Staff and the Architectural Review Board to further review the subject application in an attempt to mitigate the non-compliant components of the project. At the meeting, it was agreed that the applicant would replace the two vinyl windows on the façade, along with the first two windows (from east to west) on the south elevation, with custom aluminum-clad nine-over-one windows from Ply Gem Windows, per the order form submitted with the original application.
