# Agenda Item #3

## Application 2023-59-CA

154 S Monterey Street

After-the-Fact: Replace windows on north, south, and west elevations with vinyl windows; replace windows on façade with aluminum-clad windows

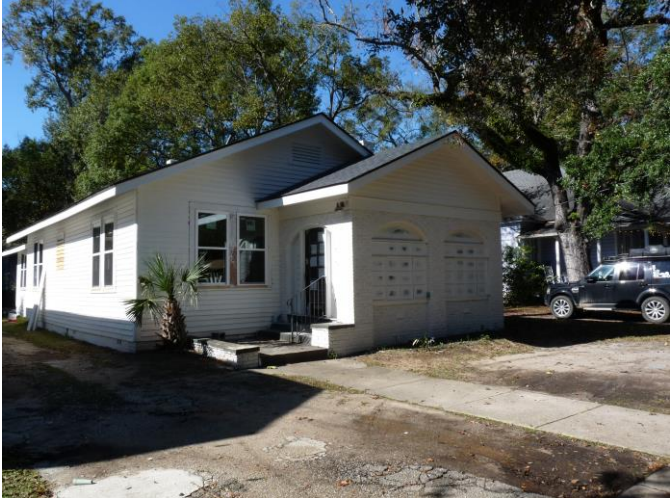
1. East elevation, looking northwest

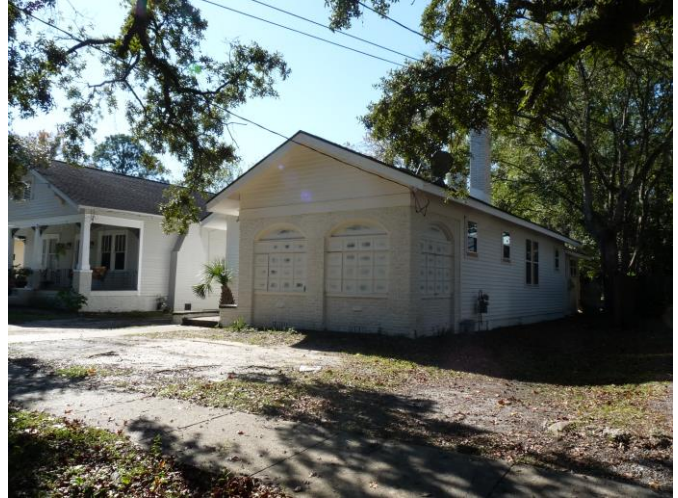
2. East elevation, looking southwest

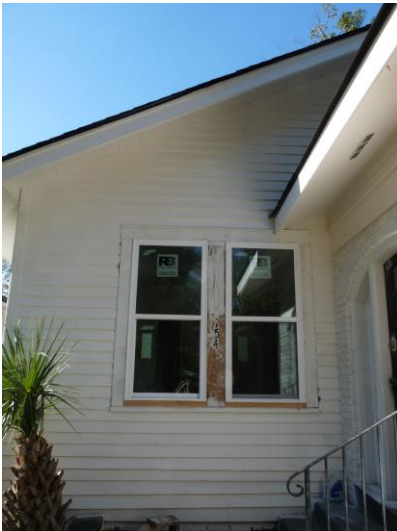
3. Facade windows

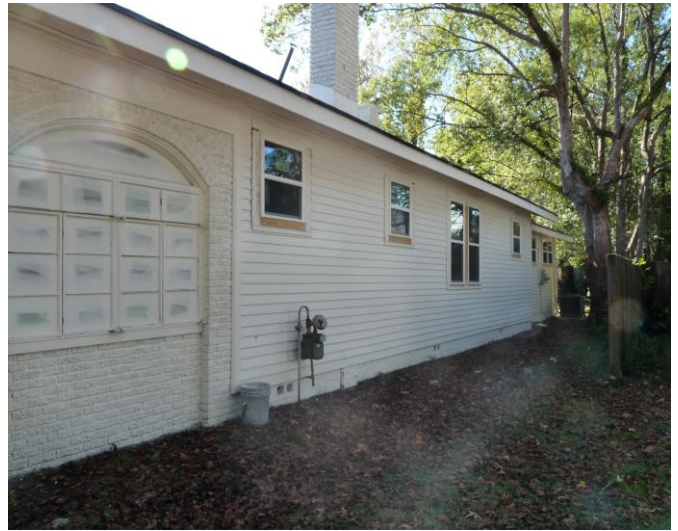
4. North elevation

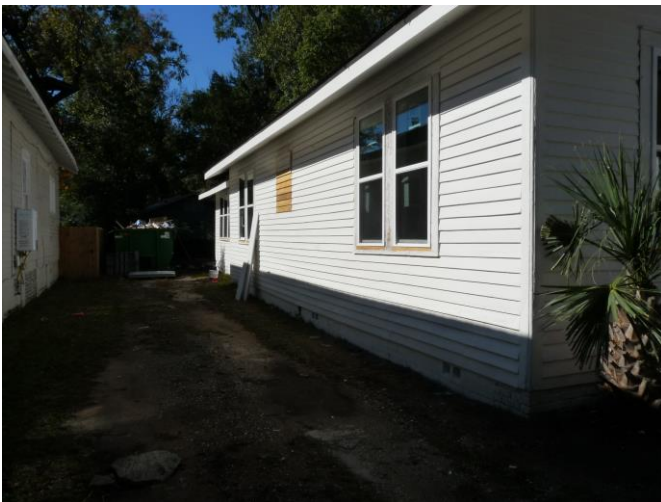
5. South elevation

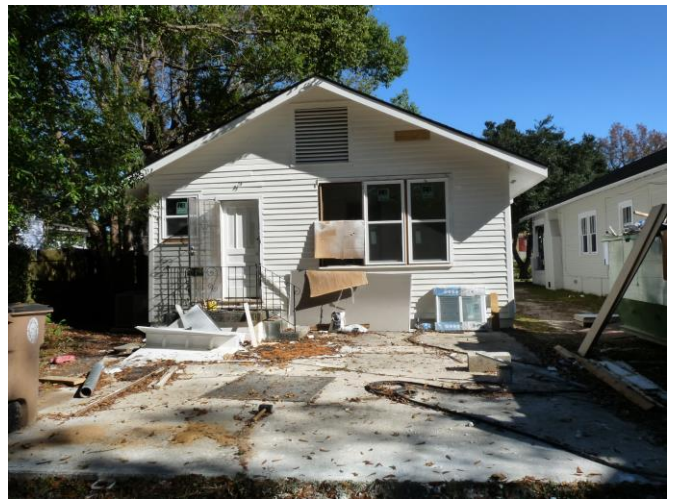
6. Rear (west) elevation
