# Agenda Item #1

## Application 2026-49-CA

161 State Street

Replace six existing wood windows with aluminum-clad wood windows

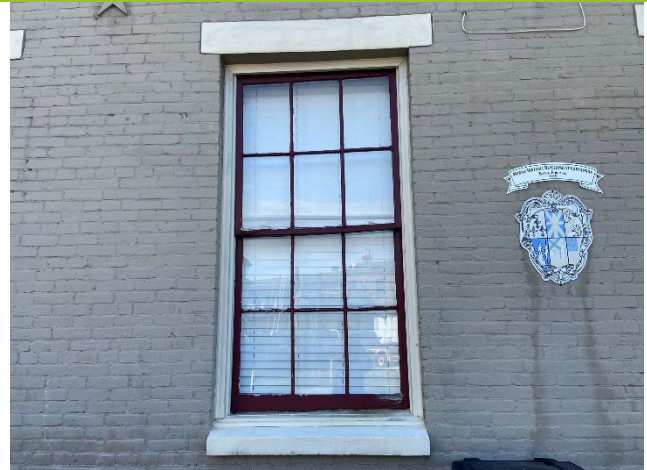
2. First-floor window, first from left

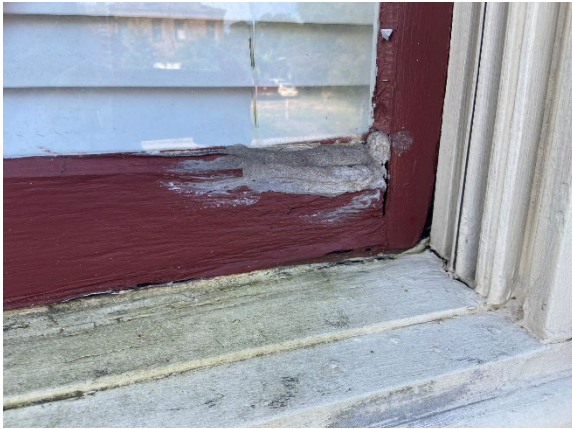
3. Detail of first-floor window, first from left

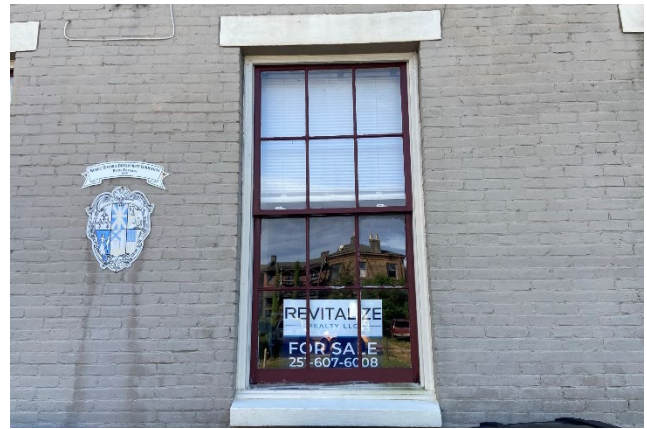
4. First-floor window, second from left

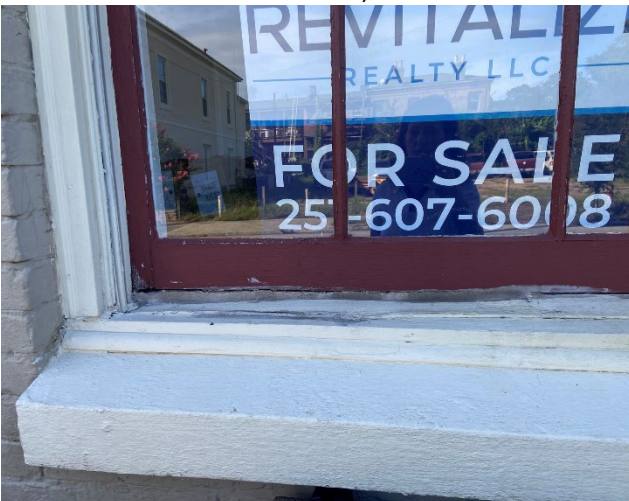
5. Detail of first-floor window, second from left

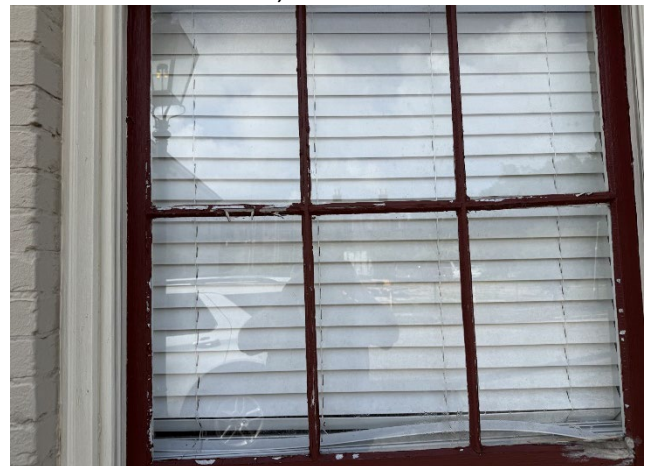
6. Detail of first-floor window

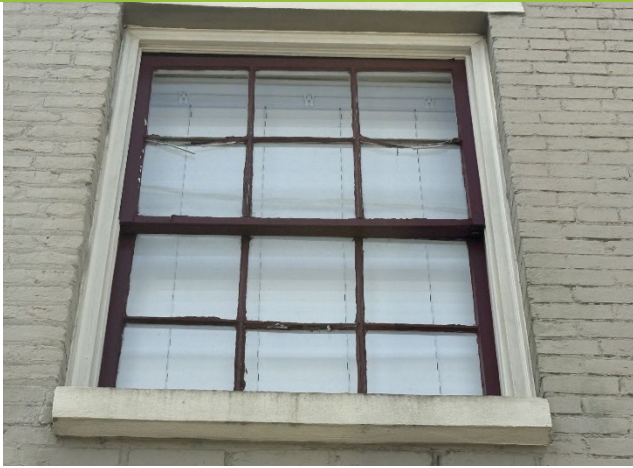
7. Second-floor window, first from left

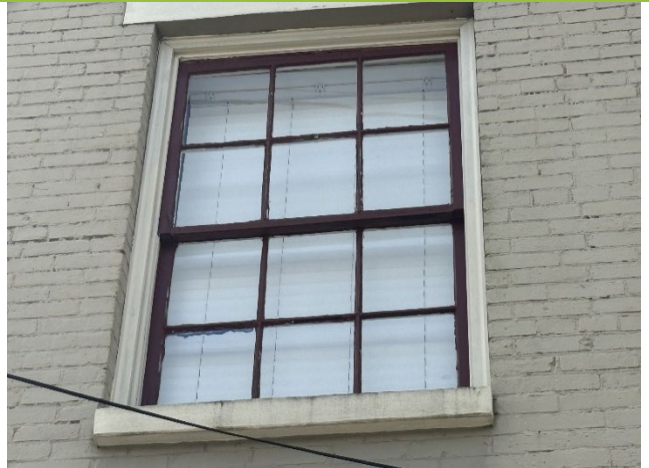
8. Second-floor window, second from left

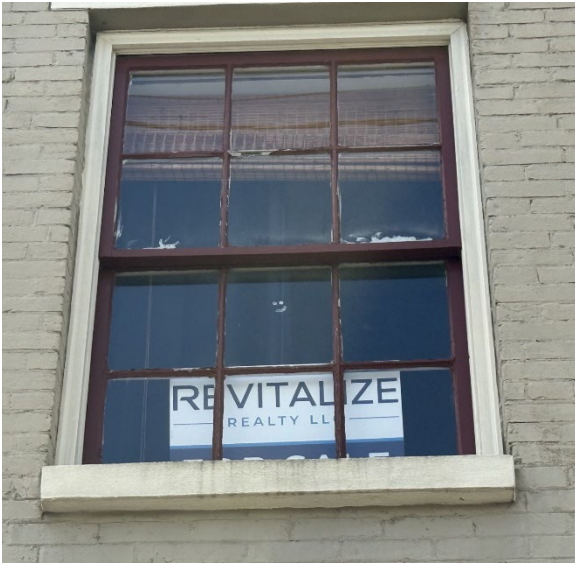
9. Second floor window, third from left

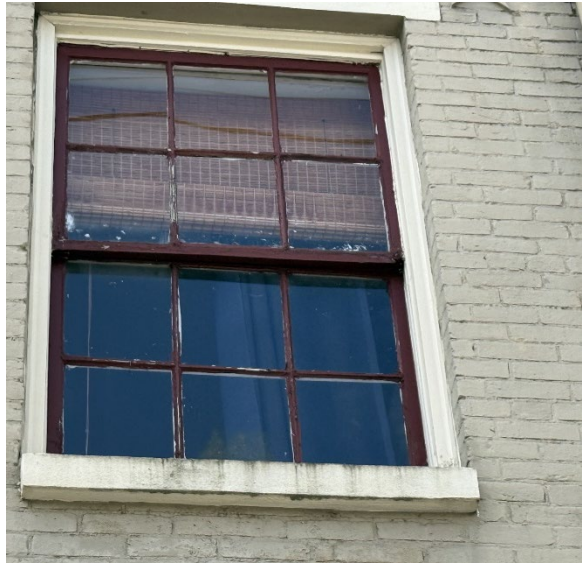
10. Second-floor window, fourth from left
