## Agenda Item #2

### Application 2025-30-CA

1159 Old Shell Road

After-the-fact window and column replacement on façade; Paint applied to brick porch wall

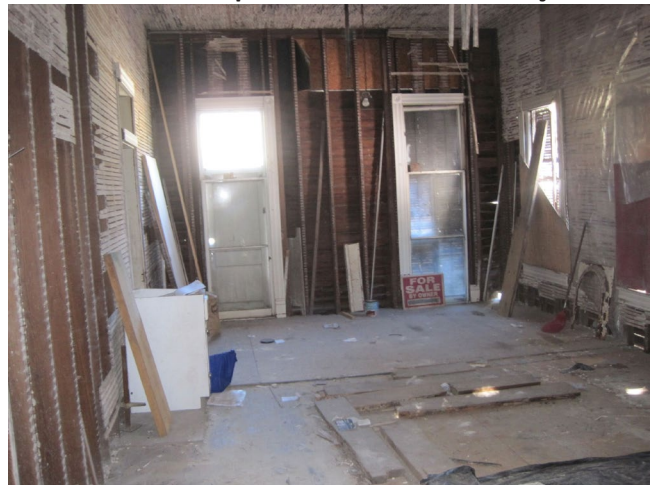
6. Interior view of box head windows in place (May 2024)

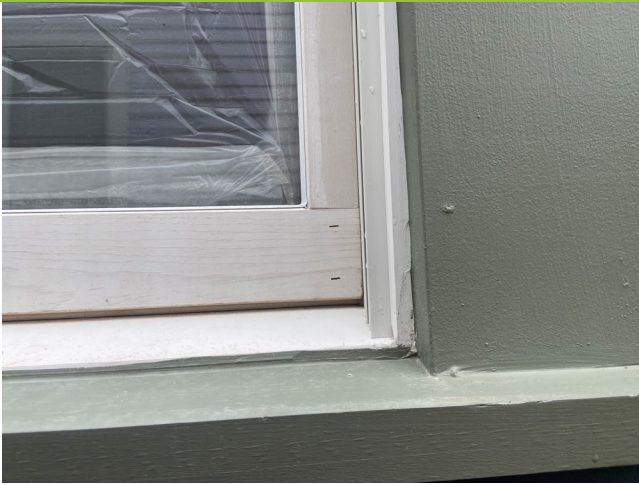
**13. Detail of replacement one-over-one windows.**

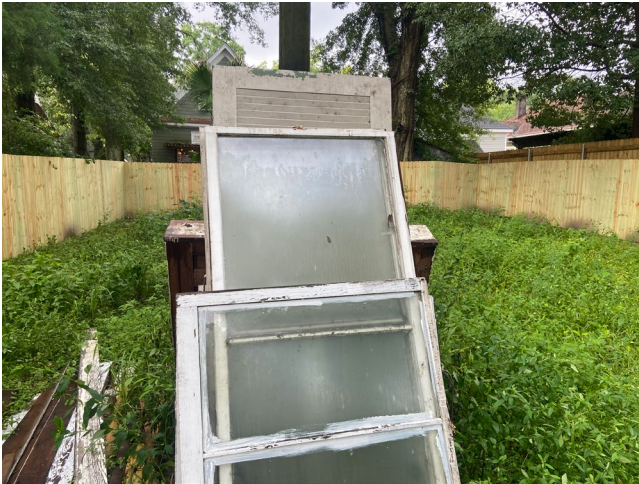
During the site visit, historic windows were found on the property. These windows appear to be the original box head windows removed from the façade, and potentially those from the bay window as well. The windows seem to be in good repairable condition. Also discovered was a dumpster containing removed trim.

**15. Removed historic windows**

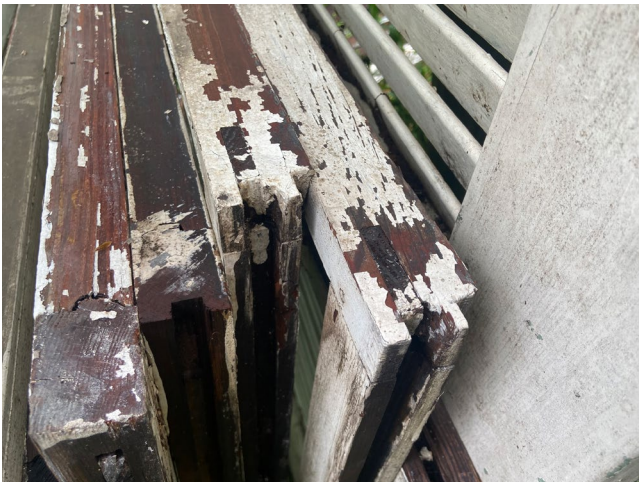
**17. Detail of replacement one-over-one windows.**

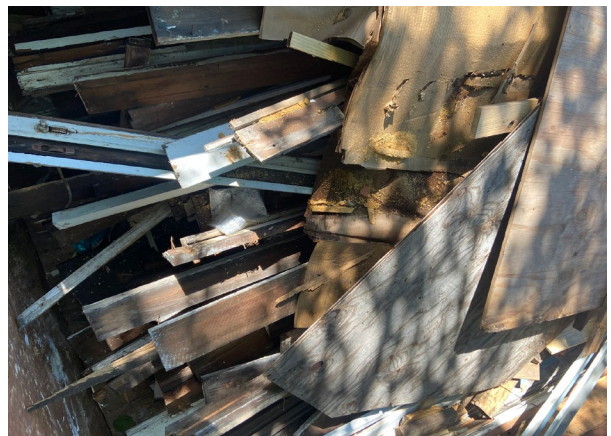
**18. Removed trim**

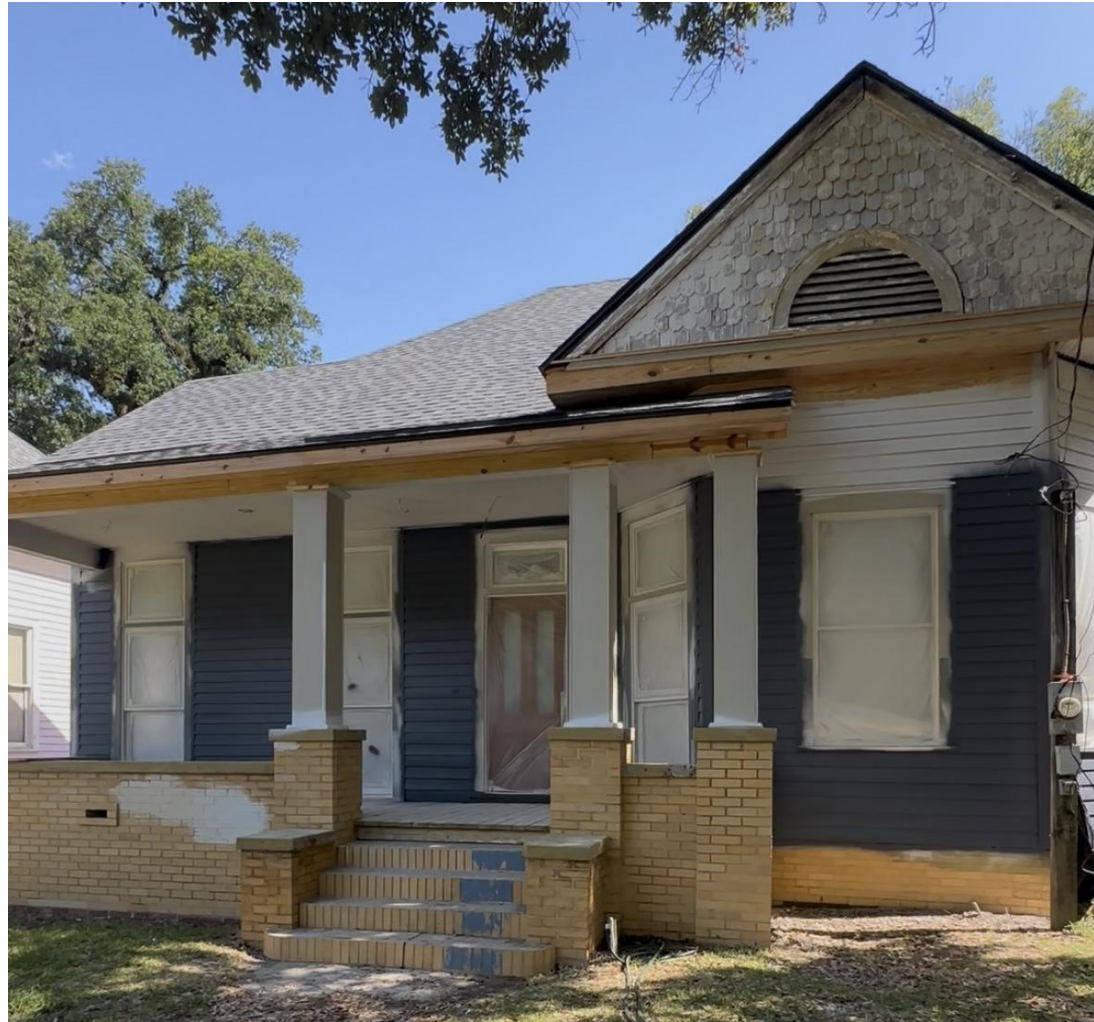
# Current Columns and window trim

*Columns and window trim replaced using fiber cement/hardie board material.*

*Because this house was not an original craftsman-style build and there was no existing porch at the time of purchase, when the porch was rebuilt, we made the decision to go back with straight columns rather than a slight taper.*
