Agenda Item #1

Application 2024-20-CA

260 N. Joachim Street

Replace windows on all elevations except for façade.

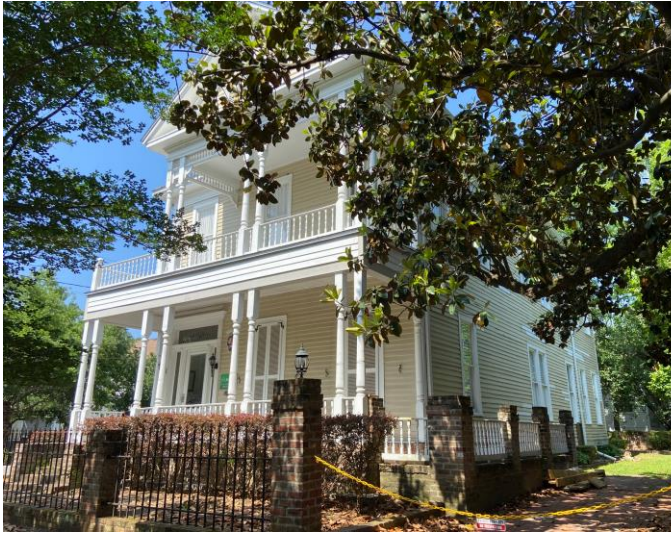
1. View of west façade (left) and south elevation (right)

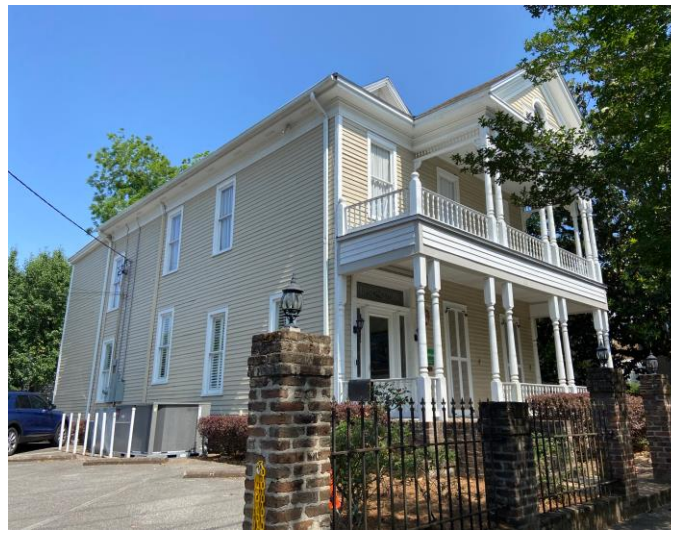
2. View of west façade (right) and north elevation (left)

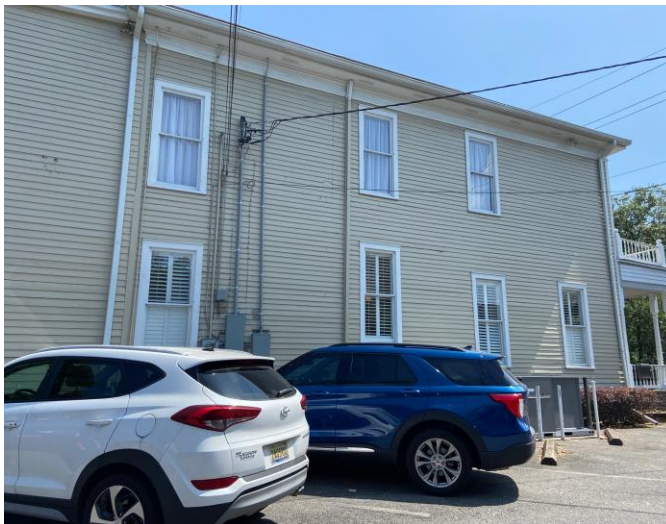
The applicant completed a window survey, assessing the condition of the windows intended for replacement on the non-primary elevations at 260 N Joachim. The survey and visual inspection reveal that the existing windows are not in a deteriorated or unrepairable state. The proposed replacement windows would be an aluminum-clad wood window, which is an acceptable window material under the *Guidelines*. Further, the replacement windows' one-over-one light configuration would match that of the existing windows. (5.6, 5.7, 5.20, 5.21)

3. View of windows on north elevation.

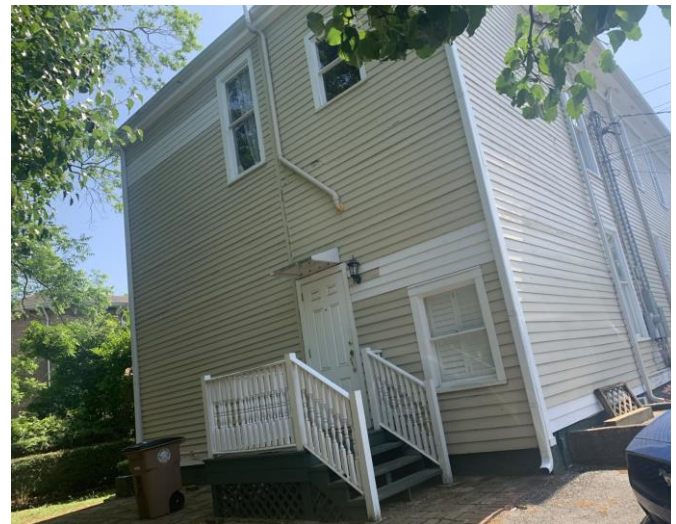
4. View of rear elevation.
