Agenda Item #1

Application 2024-13-CA

30 Hannon Avenue

After-the-Fact Approval: Reframe rear addition, fenestration changes, and install drop siding.

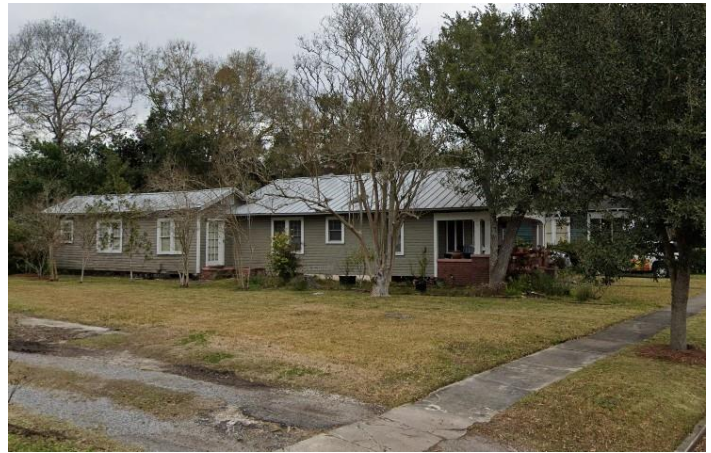
- a. Remove all windows on the south elevation (five windows) and replace with one four-light transom wood window measuring 40” wide by 12” high, located on the east end of the elevation.
- b. Prior to removal, the fenestration on the south elevation was as follows (from east to west):
Small six-over-one window, a pair of six-over-one windows, a pair of six-over-one windows.

2. South elevation prior to alteration

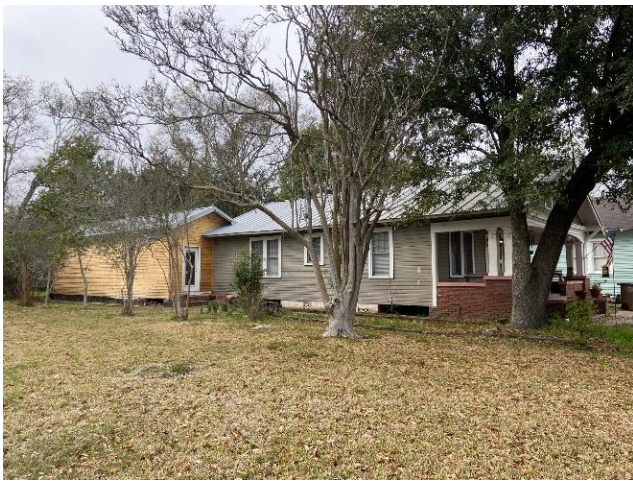
The *Guidelines* state that intact historic windows should be retained and repaired, preserving elements such as light configuration, frames, sashes, muntins, etc. In cases where windows are not repairable, new windows should match the existing as per location, framing, and light configuration. Due to the fenestration changes having been completed prior to obtaining a COA, no window survey was completed. According to the applicant, the original windows are no longer extant. Therefore, their condition at the time of removal is unknown. The replacement windows do not comply with the *Guidelines'* directive to match the existing location, framing, and light configuration of the original windows. The removal of all windows on the south elevation, leaving a blank side

wall with one small, high-wall window in the east corner is not an appropriate alteration. The removal of a traditional fenestration pattern and the established solid-to-void ratio creates an unsuitable contemporary expression on a historic elevation. Likewise, the north elevation, though less visible from the street, has been inappropriately rehabilitated using a contemporary fenestration arrangement such as the pairing of narrow one-over-one windows and the installation of a horizontal sliding glass door. In addition, vinyl is not an approved material for Mobile's historic districts. (5.20-5.22)

3. South elevation, post alterations

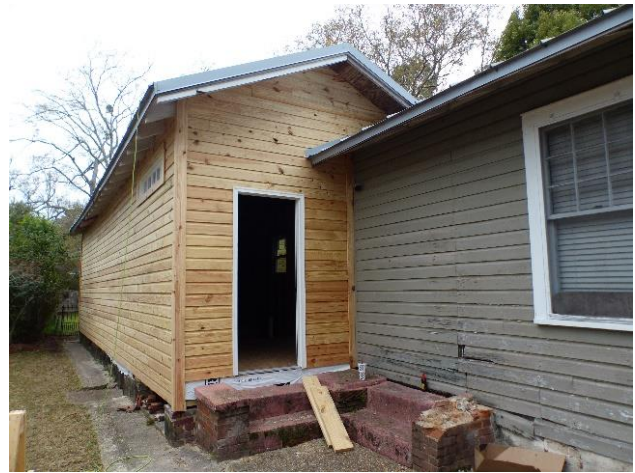
According to the *Guidelines*, replacement doors should align with the historic character of the building. Although a divided light or panel door would arguably be a more appropriate style, the single light replacement door on the east elevation of the addition (see Photo 3) is not located on a primary façade and somewhat echoes the prairie style divided light entry door on the main façade. However, vinyl is not listed as an acceptable material for historic buildings. Further, the sliding glass door on the north elevation is not compatible with the historic character of the property or district. (5.15)

4. East and south elevations of addition

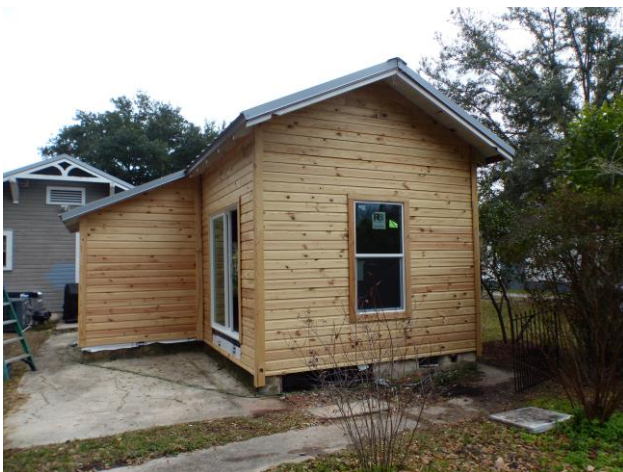
- a. Install one one-over-one window, centered on west elevation.
- b. The fenestration that existed prior to this installation is unknown.

5. View of west elevation of addition

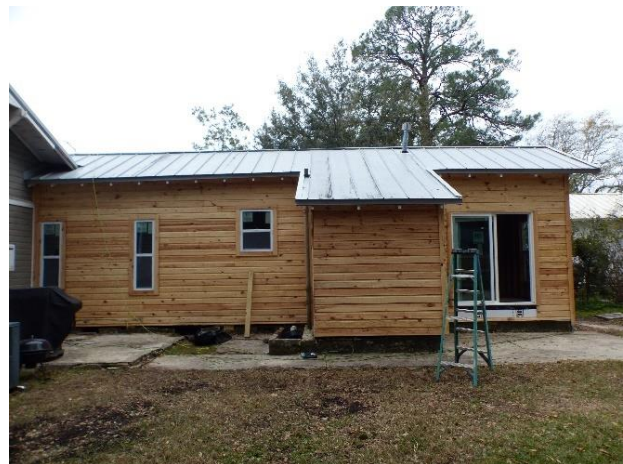
- a. Remove all fenestration on north elevation and replace with new vinyl fenestration.
- b. The fenestration pattern on the north elevation that existed prior to the alterations under review is unknown.
- c. The current fenestration is as follows:
One 1’-6” wide by 5’-0” high one-over-one window; one 1’-6” wide by 5’-0” high one-over-one window; one 2’-0” wide by 3’-0” high one-over-one window; one 6’-0” high sliding glass door.

6. View of north elevation
