Agenda Item #2

Application 2023-56-CA

34 S. Reed Avenue

Site Photos – 34 S. Reed Avenue

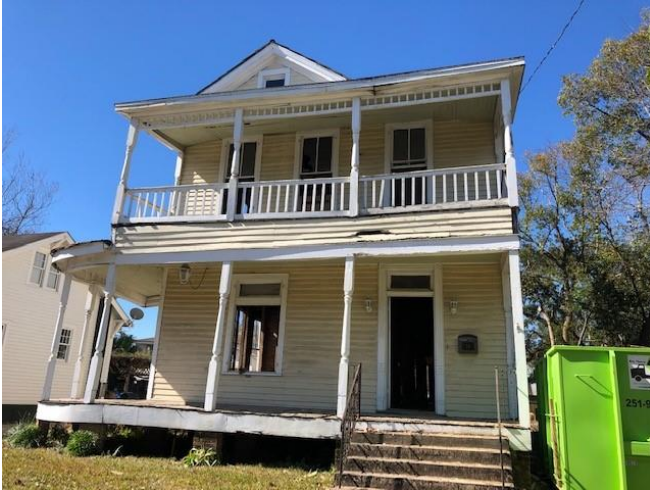
1. View west-southwest to east elevation (façade) of subject property; photo taken January 2021
