Agenda Item #1

Application 2024-05-CA

351 Flint Street

After-the-Fact: Demolish accessory structure; remove exterior brick chimney; create new window opening at former chimney location; demolish deteriorated rear addition.

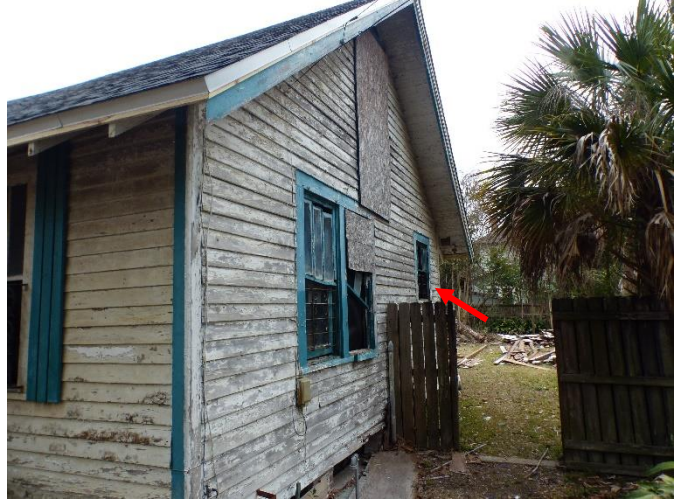
2. South elevation, looking northeast. Arrow indicates window proposed for infill.

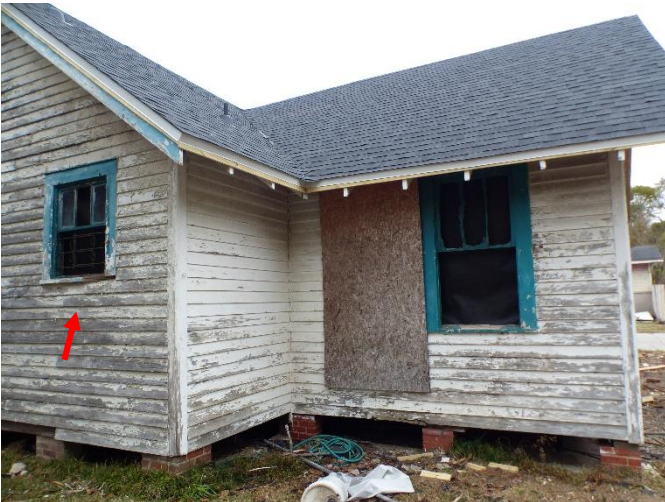
3. South elevation, looking northwest. Arrow indicates window proposed for infill.

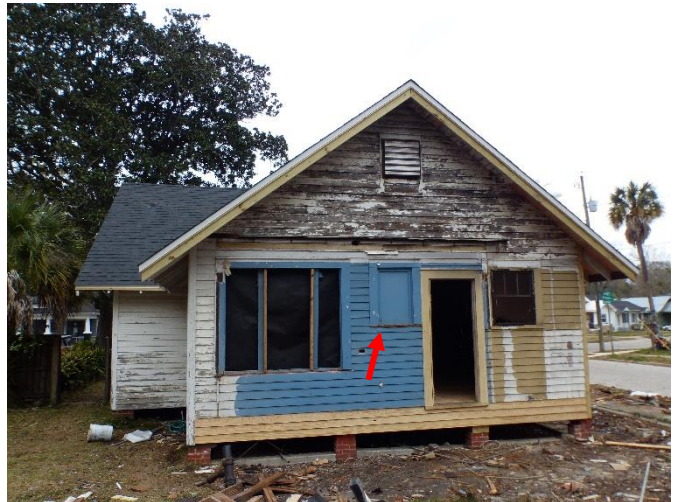
4. East (rear) elevation, looking west. Arrow indicates window proposed for infill.

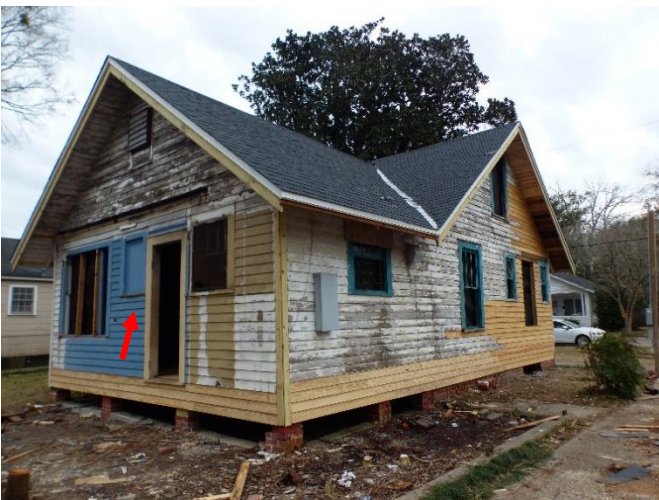
5. North elevation, looking southwest. Arrow indicates window proposed for infill.

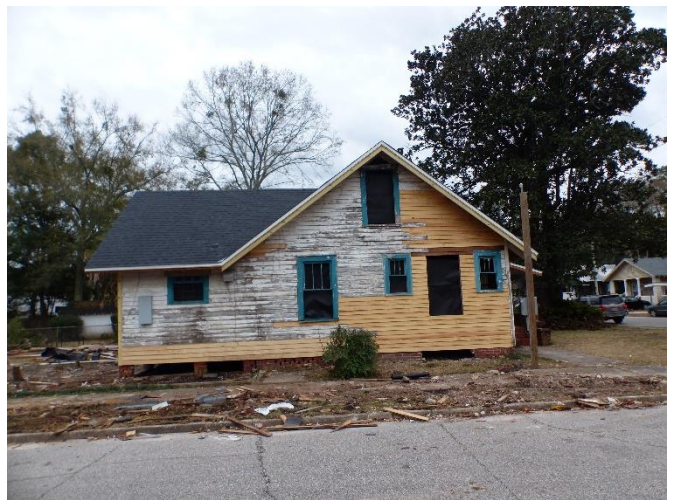
Following removal of the chimney, the applicant began making repairs to the deteriorated siding in that location. The applicant made the decision at this time to frame out a new window opening in this location. The window opening has the same dimensions as the existing full-sized window openings. The applicant proposes installing a salvaged 3-over-1 wood window to match the existing windows.

The *Guidelines* instructs property owners to “maintain significant historic façades in their original form” and specifically to “pay special attention to maintaining the historic appearance of building walls of corner buildings.” (5.3) 351 Flint Street is a corner building, and the new window opening is on the north elevation, which fronts Alabama Street. The *Guidelines* also identify window “location and configuration” as significant character defining features. The proposed new window opening will introduce a change to the original fenestration pattern of the north elevation of 351 Flint Street. However, addition of the new window will also fill blank wall space left by the demolition of the chimney. The use of a salvaged 3-over-1 wood window at this location identical to the existing windows will further minimize disruption to the “rhythm” of the north elevation.

6. North elevation, looking south. New window opening shown at former location of demolished chimney.

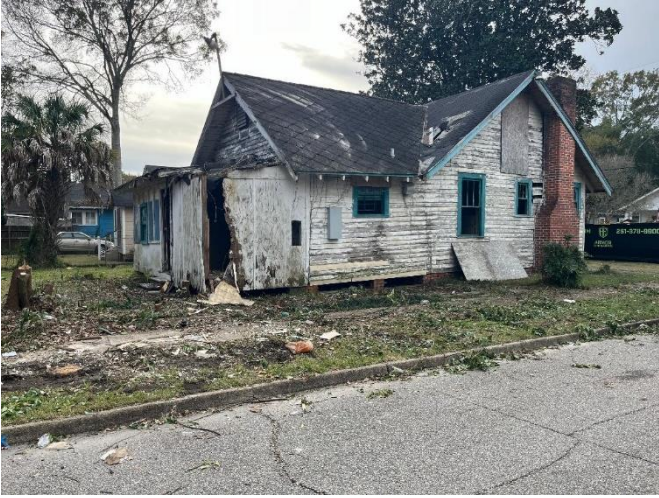
The *Guidelines* instruct property owners to maintain historic roof elements, including chimneys, wherever possible. (5.10) The applicant has provided documentation that the existing brick chimney was structurally unstable and that attempts to stabilize it were unsuccessful. Daniel Franklin, a Certified Field Inspector for AFS Foundation Repair, performed a site inspection and found the chimney to be more than 5 inches out of plumb with horizontal cracking approximately 1/3 of the way up the chimney. An attempt was made to install helical piers to bring the chimney back into alignment, but the job foreman determined that the chimney did not have a proper footing that would support the piers. The inspector concluded that the only structure preventing the

chimney from toppling over was a rotten roofing truss. The chimney was determined to be a legitimate safety concern and was taken down.

7. North elevation prior to removal of chimney and rear addition (photo provided by applicant)

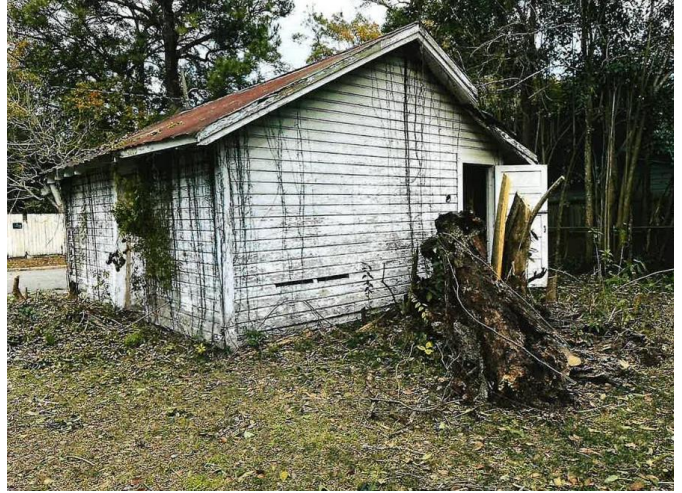
The *Guidelines* also state that "demolition may be more appropriate when a building is deteriorated or in poor condition." Both the rear addition and the garage had been neglected and allowed to deteriorate for many years. The rear addition was in particularly poor condition. Google maps images from 2011 and 2013 show both structures with peeling paint and encroaching vegetation. The rear addition appears to have a partially tarped roofed in both 2011 and 2013. Vines and other vegetation completely covered the east side of the garage in 2013. The applicant has provided more recent photographs showing that the addition's northwest corner and a portion of its roof had collapsed. There was also visible rot and deterioration of the wood cladding. The applicant's photos also show a hole in the southeast corner of the garage roof.

8. Garage prior to removal (photo provided by applicant)
