Agenda Item #6

Applications 2024-25-CA

6 S. Franklin Street

Remove frame and metal enclosure of rear double gallery and secure exposed openings. Perform emergency repairs of north and south elevation brick walls.

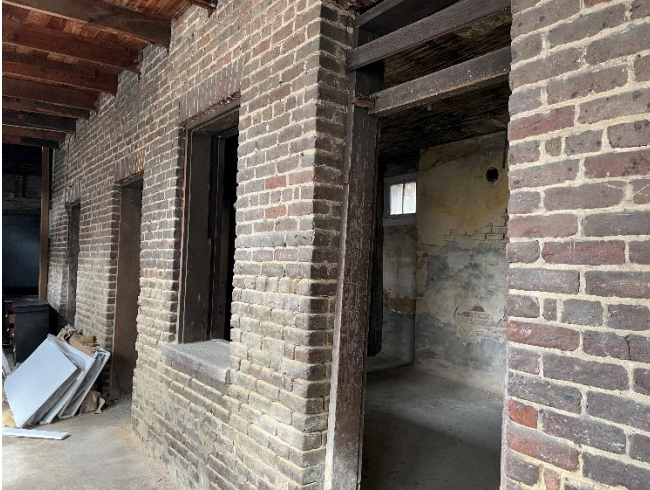
1. View west-northwest along south wall of 1st floor porch, rear wing

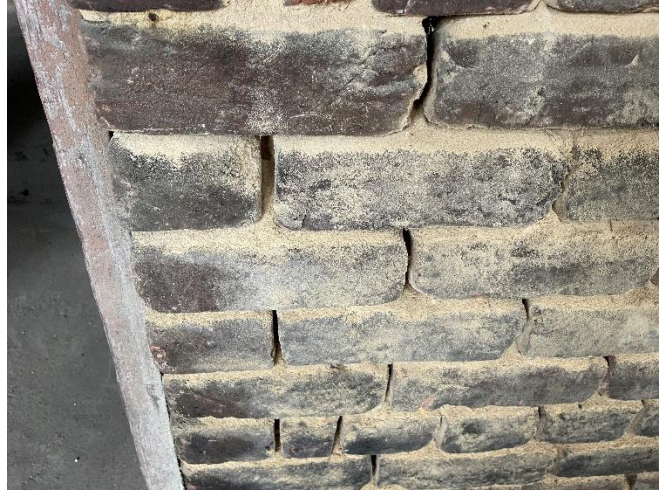
2. example of deteriorated mortar in south wall of rear wing

- b. Repoint areas where historic mortar has deteriorated, using an appropriate lime-based mortar.
 - c. Remove and replace damaged/deteriorated roofing, rafters, and decking. Extant slates will be stored for later reinstallation. Install a temporary peel-and-stick shingle roof for stabilization purposes until the slate roof is reinstalled in a future phase.

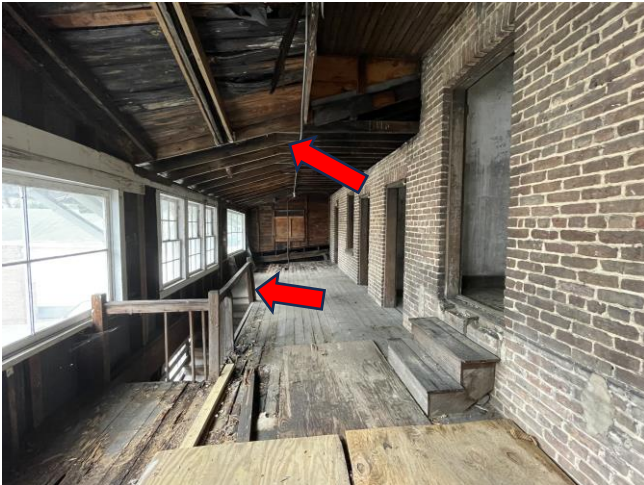
3. View west along south elevation, 2nd floor porch, rear wing; note later roof extension and stairs (left)

- b. The original porch roof (the overhang of the rear wing roof) would remain. The later porch addition framing, including the roof extension, would be removed.

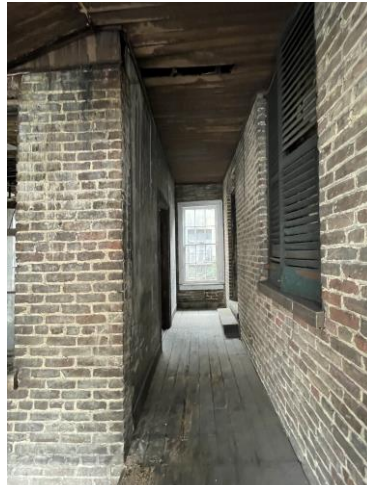
4. View north into space between front block of house and rear wing (shown as frame porch on Sanborn maps)

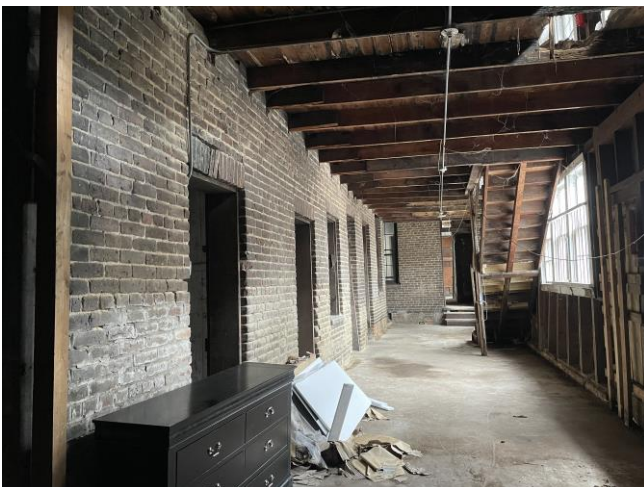
5. View east along south wall, 1st floor porch, rear wing

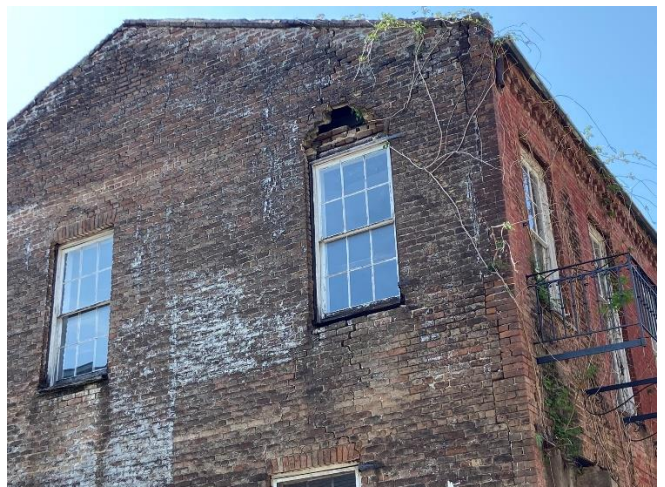
6. View north-northwest to area of missing bricks over window on south elevation

1. Complete emergency repairs and stabilization.
 - a. Remove failing portions of north and south (side) walls and rebuild using existing bricks. Replace missing bricks in-kind. All masonry work will utilize an appropriate lime-based mortar mix.

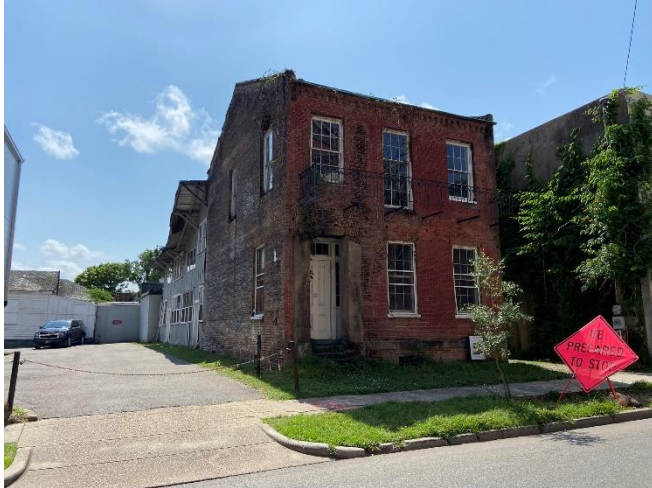
7. view northwest to south (left) and east (right) elevations of subject property

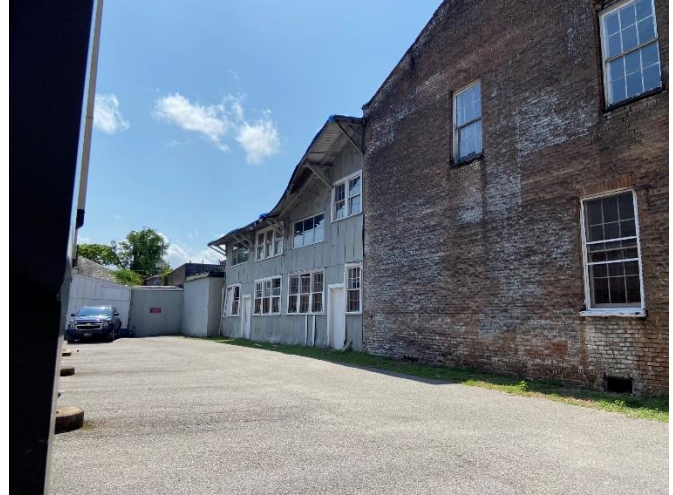
8. View northwest to frame and metal enclosure of double gallery at rear wing

2. Remove rear double gallery enclosure.
 - a. The two-story frame and metal enclosure (including windows, door, later decking, and stairs) of the rear double gallery would be removed.

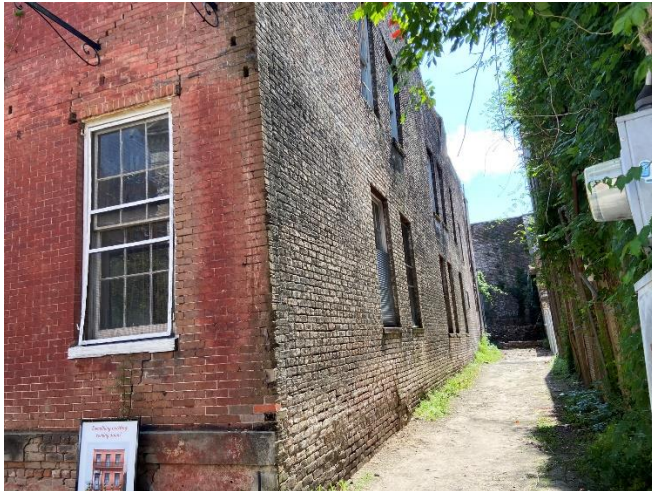
9. view west-southwest to north elevation of subject property; note precarious condition of brick wall
