Agenda Item #4

Application 2026-30-CA

960 Dauphin Street

After-the-fact approval to remove original doors, transoms, and sidelights from the south façade and replace with new wood doors that do not match existing.

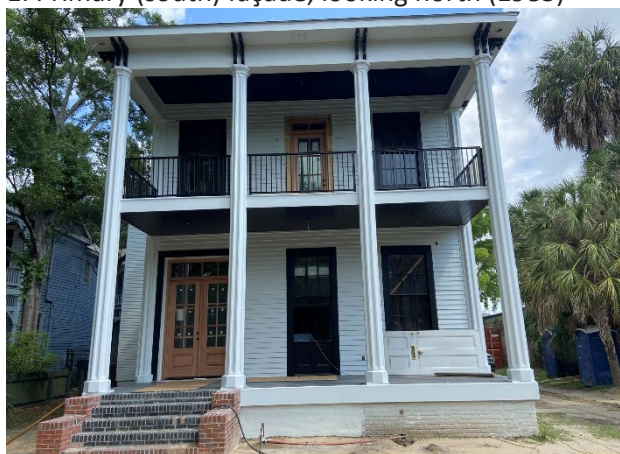
If for any reason the doors and surrounds could not be reinstalled, the *Guidelines* specify that a new door and surrounds would need to match the original as closely as possible. Since the original door and trim survive, it would be possible to have them replicated exactly in an insect-resistant wood such as mahogany. In contrast, the current replacement doors do not replicate any detail of the original. The original single-leaf entry door with transoms has been replaced with a double-leaf door without transoms. The new trim is lacking in the characteristic detail and depth of the original Italianate door surrounds. The new multi-light doors are themselves a significant departure from the historic solid wood paneled doors.

3. Replacement doors (April 2026)

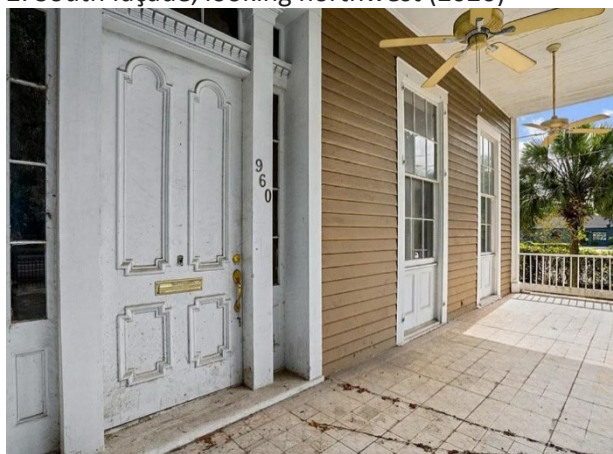
While staff agree that the main entry showed considerable signs of wear, onsite inspections during the construction process indicated that the paneled wood door, sidelights, transom, and decorative trim could be repaired. Staff received no communication during the construction process that repair of the either of the two façade door assemblies was not possible. To the contrary, prior to their removal, both façade doors and their surrounds had been repaired and painted in the white and black color scheme used on the rest of the residence. New hardware had been installed on the main entry door, suggesting it was operable. Upon receiving a 311 complaint that both doors had been replaced, staff visited the site and found that the contractor had salvaged both doors as well as their decorative surrounds, transoms, and sidelights. Workmen onsite assured staff that the doors and surrounds could be reinstalled in their original location and condition.

4. Historic entry door, sidelights, and transom (2020)

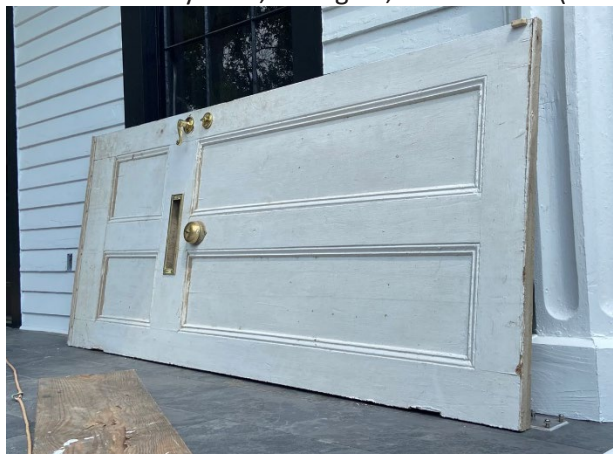
6. Original entry door with new hardware installed

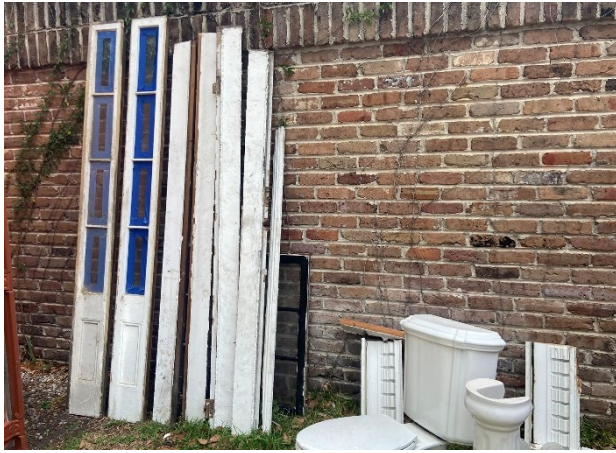
7. Sidelights and door surround trim

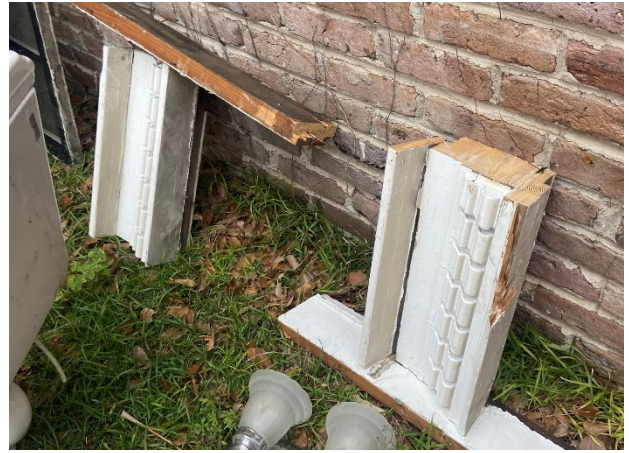
8. Door surround trim and transoms

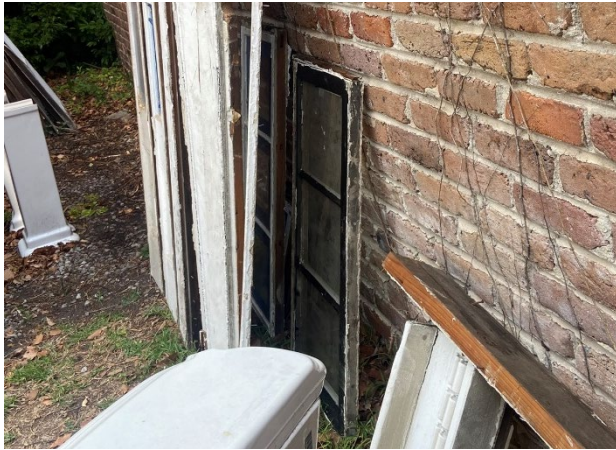
9. Transoms behind door trim pieces

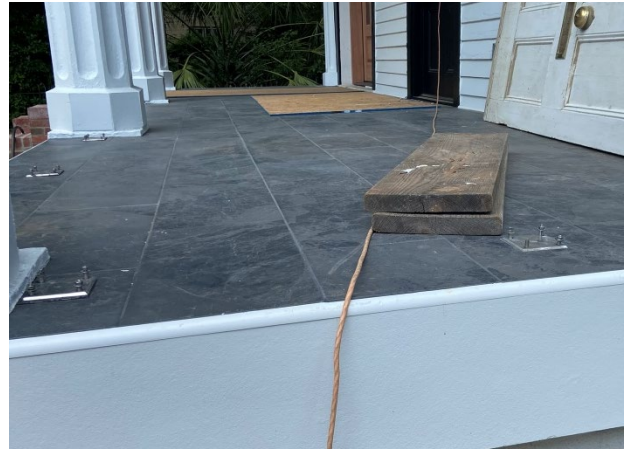
Prior to this most recent renovation, the porch floor at 960 Dauphin was clad in a square ceramic tile that did not appear to be original. The original porch material is unknown. The newly installed tile floor features rectangular tiles of a single color in a simple running bond. This gives the tile floor a much more modern appearance than what would be expected of a c. 1860 dwelling. However, the material itself is one that would have been historically available, and the tile floor is minimally visible from the public right-of-way.

10. New tiles on south porch deck
