Agenda Item #9

Application 2026-11-CA

Location:
153 S. Catherine Street

Summary of Request:
Replace thirteen existing wood windows with vinyl sash windows.

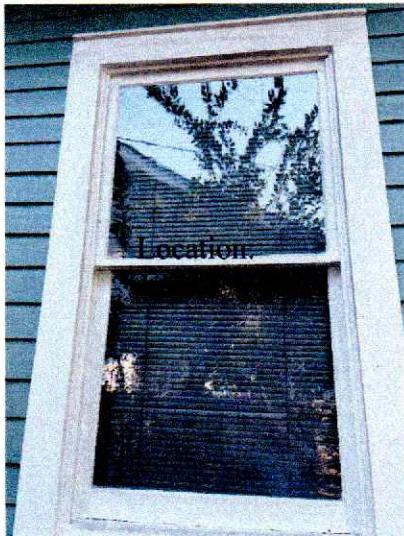
north side of house

original glass offers no insulation from sound or weather - I can hear music from

person's phone standing outside as if they're in my house.

FUNCTION	
Handles	
Movement mechanics	
Locks	no lock - painted shut
"Square"	
Weatherstripping

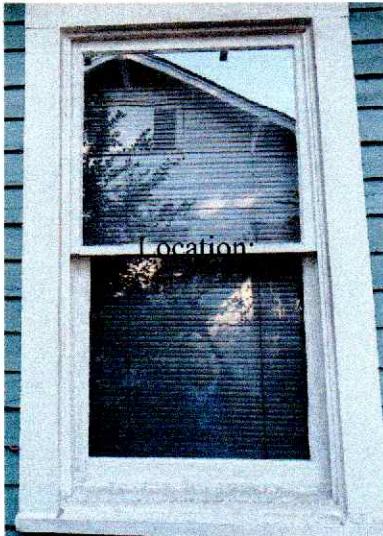
North side of house

Window Component	Description of Issue/Problem
FRAME	original glass offers no insulation from sound or weather. During snow- storm, my house dropped below 40°
Sill	inside when floor pump
Jambs	broke + you could feel breeze from windows,
Exterior trim & stops	
Interior trim & stops	
Interior wall surface

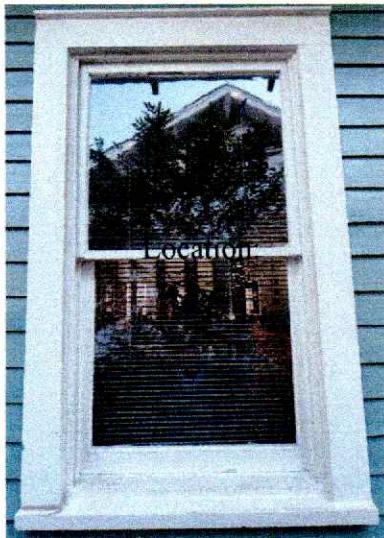
north side of house

Description of Conditions: *Original glass offers no insulation from sound + weather*

FUNCTION	
Handles	
Movement mechanics	<i>unable to open even though it's the one not painted shut</i>
Locks	
“Square”	
Weatherstripping

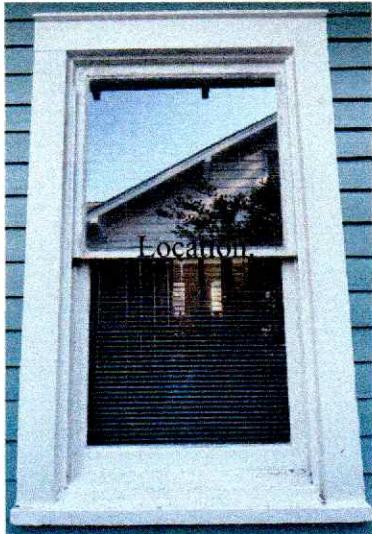
north side

original window glass opens no
insulation from sound or weather

FUNCTION	
Handles	
Movement mechanics	
Locks	
“Square”	printed sheet, no lock
Weatherstripping

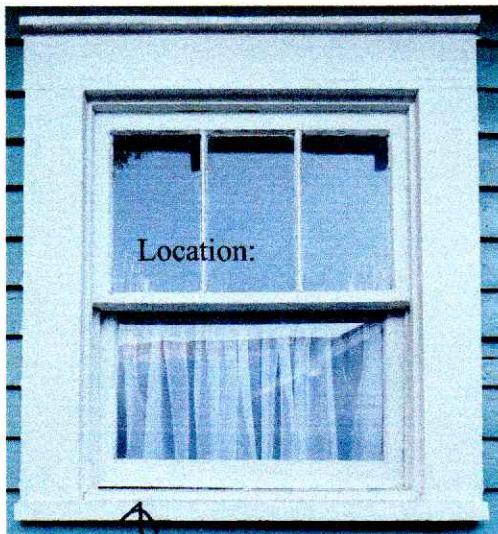
with side kitchen window

breeze + bugs come through bottom - had to cover with a towel in winter + put a bug trap in kitchen

FUNCTION	
Handles	
Movement mechanics	
Locks	
"Square"	not square
Weatherstripping	no lock, moves back & forth but difficult to open

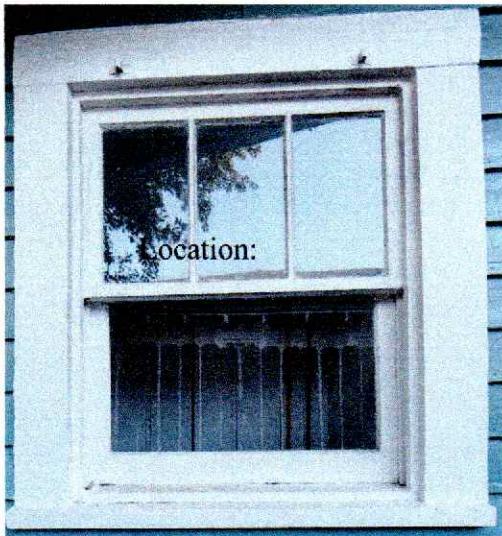
north side
laundry room

Original glass provides no insulation
from sound & weather

FUNCTION	
Handles	
Movement mechanics	
Locks	
“Square”	
Weatherstripping	Difficult to open, breeze + dust comes through bottom due to poor fit

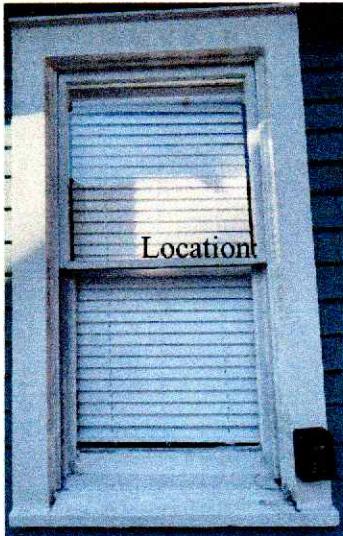
*original glass offers no insulation
from sound & weather*

FUNCTION	
Handles	
Movement mechanics	
Locks	
“Square”	<i>painted shut - no lock</i>
Weatherstripping

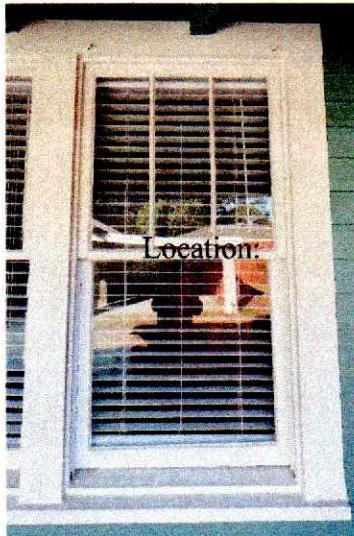
Back of house

original glass offers no insulation
from sound & weather.

FUNCTION	
Handles	
Movement mechanics	
Locks	
“Square”	
Weatherstripping	Dose fit + slope/debris come in the bottom

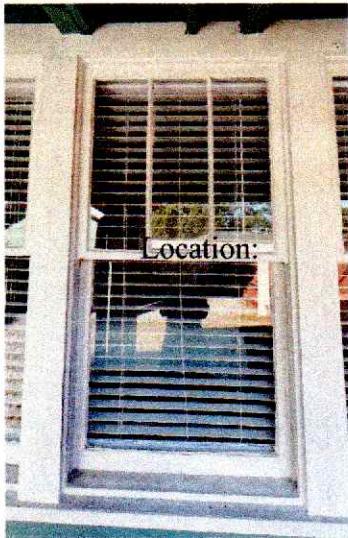
Back of house

Original glass offers no insulation
from sound of weather

FUNCTION	
Handles	
Movement mechanics	
Locks	
“Square”	Painted shut - no lock
Weatherstripping

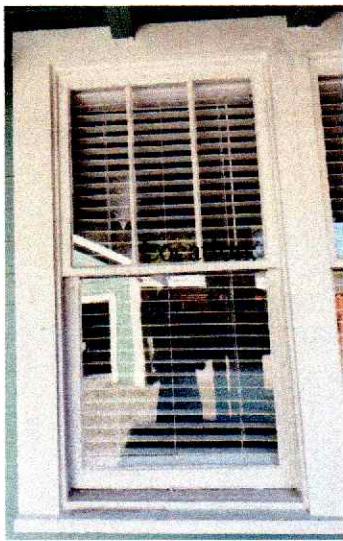
Back of house

original glass offers no insulation +
cannot open window, *from sound + weather*

FUNCTION	
Handles	
Movement mechanics	
Locks	<i>no lock - painted shut</i>
"Square"	
Weatherstripping
