Agenda Item #4

Application 2026-6-CA

7 N Claiborne Street

Replace windows and siding on the northeast 1929 addition.

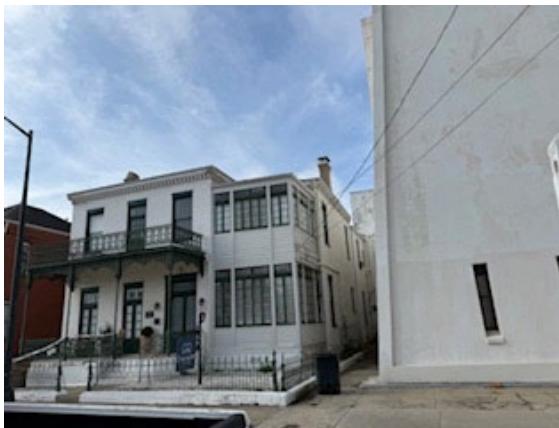
3. View of windows on 1929 addition.

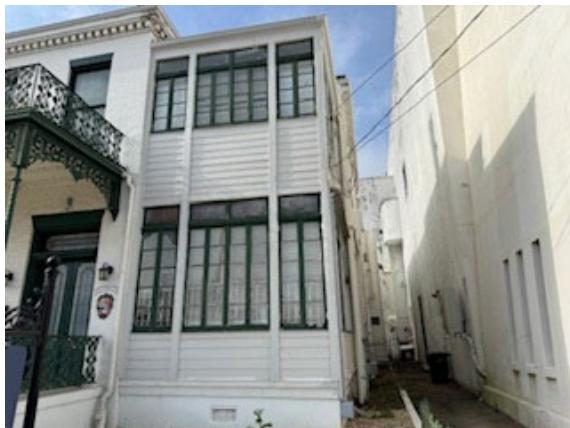
4. View of east elevation subject windows.

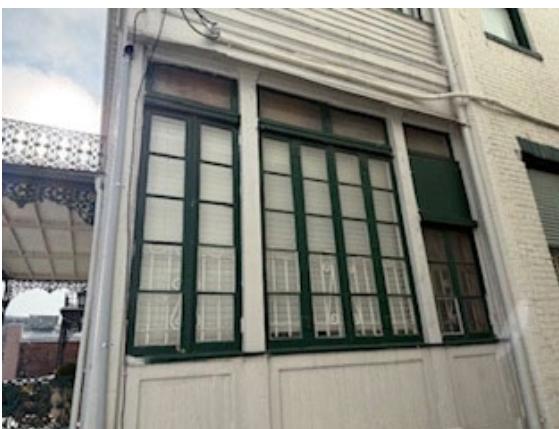
5. view of subject windows on first floor of north elevation.

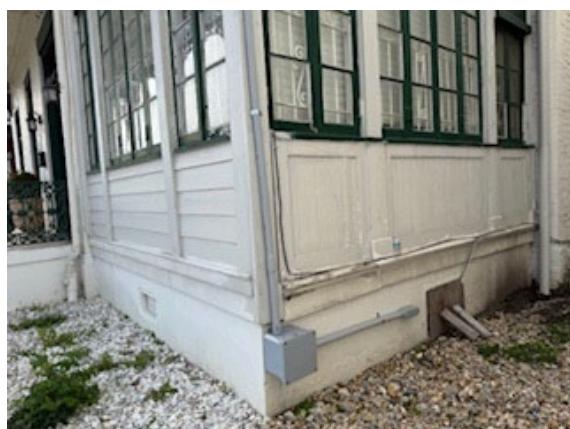
6. Northeast corner of subject windows on first floor.

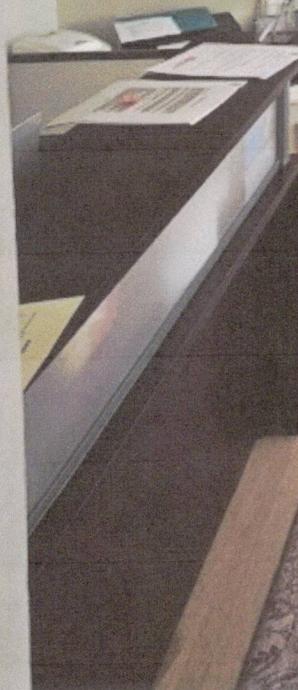
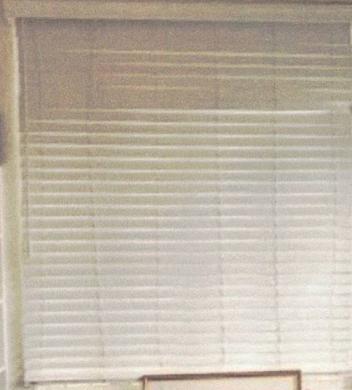
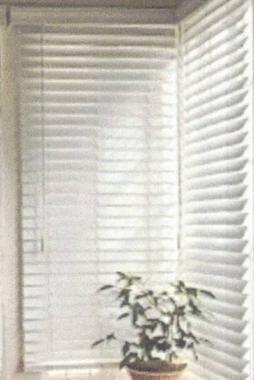
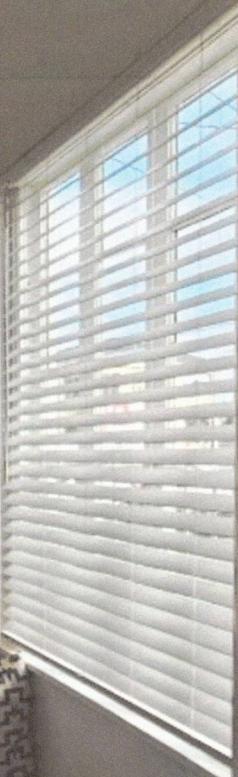
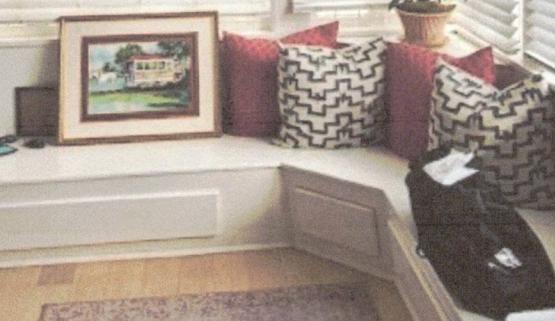
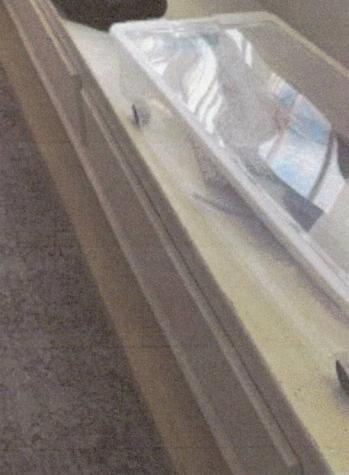
TRANSOMS
ARE
COVERED!

The sashes appear to be original but neglected. There are multiple layers of paint that have cracked and peeled thereby trapping moisture that has led to rotting. This is particularly evident in the bottom rails, the most important structural element of the sash.

There is evidence of multiple layers of caulk that suggest intact removal, combined with rotten bottom rail, will be extremely difficult. This would make any attempt at restoration expensive and time-consuming.

We strongly recommend that the homeowner replace these windows with an historically accurate wooden replacement. Using a tropical hardwood, the owner can expect many decades of trouble-free use.
