## Agenda Item #5

### Certified Record 2026-30-CA

960 Dauphin Street

After-the-fact approval to remove original doors, transoms, and sidelights from the south façade and replace with new wood doors that do not match existing.

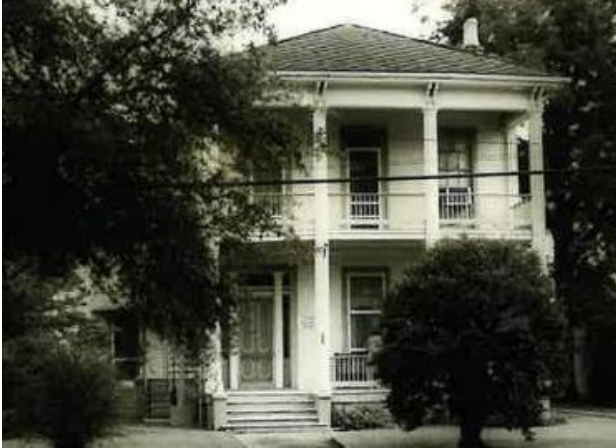
1. Primary (south) façade, looking north (1983)

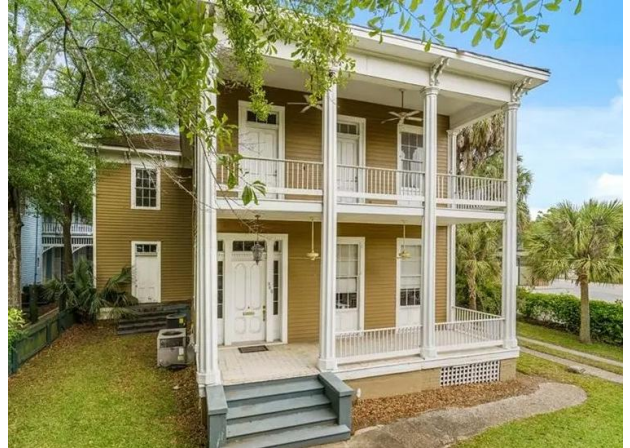
2. South façade, looking northwest (2020)

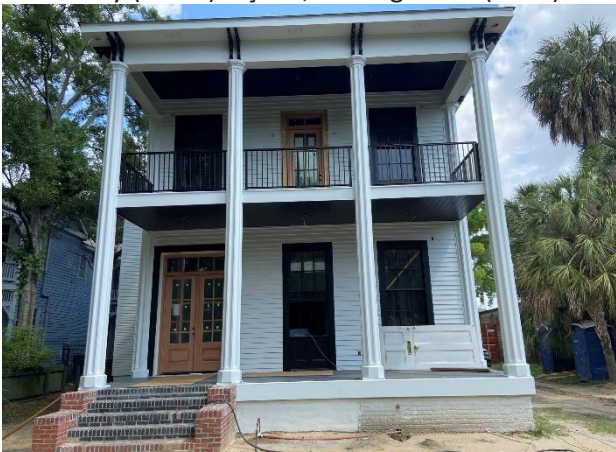
The CAD drawings submitted do not replicate the intricate detail of the historic surround. They also significantly alter the relative proportions of the door, transom, and sidelights. The neoclassical pilasters on either side of the door are not present at all in the new drawing. Instead of the tripartite transom of the original, the proposed drawing has a single 4-light transom. The door has been simplified, and its 1-over-1 wood panels are far more typical of the early 20<sup>th</sup> century than the c. 1860 construction date of the subject property. The dentil molding is entirely out of scale. While the new design would be a significant improvement over the current multi-light French doors, it does not faithfully replicate the original Italianate door and surround.

3. Replacement doors (April 2026)

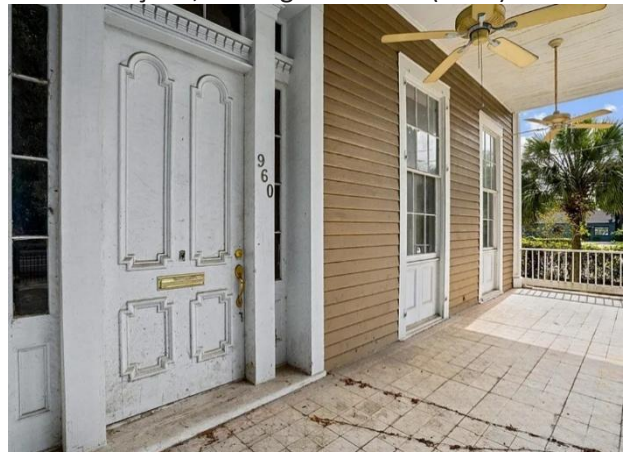
While staff agree that the main entry showed considerable signs of wear, onsite inspections during the construction process indicated that the paneled wood door, sidelights, transom, and decorative trim could be repaired. Staff received no communication during the construction process that repair of the either of the two façade door assemblies was not possible. On the contrary, prior to their removal, both façade doors and their surrounds had been repaired and painted in the white and black color scheme used on the rest of the residence. New hardware had been installed on the main entry door, suggesting it was operable. Upon receiving a 311 complaint that both doors had been replaced, staff visited the site and found that the contractor had salvaged both doors as well as their decorative surrounds, transoms, and sidelights. Workmen onsite assured staff that the doors and surrounds could be reinstalled in their original location and condition.

4. Historic entry door, sidelights, and transom (2020)

If for any reason the doors and surrounds could not be reinstalled, the *Guidelines* specify that a new door and surrounds would need to match the original as closely as possible. Since the original door and trim survive, it would be possible to have them replicated exactly in an insect-resistant wood such as mahogany. In contrast, the current replacement doors do not replicate any detail of the original. The original single-leaf entry door with transoms has been replaced with a double-leaf door without transoms. The new trim is lacking in the characteristic detail and depth of the original Italianate door surrounds. The new multi-light doors are themselves a significant departure from the historic solid wood paneled doors.

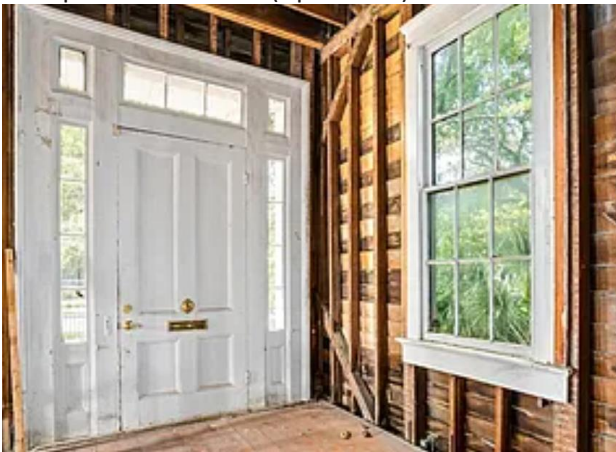
5. Interior of historic entry door (2020)

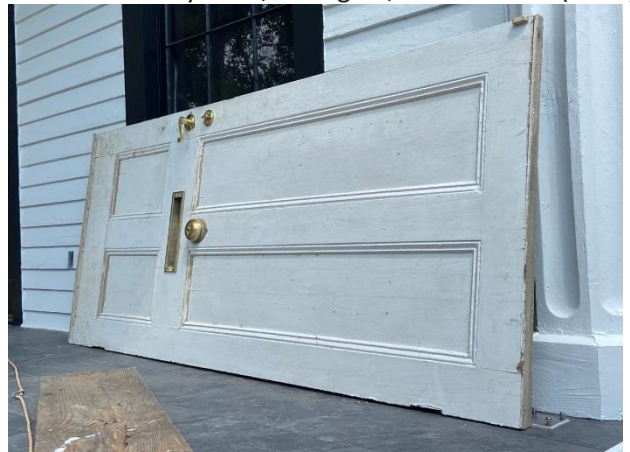
Ms. Annie Sawyer Allen provided that staff advised the applicant to repair the doors if necessary. She added during a site visit, staff observed the first-floor front door and surround. The door, casing, and surround had been sanded, painted and adorned with new hardware. They did not appear to be in need of repairs.

6. Original entry door with new hardware installed

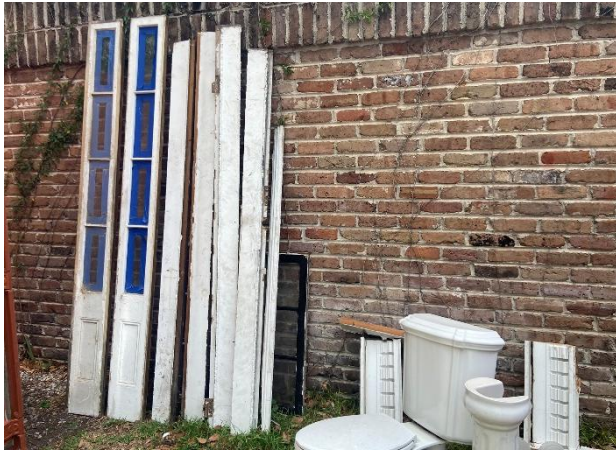
7. Sidelights and door surround trim

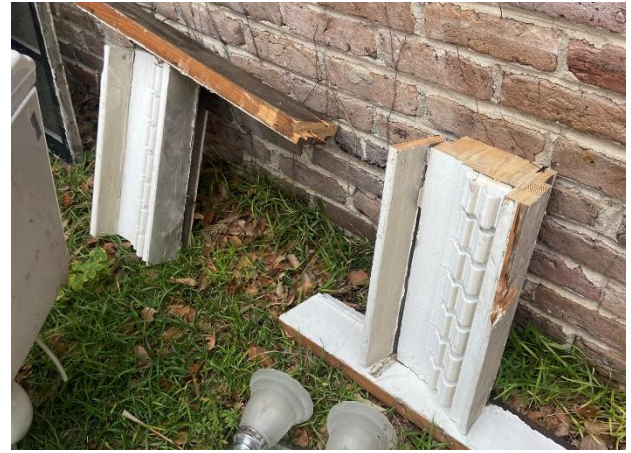
Photos of the transom show relatively minor damage that could be repaired with dutchman and/or a wood epoxy. The black material shown on the transom in one photograph appears to be surface mildew, which would not compromise the integrity of the wood itself.

8. Door surround trim and transoms

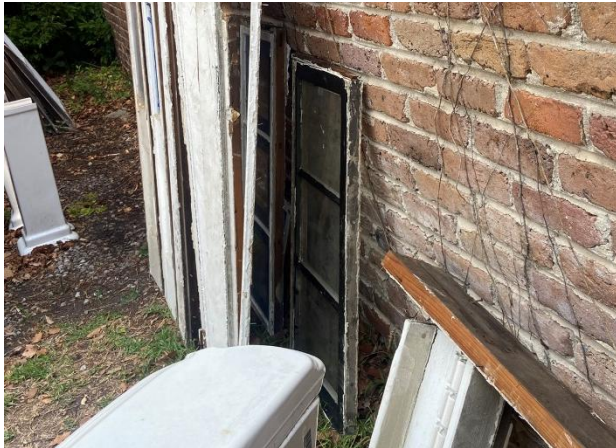
9. Transoms behind door trim pieces

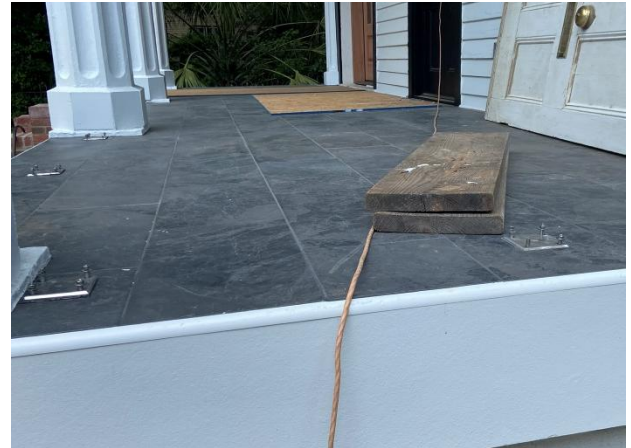
Prior to this most recent renovation, the porch floor at 960 Dauphin was clad in a square ceramic tile that did not appear to be original. The original porch material is unknown. The newly installed tile floor features rectangular tiles of a single color in a simple running bond. This gives the tile floor a much more modern appearance than what would be expected of a c. 1860 dwelling. However, the material itself is one that would have been historically available, and the tile floor is minimally visible from the public right-of-way.

10. New tiles on south porch deck

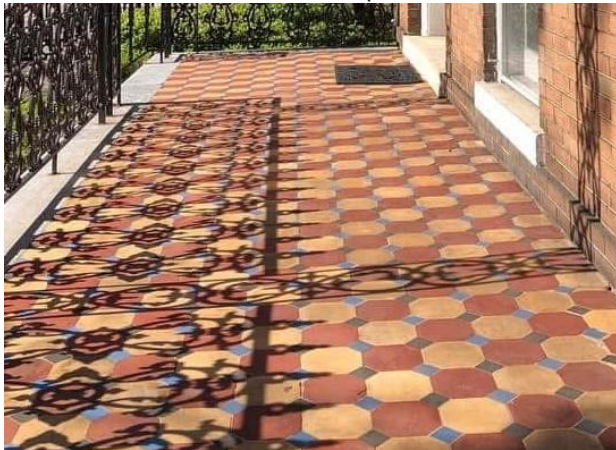
Where the original porch floor is no longer extant, the *Guidelines* support installing a porch material that might have existed at the time the home was constructed (6.5, 6.6). When the home was constructed in about 1860, the most common porch type for the period would have been tongue-and-groove wood planks. Some high-style dwellings from the period featured mosaic floors made with either terra cotta or stone tiles. These were typically di- or polychromatic mosaics using square, hexagonal, or octagonal tiles made of either terra cotta or stone (see images 11 and 12).

11. Tile porch floor, Guesnard House (c. 1855) at 51 S. Jackson Street

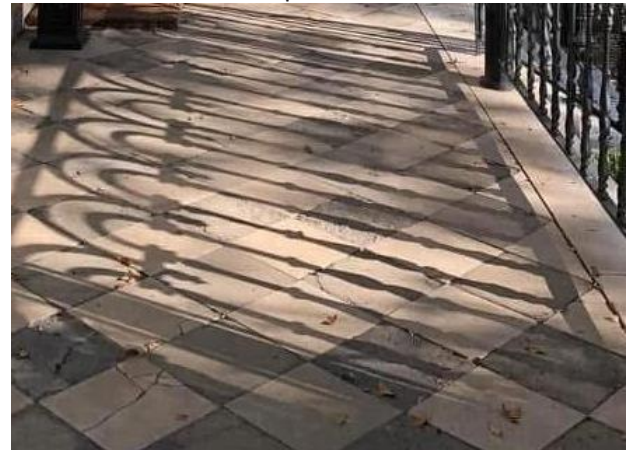
12. Stone porch floor, St. John-Rutherford House (c. 1857) at 201 N. Conception Street
