## Agenda Item #5

### Certified Record 2026-59-CA

1206 Elmira Street

After-the-fact approval to remove all existing wood windows and replace with vinyl windows; after-the-fact approval to paint brick foundation, knee wall, and column piers.

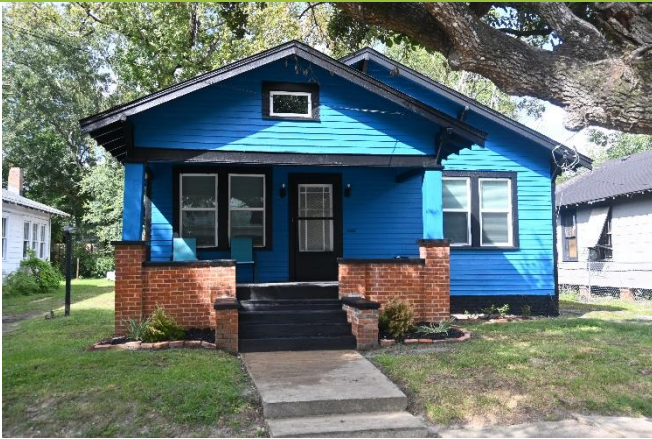
1. South façade, looking N

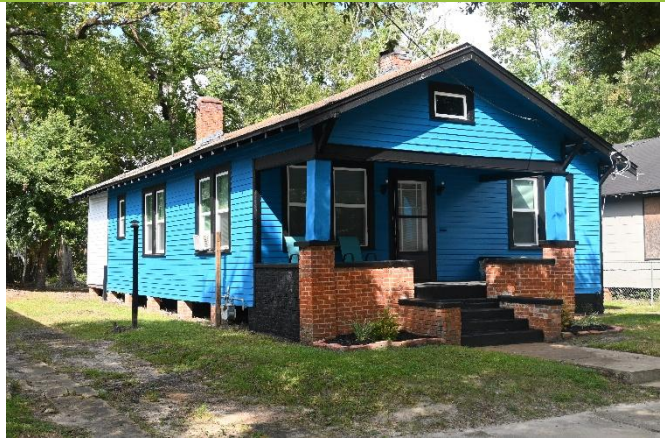
2. South façade and west elevation, looking NE

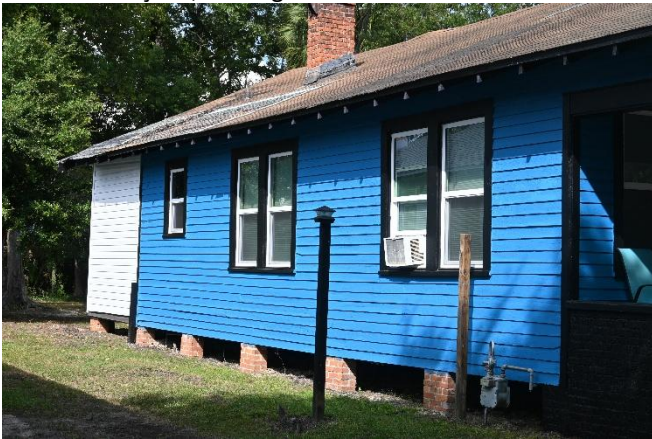
3. West elevation, looking NE

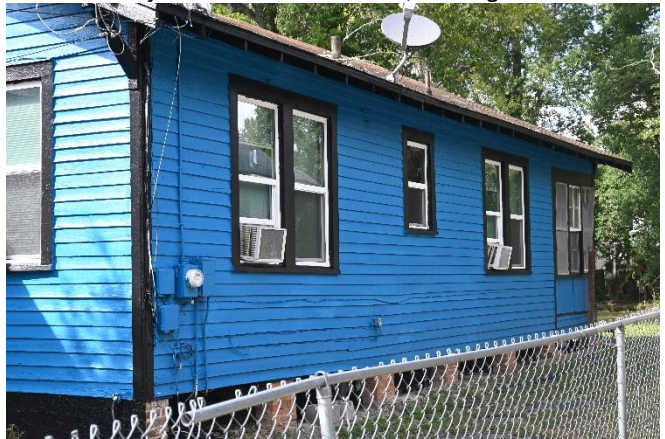
4. East elevation, looking NW

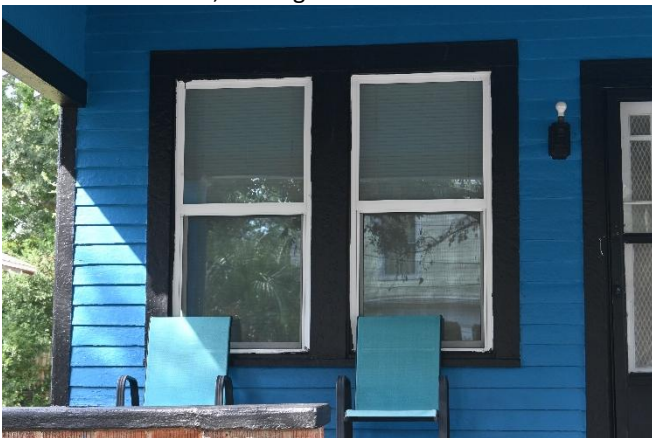
The existing replacement windows are non-compliant regarding their material, configuration, and details. They appear to be compliant in their dimensions and placement.

The Design Guidelines explicitly list vinyl as inappropriate for replacement windows in existing structures in the local historic districts. The one-over-one sash configuration does not replicate the original four-over-one double-hung wood windows. However, one-over-one sash windows would have been in common use when the subject property was constructed in 1929. The replacement windows are therefore in keeping with the period of construction even if they do not exactly replicate the original appearance of this specific structure. A one-over-one configuration is also preferable to a four-over-one sash with superficial “stick-on” muntins. The addition of superficial muntins at this point would therefore not be a desirable compromise.

The replacement windows do appear to fit the existing openings. Likewise, it does not appear that any window openings were removed or added as part of the unpermitted work. The overall fenestration pattern therefore remains intact.

5. Closeup of vinyl replacement windows on south façade at front porch. Windows appear to fit the existing opening.

The primary points of mitigation are therefore the inappropriate window material and the one-over-one light configuration. The narrow side yards on this block of Elmira Street mean that most of the windows on the side of the home are minimally visible from the public right-of-way. Windows on the rear are not visible at all from the public right-of-way. One possible mitigation would be to replace the four windows on the facade and the two windows nearest the street on the east elevation with either wood or aluminum-clad wood windows with a four-over-one light configuration. These windows would need to have exterior muntins and an interior spacer bar to imitate the appearance of the original windows.

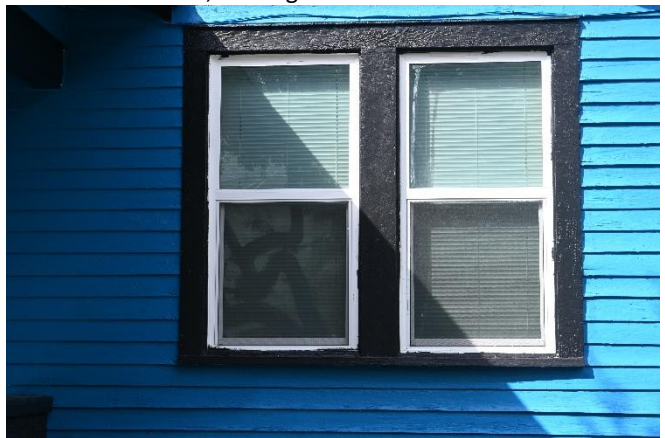
6. Closeup of vinyl replacement windows on south façade. Windows appear to fit the existing opening.

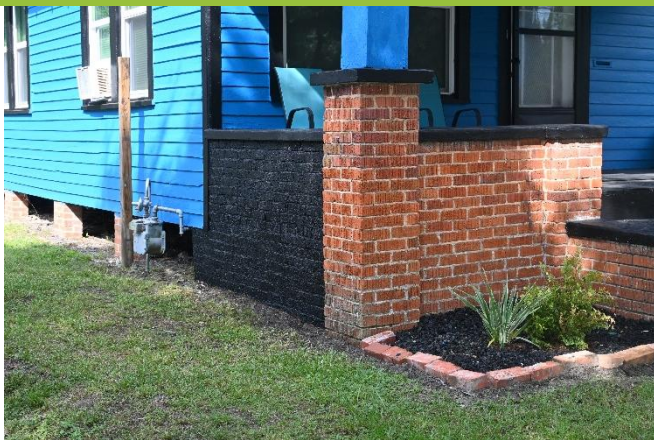
When staff responded to a complaint regarding unpermitted work, the brick foundation and porch were already partially painted. Painting unpainted historic brick is not recommended because it alters the structures original material palette and design intent. Painting can also damage historic masonry if the paint used is not sufficiently vapor permeable. It is not known what type of paint was used in this application. If a masonry-specific paint formula was used, risk to the brick is minor.

The visual impact of the painted brick is far less significant than the inappropriate replacement windows. Painting is limited to the side knee walls of the front porch and the continuous foundation at the south façade. The south walls and steps of the porch remain unpainted. Paint removal is likely to cause damage and is therefore not a realistic mitigation.

7. West knee wall of porch painted black

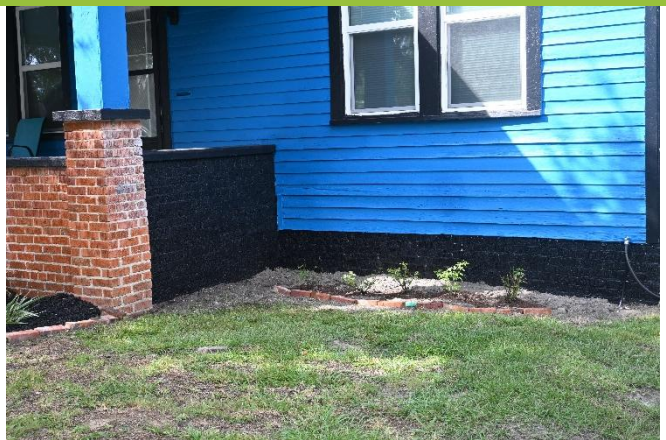
8. East knee wall of porch and foundation painted black.

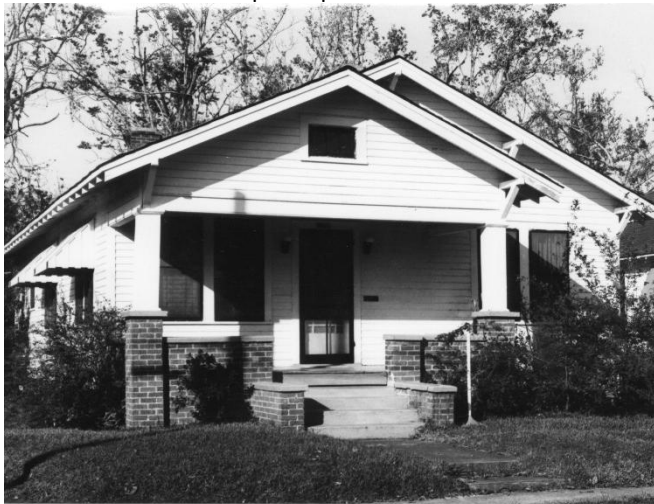
9. MHDC survey photo of property (1979)

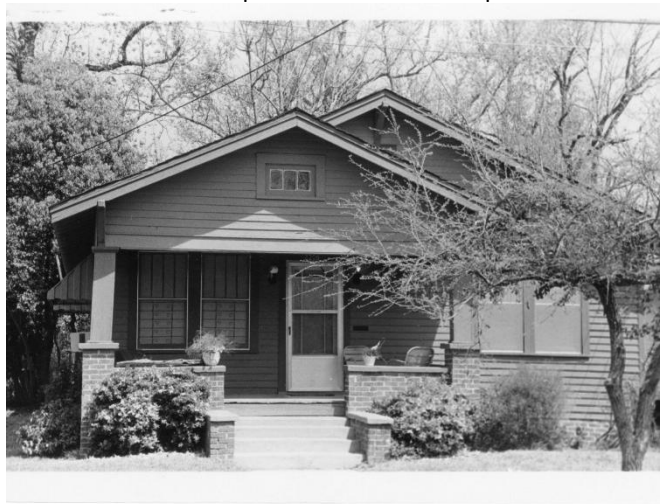
10. Original four-over-one windows visible in MHDC survey photo of property (1989)

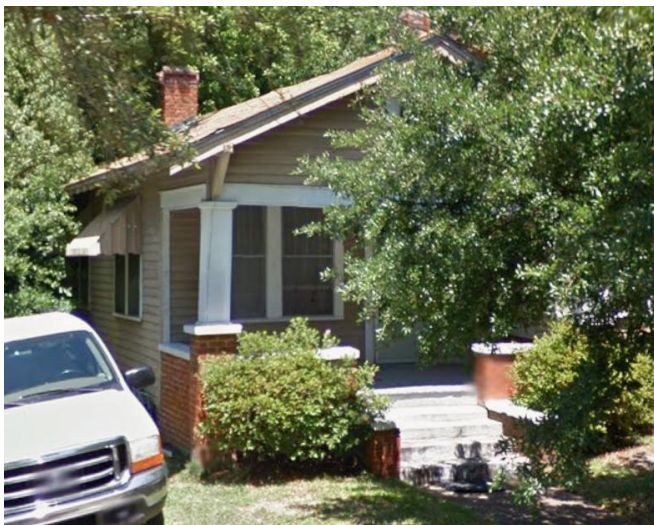
11. Google Map Street View of property (2016). Four-over-one sash windows are visible on south façade at porch.

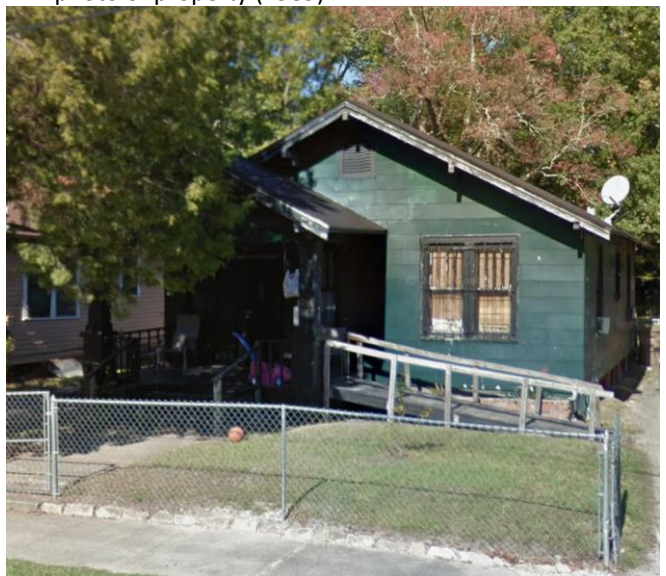
12. Comparable four-over-one windows in place at 1204 Elmira Street (Google Maps, 2016)
