# Agenda Item #1

## Application 2026-47-CA

155 Houston Street

Replace thirteen existing wood windows with aluminum-clad wood windows

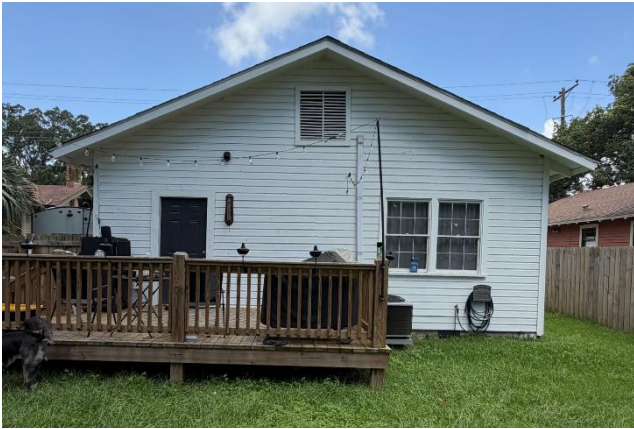
The subject property is listed as non-contributing in the Old Dauphin Way Historic District. The application under review seeks approval for the replacement of thirteen double-hung wood windows with aluminum-clad wood windows to match the existing in overall dimension and light configuration. The double-hung wood windows on the original c. 1925 match those on the c. 1960 addition, suggesting the windows date to the later period.

3. East (rear) elevation of c. 1960 addition, looking W

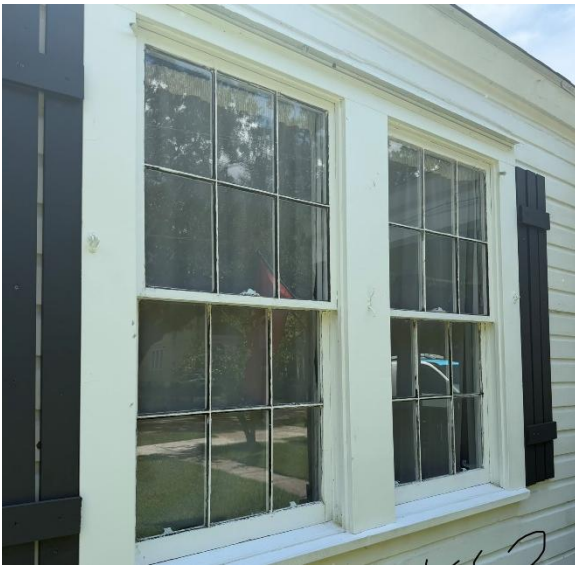
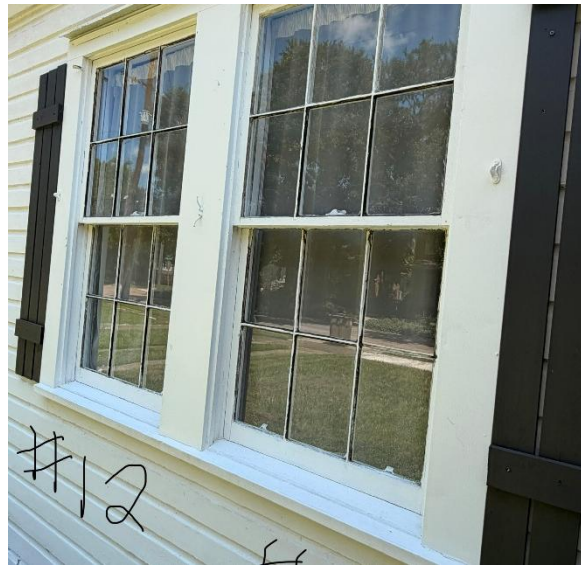
9. Windows #12 & 13 on west facade

in repairable condition. Photographs do not depict any obvious signs of rot or termite damage to the wood sash and muntins. The glazing putty – which frequently is loose, cracked, or entirely missing on poorly maintained wood windows – is intact and well-adhered. This suggests that the windows have been reglazed fairly recently and otherwise well maintained. The glazing putty has blackened on nearly all windows. This commonly occurs if fresh window putty is painted over before it is allowed to dry fully. Excess moisture escapes from the putty as it cures, causing the paint surface to mildew. This can be removed with by washing the windows with a dilute dish soap solution. A small amount of bleach may be added to the water for stubborn staining. Once the mildew is removed, a fresh coat of paint treated with a mildewcide should prevent the blackening of the putty in future.

10. Windows #12 & 13 on west facade
