## Agenda Item #5 Application 2026-26-CA

120 Michael Donald Avenue

After-the-fact fenestration replacement and alterations.

## Site Photos- 120 Michael Donald Avenue

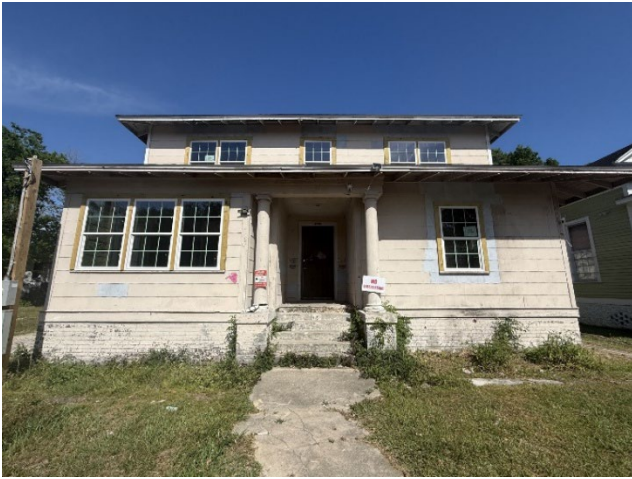
1. View of W façade of property.

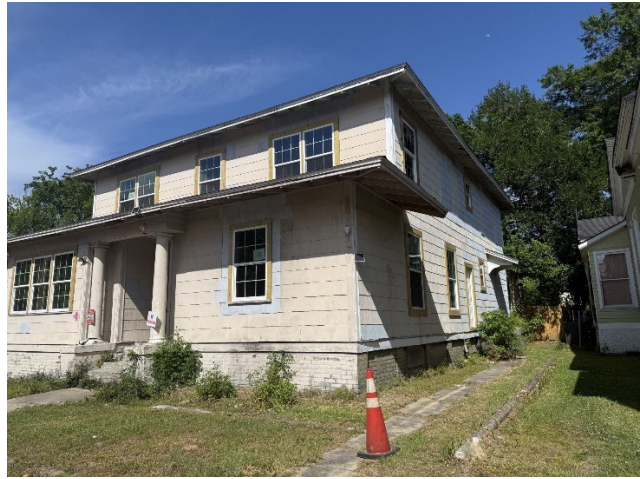
2. View of west and south elevations of property, looking NE.

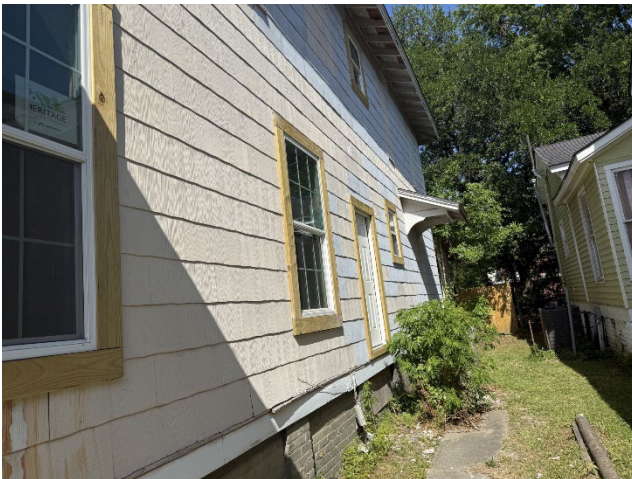
Additionally, windows have been deleted from the north and south elevations, doors have been moved on the north and south elevations, and a door has been deleted on the east elevation. When the 2018 COA was given to board up the existing window openings, there were eleven window openings on the south elevation and twelve window openings on the north elevation. Currently, both south and north elevations express five windows each.

3. View of south elevation, looking E.

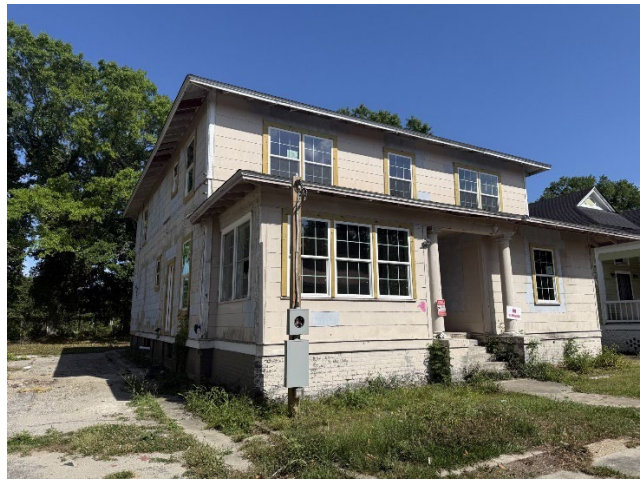
4. View of west and north elevations, looking SE.

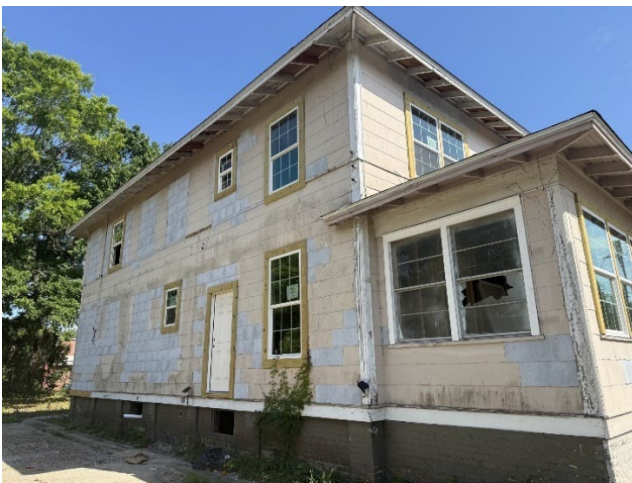
5. View of north elevation, looking SE.

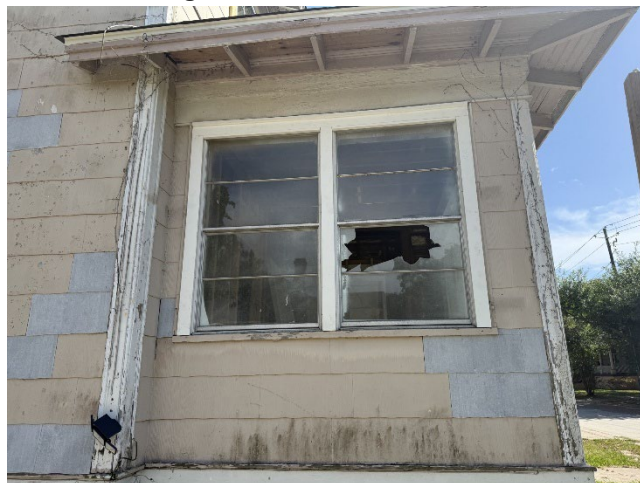
The condition of the windows prior to the installation of the current unpermitted vinyl windows is unknown. Photos from 2013 show that the windows present were one-over-one wood windows with metal windows in the enclosed porch on the west façade and north elevation. One metal window is still present on the north elevation of the enclosed porch and features a broken pane of glass.

6. View of extant metal window on the north elevation of the enclosed porch.

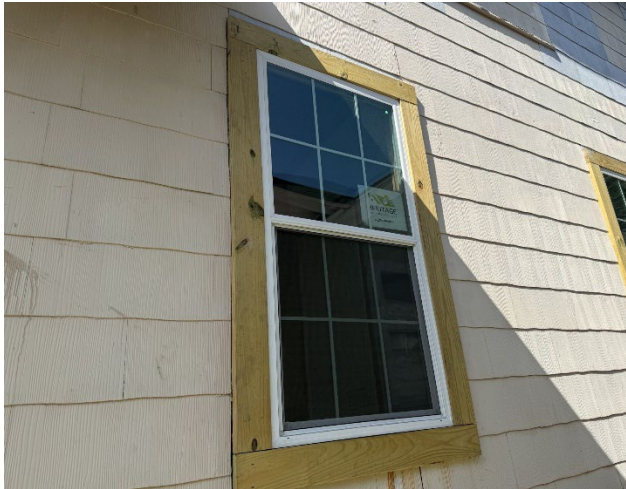
The *Guidelines* instruct that unrepairable historic windows should only be replaced with windows that match the design of the originals (5.21), which includes profile, dimension, and material. (5.19) “In instances where there is a request to replace a building's windows, the new windows shall match the existing as per location, framing, and light configuration.” Vinyl windows are expressly considered unacceptable in Mobile's historic districts (5.22).

7. View of vinyl window and trim on the north elevation.

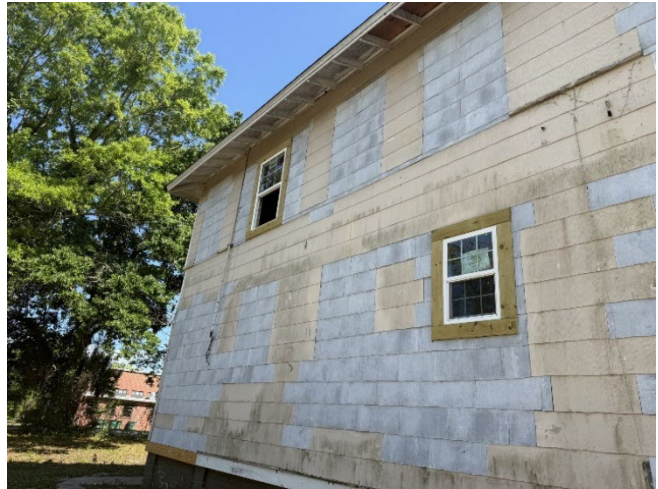
8. View of deleted windows on the north elevation.

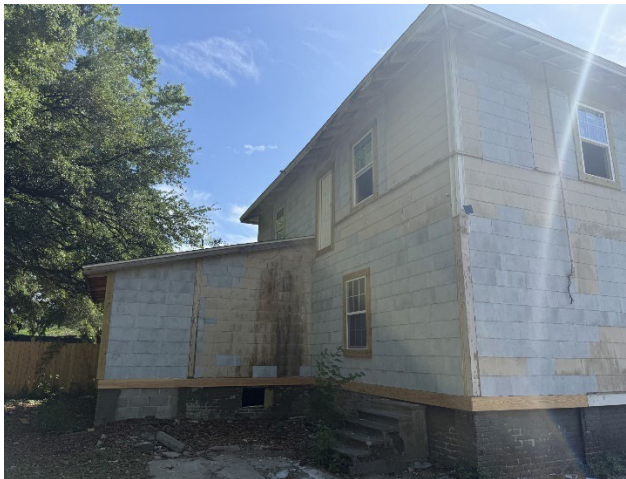
9. View of east/rear elevation of the property, looking SW,

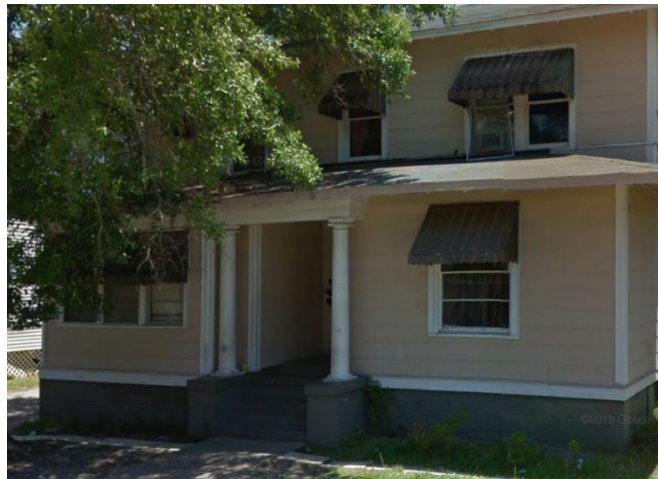
10. View of west façade (from May 2013)

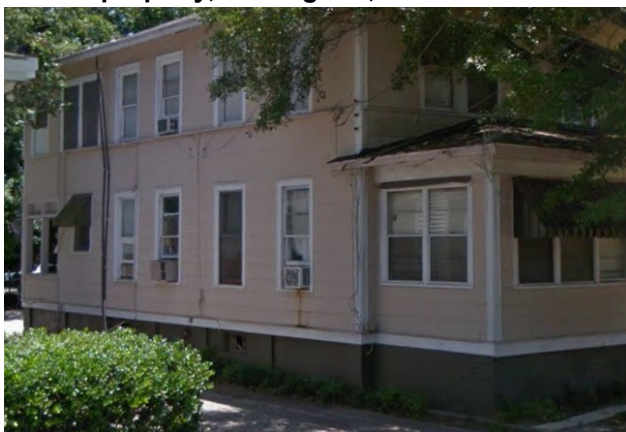
11. View of north elevation (from May 2013)

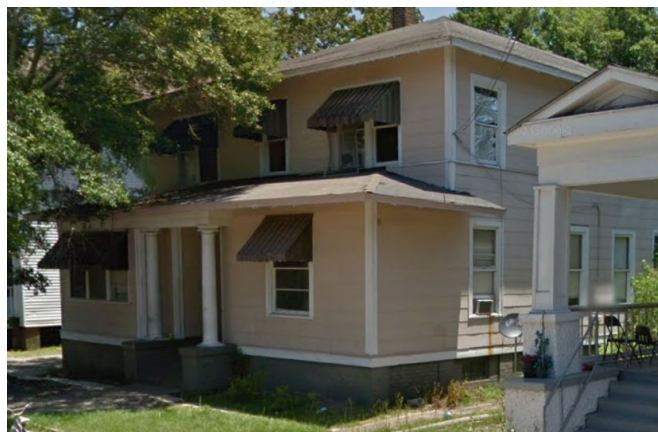
12. View of west façade and south elevation (from May 2013)
