# Agenda Item #1

## Application 2023-56-CA

34 S. Reed Avenue

Update to After-the-Fact Approval: Install aluminum-clad replacement windows that do not match muntin profile of the original windows, as issued COA required; replace two windows with French doors on façade; replace two-light window with single-light sash; remove attic gable window.

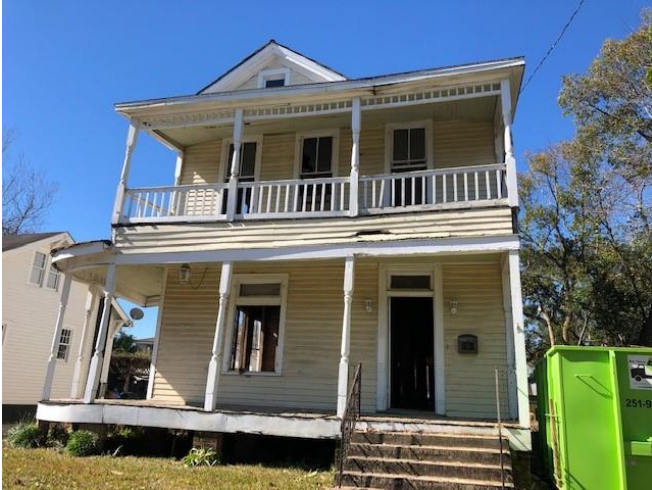
1. View west-southwest to east elevation (façade) of subject property; photo taken January 2021

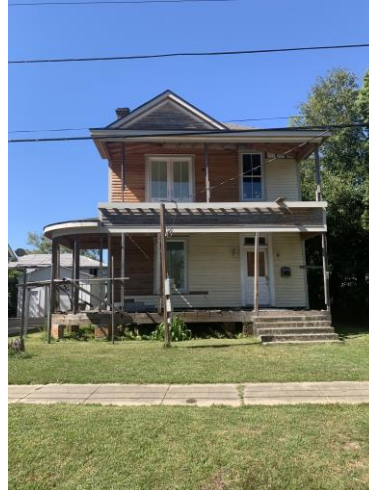
The *Guidelines* specifically reference “key character-defining” walls. The façade (east elevation) and original block of the south elevation are the most visible walls of the building and may be considered character-defining. Therefore, the removal of the four-light fixed window in the attic gable on the façade (without review) was not in compliance with the *Guidelines*. (5.20, 5.22) Likewise, the removal of two (2) two-over-two windows at the second-floor level of the façade and their replacement with French doors (without review) was not in compliance with the *Guidelines*. (5.20, 5.22)

2. view west to east elevation (façade) of subject property; photo taken October 2023

- ARB members agreed that it would be acceptable for the existing windows in the side and rear elevations to remain as-is since they are secondary elevations.
- Mr. Terrell agreed to place a louvered vent in the gable on the front elevation.

- Mr. Terrell has ordered a window for the second floor of the façade which will replace one of the French doors. The second floor fenestration pattern (from left to right) will be converted to single door; two-over-two window; two-over-two window.

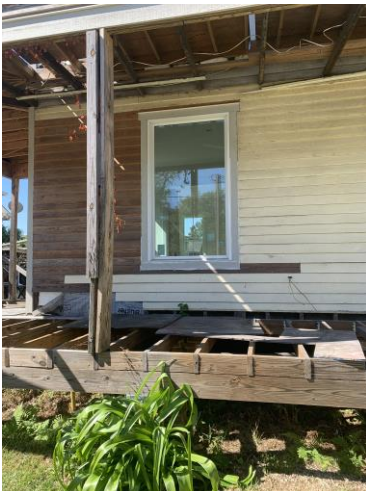
The original window at the south end of the east elevation (façade) on the first floor had two fixed lights, and the smaller upper light echoed the transom above the front door to its immediate north. The window has been replaced with a single-light fixed window that does not match the original light configuration, as required by the *Guidelines* and the issued COA. (5.21)

3. View west to replacement window at south end of east elevation (façade); photo taken October 2023

- Mr. Terrell stated that the window manufacturer is not able to make a simulated divided light thick enough to resemble the missing transom on the first-floor façade window. Possible alternative solutions presented were installing a two-over-two window to match other existing windows, or to install a simulated two-over-two divided light on the single-light window.  
ARB members were not amenable to installing a simulated divided light, but agreed with the option of replacing the single-light window with a two-over-two window to match existing windows. They recommended moving an existing two-over-two window from a secondary elevation to the façade and reusing the single-light window on a non-primary elevation.

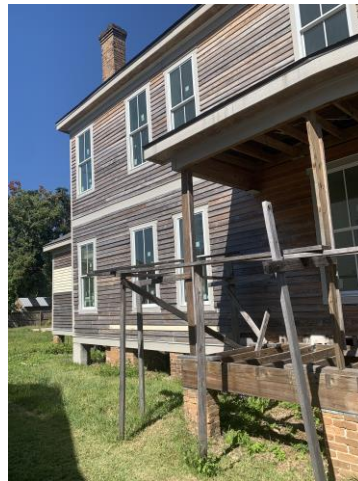
4. View west-northwest to south elevation of subject property (October 2023)

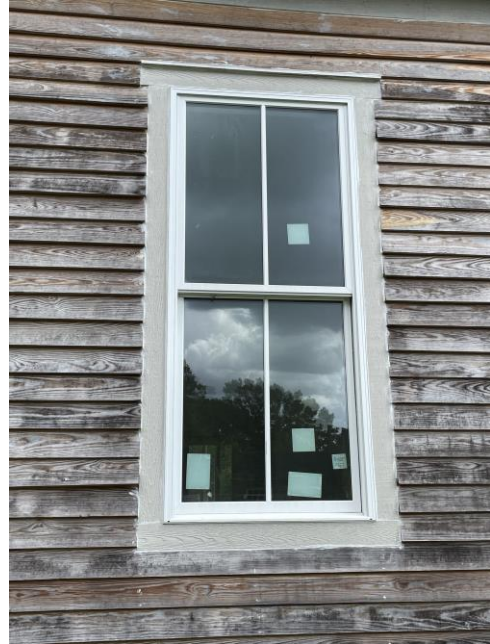
The *Guidelines* require that when a window located on “a key character-defining wall” must be replaced, a historically accurate replacement matching the “configuration, dimensions, and profiles of the original windows” should be used. (5.22) The balance of replacement windows (excluding the window discussed above) installed in the house are aluminum-clad sashes in a two-over-two light pattern, matching the original windows. The dimensions of the rails and stiles of the replacement windows closely match those of the original windows. The width of the muntins is also a close match to the originals. However, the depth and profile of the muntins in the replacement windows does not resemble the original windows, as required by the *Guidelines* and the issued COA.

8. typical replacement window (October 2023)

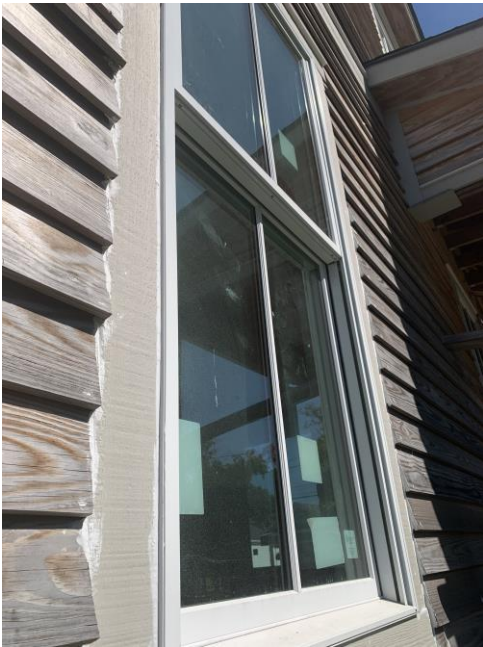
With the key character-defining walls in mind, the profile of the muntins in replacement windows located at the west end of the south elevation, on the west elevation, and on the north elevation may not be as critical since

these would not be considered key character-defining walls. Therefore, the lack of matching profile on those elevations may be permissible.

9. Detail: replacement window on south elevation of subject property (October 2023)

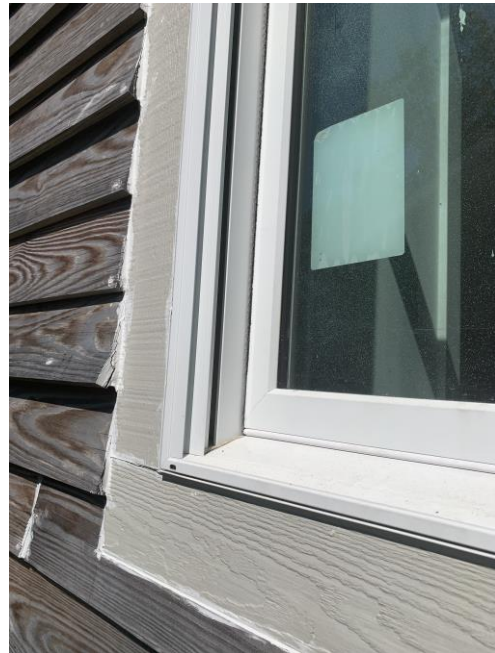
10. Detail: typical replacement window (October 2023)
