Agenda Item #5

Application 2026-7-CA

Remove an existing carport from the east elevation

Site Photos – 1557 Blair Avenue

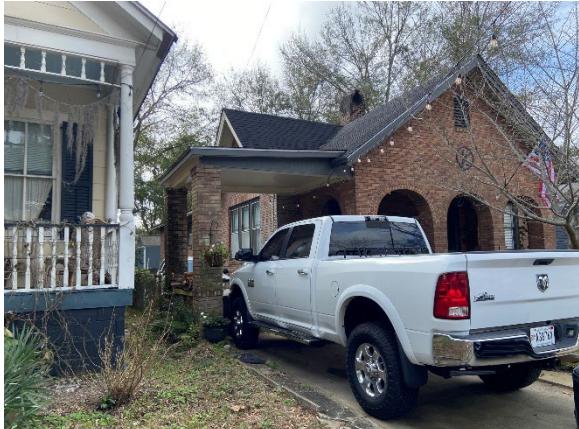
3. East elevation and carport, looking SW

1. Remove existing carport structure from east elevation.
2. Repair east elevation as necessary to match brickwork on the west elevation.

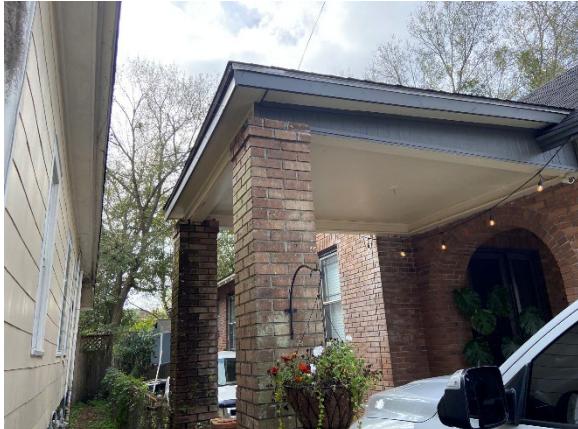
4. View of carport, looking SW

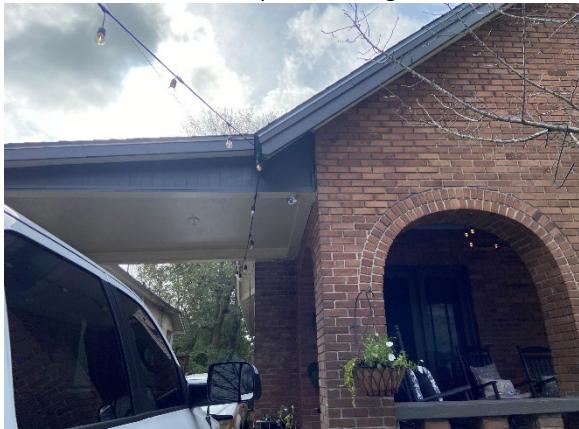
It is not known how, if at all, the carport structure is tied into the structure of the porch. It is possible that the roof of the structure simply abuts the brick cladding of the east elevation. If this is the case, removal poses minimal risk to the original building materials. If the carport is tied into the brick veneer, its removal will likely

result in some damage to the underlying brick. The applicant proposes repairing this brick to match extant brick on the west elevation.

5. Carport appears to abut east elevation

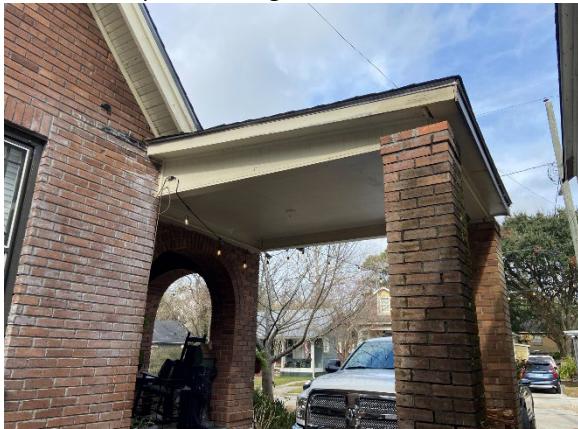
6. View of carport, looking NW

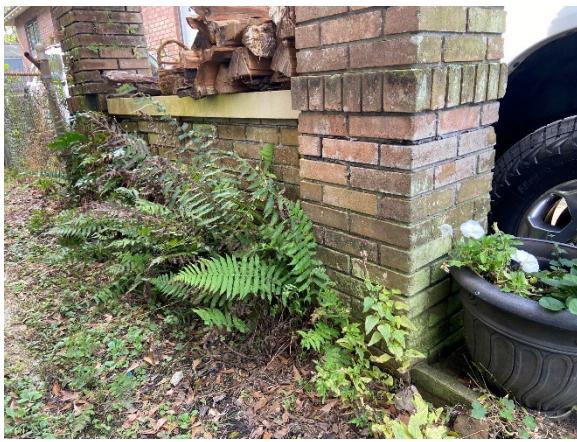
7. Mortar loss and vegetation growth at carport supports

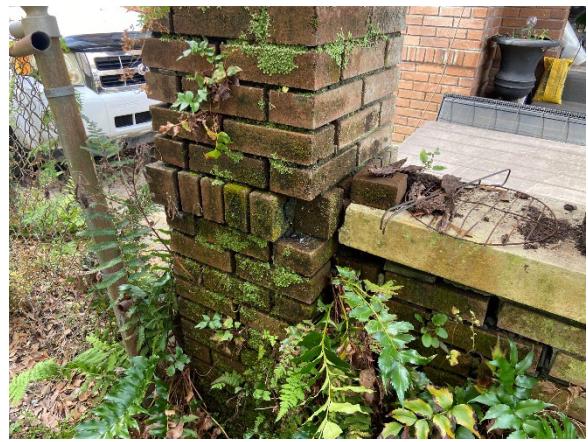
8. Mortar loss and displacement of carport supports

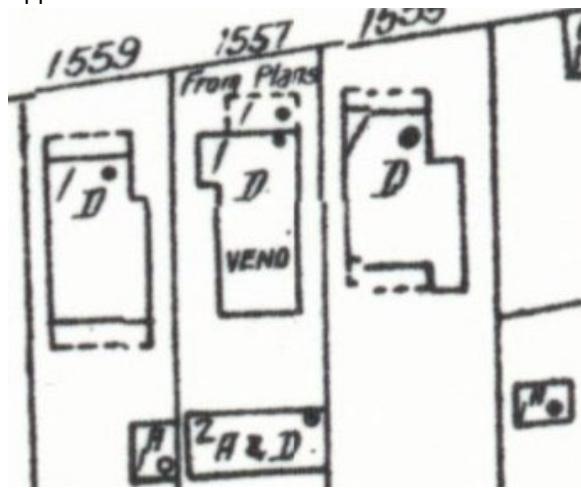
The application proposes removing a non-original carport addition on the east secondary elevation. While the carport is in keeping with the style of the historic dwelling, Sanborn Fire Insurance maps show that the carport was added sometime between 1956 and 1984. The carport likely dates to the same period as other alterations visible in 1984 photographs, including the screened-in front porch and a small addition constructed within the footprint of an original terrace. Despite not being original, the alterations may have occurred prior to 1975, which would make them “historic” under National Park Service criteria. The exact date of these alterations is not known. It should also be noted that both the terrace addition and the screened in porch appear to have been thoughtfully designed so as to be reversible.

9. Representation of 1557 Blair with no attached carport on 1956 Sanborn Fire Insurance Map

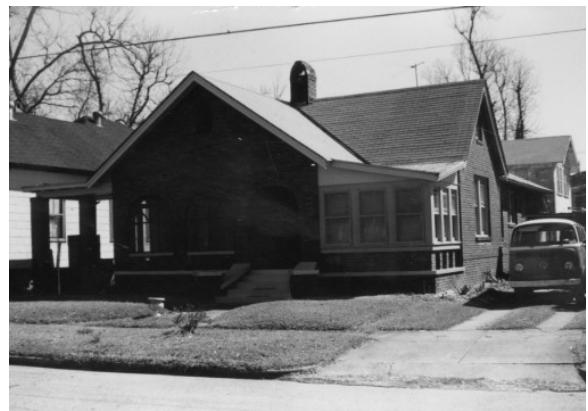
The small addition pictured in 1984 left the masonry balustrade of the northwest terrace intact. Similarly, the porch screens were installed on the inside of the masonry arcade, preserving both the masonry columns and matching balustrade. Both the addition and screening have since been removed to restore the porch and terrace to their original configuration.

10. View of property in 1984, looking SE
