## Agenda Item #5

### Certified Record 2025-47-CA

360 Dauphin Street

Alterations to south facade

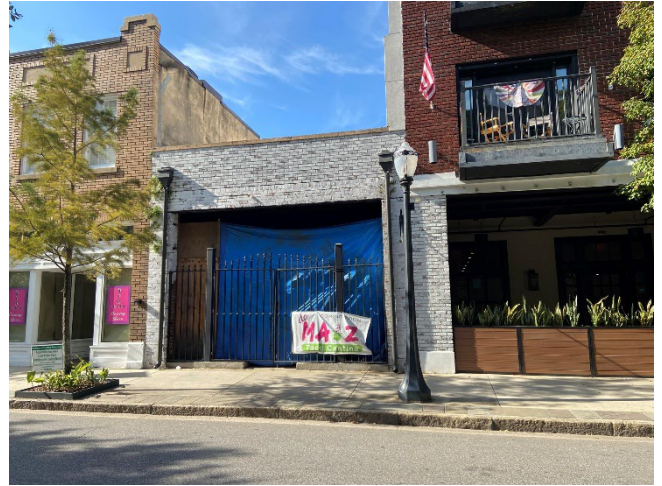
2. View of south facade, looking N

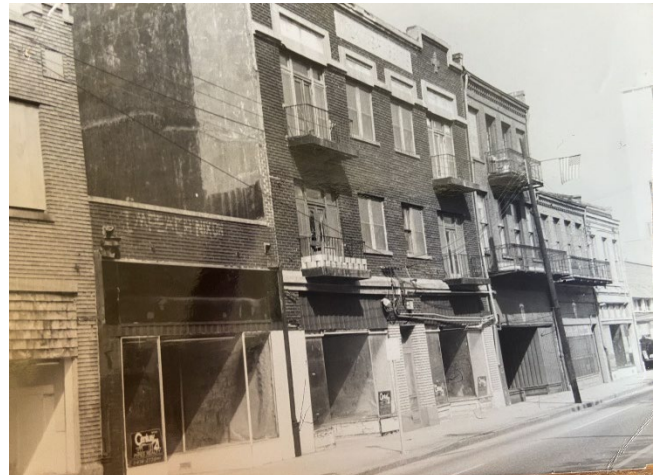
6. View of south facade c. 1974, looking NE

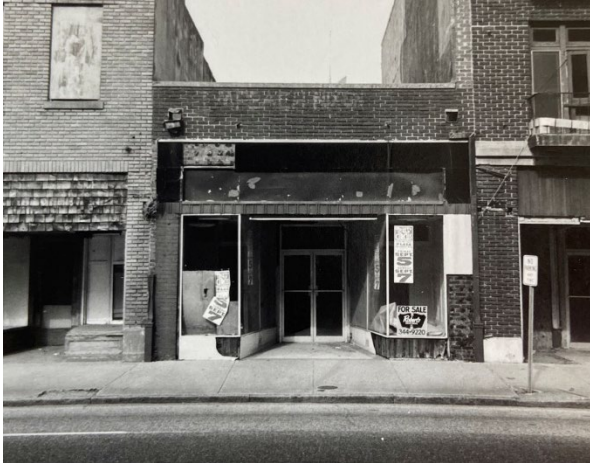
7. View of south facade in 1981, looking N

A photograph taken in 1981 shows the one-story structure with its existing brick cladding and a recessed plateglass storefront over a bulkhead of unknown material. In 1981, a Federal Historic Tax Credit application was submitted for both properties. Construction progress photos taken between 1981 and 1985 show that all existing windows and storefronts were removed from both buildings during this period. By 1985, the one-story building had also lost its roof and full interior. In 1994, a fire reportedly gutted what remained of the interior of the neighboring Wilkins-Higgins building. Both facades were stabilized and shortly thereafter a one-story interior constructed behind the Wilkins-Higgins facade. This space operated as a restaurant through much of the 2000s and 2010s. During this period, the shell of the one-story structure was used as an outdoor courtyard dining area. The second and third floors of the Wilkins-Higgins building were reconstructed in 2015.

There is no storefront extant on the facade in question, and photographic evidence is insufficient for replicating the form, orientation, or details of an original or historic storefront in this location. Photographic evidence shows that a chamfered recessed glass-and-aluminum storefront existed in 1981, but the storefront shown is clearly not original. The photograph shows that a transom window had been either painted over or boarded. The transom is flush with the facade, suggesting that an earlier storefront may have been flush rather than recessed. At least one panel of a semi-reflective cladding material has been removed or fallen away, revealing brick that appears to have been painted. In short, existing photographic evidence does not provide one specific original or historic design to emulate.

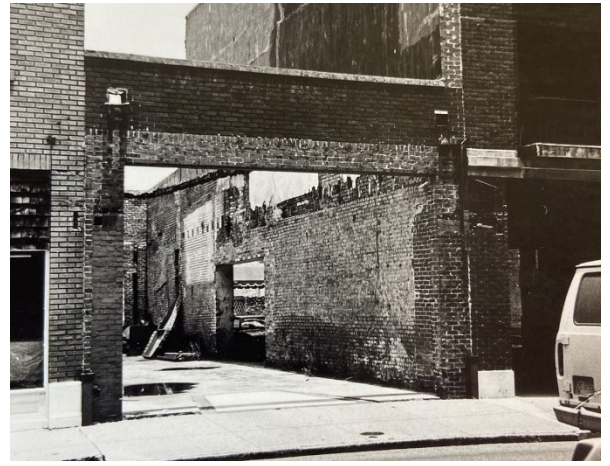
8. View of south facade in 1985, looking NE

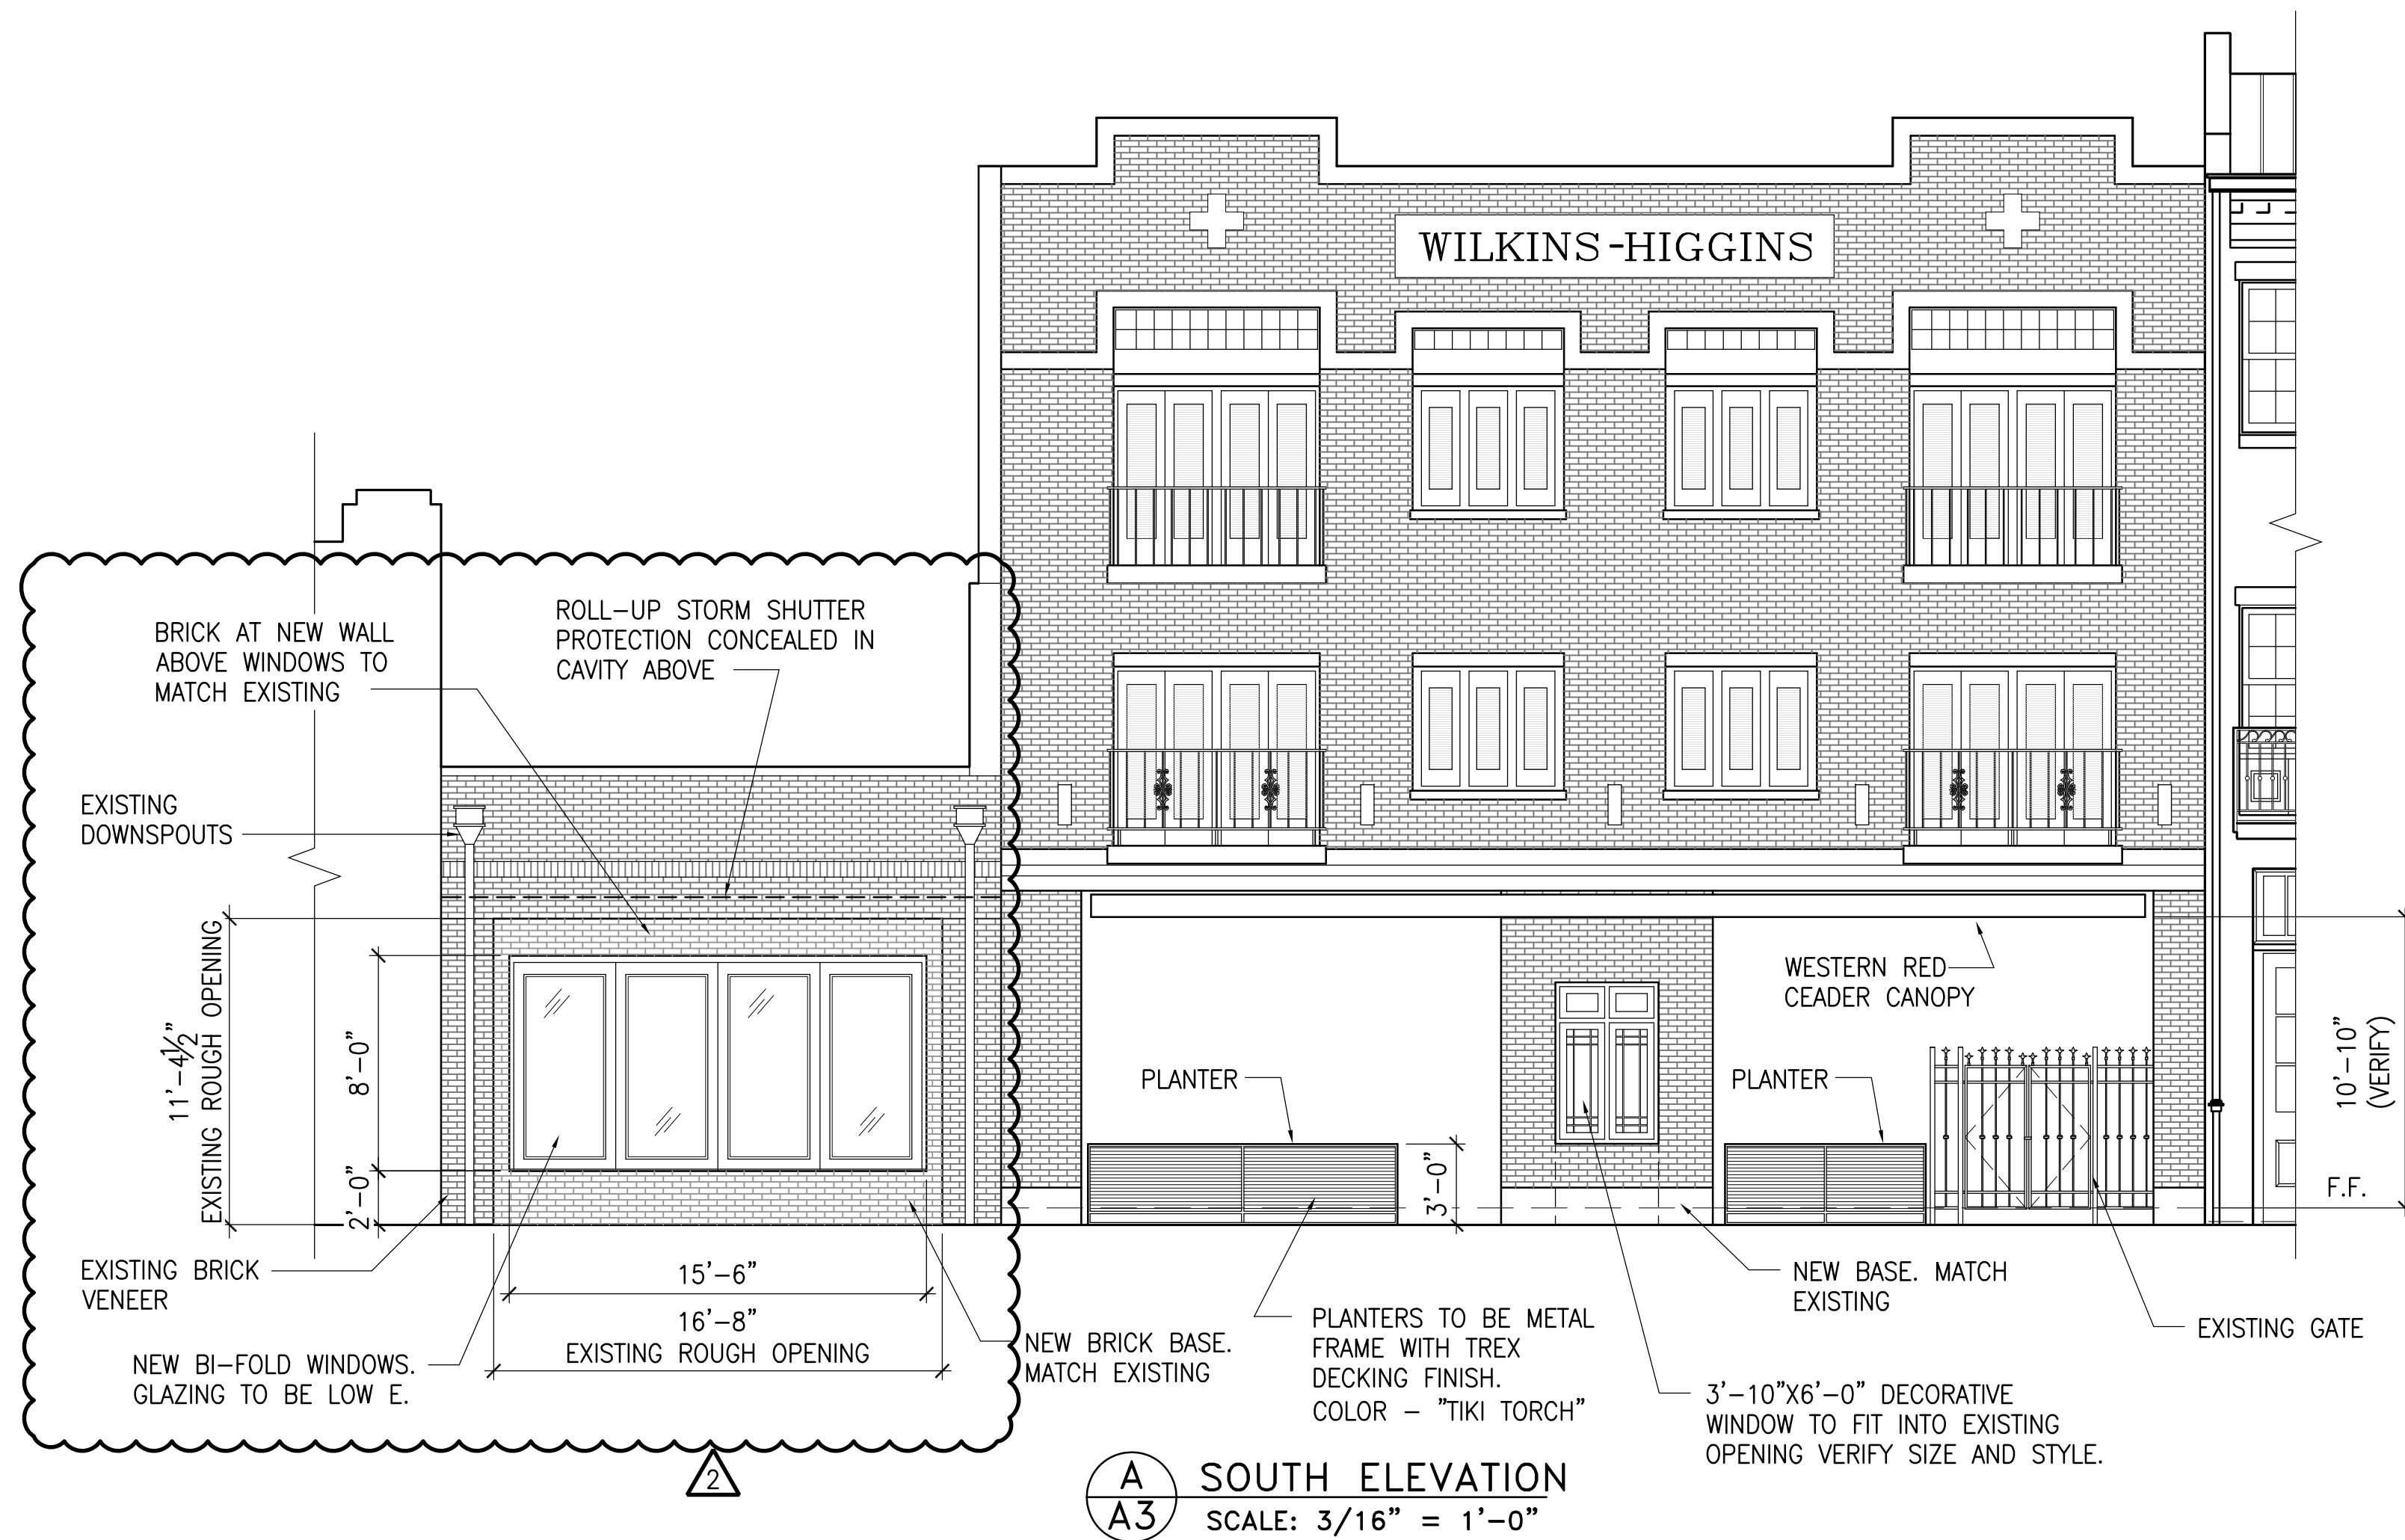
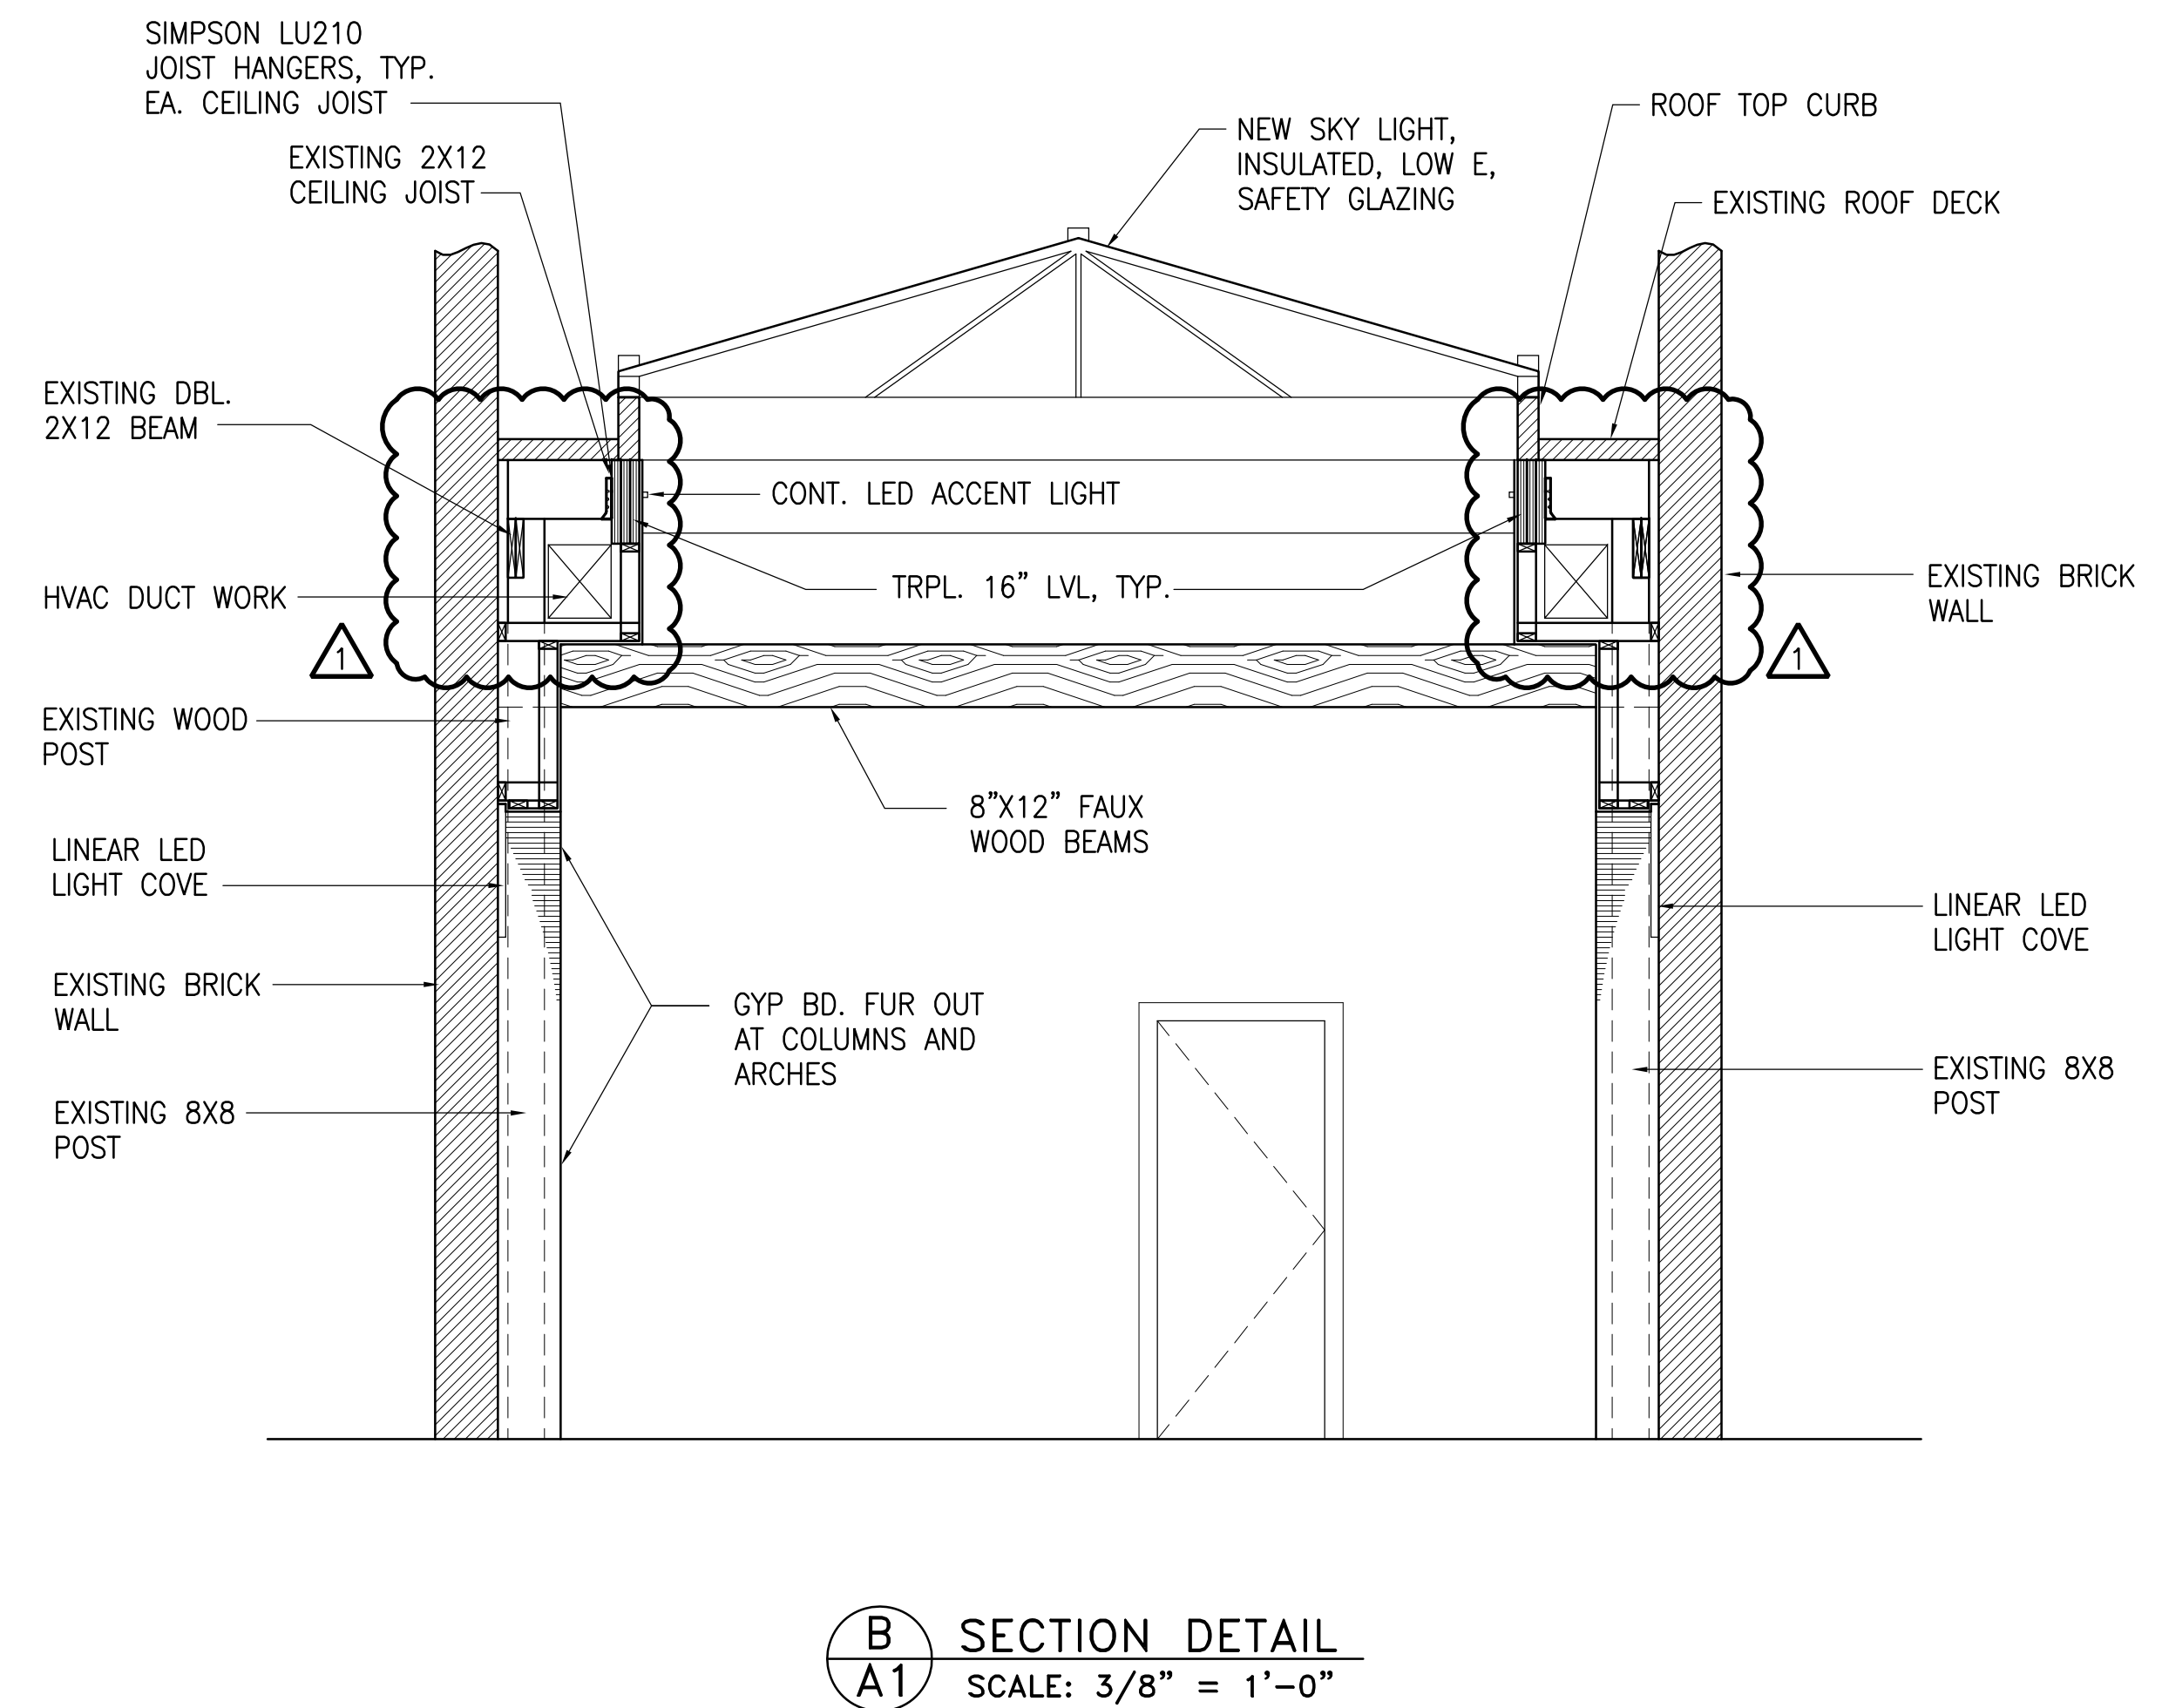
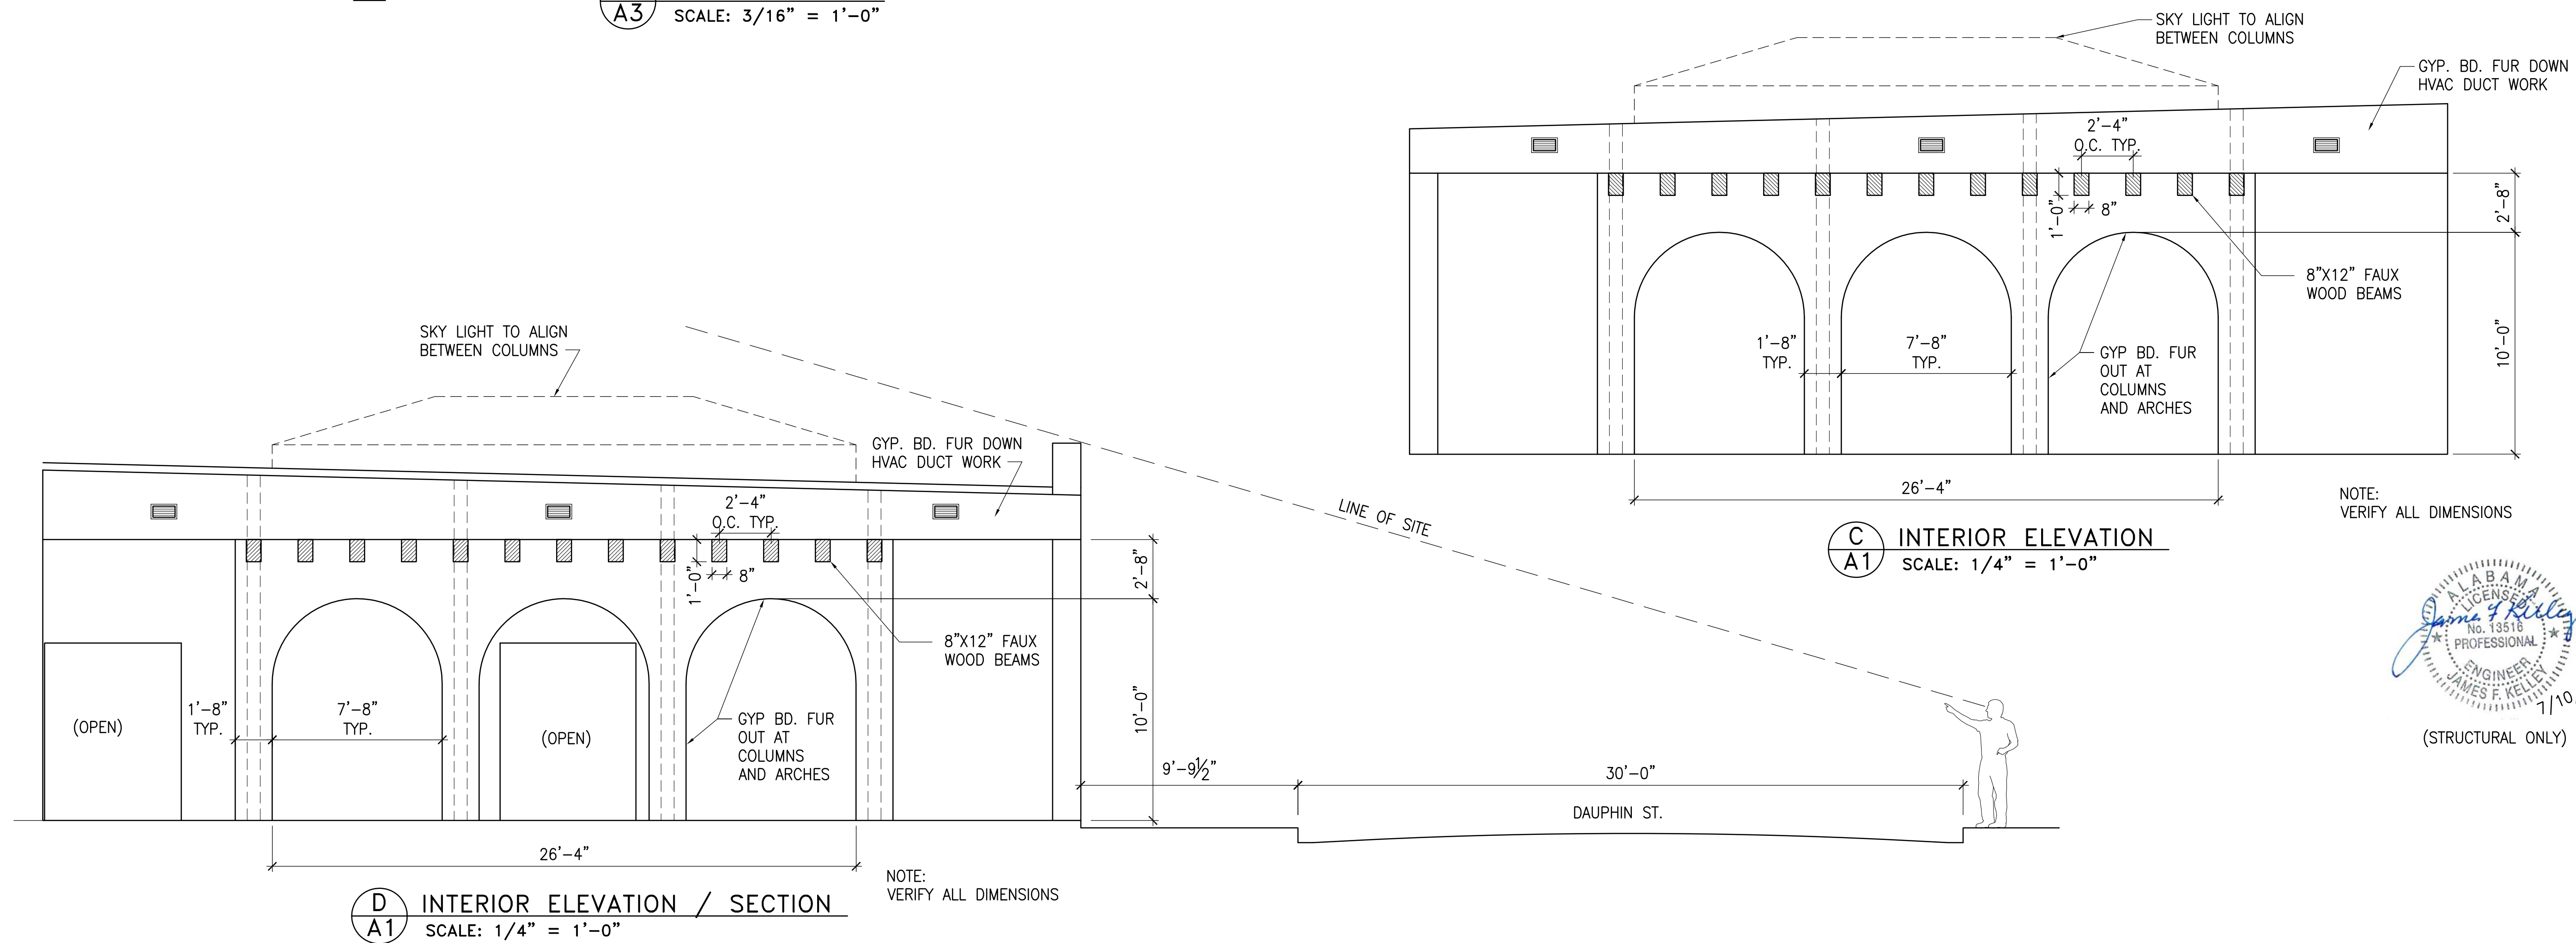
**A3**

DATE: 7/10/25  
DRAWN: JF  
CHECKED: PNO  
TITLE: Interior and Exterior Elevations  
REVISION:  
NO. DATE:  
1 9/3/25  
2 9/24/25  
SHEET:

- b. The infill would be recessed 1' behind the existing brick facade.
  - c. A roll-up impact-rated storm shutter would be concealed above the windows in the cavity between the existing facade and the recessed infill.
  - d. Apply a faux "limewash" treatment to blend new brick infill with existing brick claddings from two different construction periods.
2. Install 4 aluminum-and-plate-glass windows
    - a. Each window would be a single large pane of plate glass set in an aluminum frame with a clear anodized finish. Each window would measure 6'-0" in height by approximately 3'-10.5" wide, for a total combined width of 15'-6".
    - b. Apply a low-e film to window glass.
    - c. The proposed sliding windows could be opened in good weather to create an open-air dining area for the adjoining restaurant.

All work is to be done on the south facing building front. Construct new Bulkhead recessed one foot into existing opening and face with matching brick. Install roll down Hurricane shutter behind existing brick lintel in order to hide roll down mechanism from view. Apply keim limewash over exterior brick. Install new 4 panel clear anodized aluminum sliding window. Window measures 96" x 186". Brick base-bulkhead will be 2' Tall. All other openings will be framed and bricked in after window installation.
