Agenda Item #4 Application 2025-46-CA

406 Conti Street

Demolish historic structure

The application under review proposes the demolition of one of two historic dwellings at 406 Conti Street.

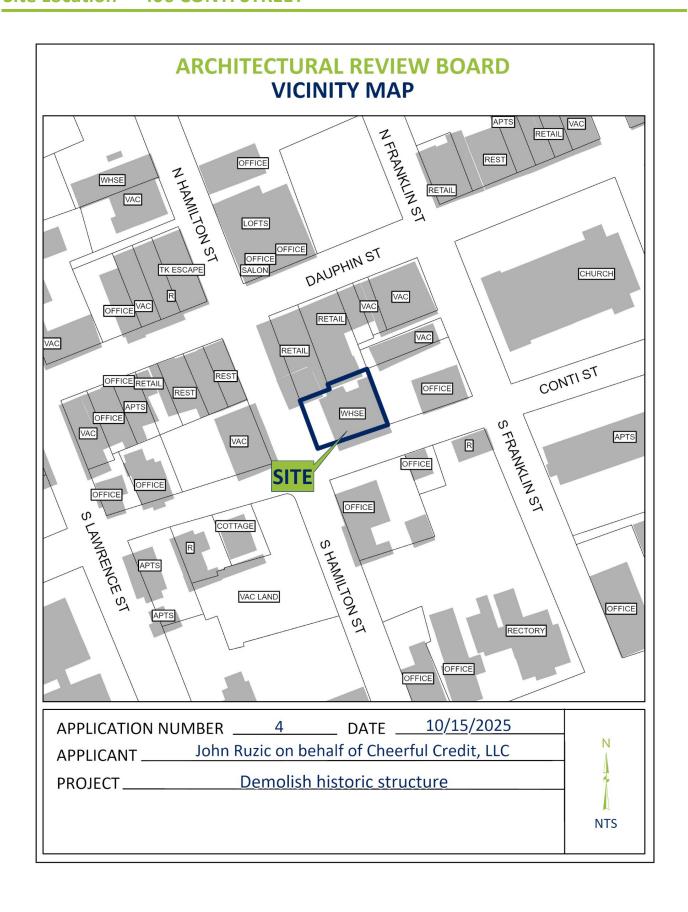
Site Photos – 406 CONTI STREET

1. View of property, looking NE

3. Details of exposed exterior walls

5. Detail view of interior

2. Detail of south elevation, looking N

4. Detail of exposed exterior walls

6. Detail view of interior

The property at 406 Conti, which consists of two frame historic dwellings, is designated as non-contributing. Due to extensive alterations, the two houses have lost their architectural integrity and no longer contribute to the district's historic built heritage. The houses are in a state of disrepair. According to submitted letters from architects and designers on site who are involved in a wider project at the subject and adjoining parcels, the house on the west end of the lot has lost its structural integrity.

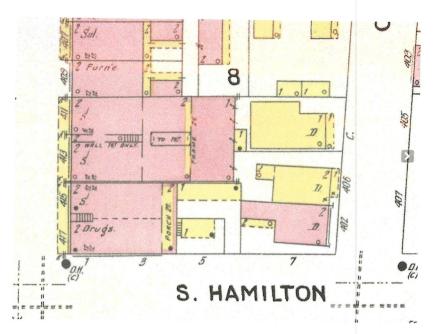
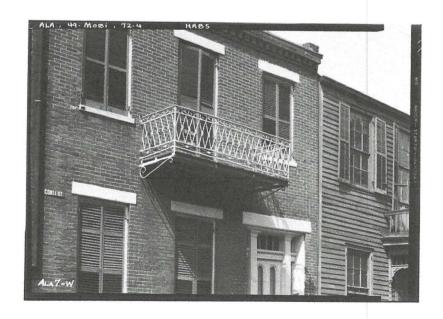
I am writing in regard to the westernmost portion of the building located at 406 Conti Street. The west building was originally a 2 story wood framed house with what appears to be a gable roof separated from the eastern portion by a side yard as shown in the attached screenshot from the 1925 Sanborn Fire Map and the HABS photograph. At some point the building lost the second floor and small Victorian porch and was roofed with a low slope roof and a brick columned cover was built in front on the sidewalk. A roof was added to cover the side yard that connected it to the single story Victorian house to the east.

I toured the house several months ago and the westernmost building is in a terrible state of dilapidation- the flat roof and the floor system has failed, 90% of the interior walls have been removed, the western wall was replaced with a cmu wall when the corner brick house was demolished- there is nothing left worth preserving except the 2 downstairs windows and Victorian entrance door casing facing Conti Street and a window or two on the east elevation.

As much as I hate to say it, the building has been severely compromised and is not

salvageable. The brick columns and canopy along Conti Street are of no architectural significance.
