MTC-086176-2021

304 Long Ct

Willow Oaks are damaging sidewalk. Resident wants to remove and replace with something else.

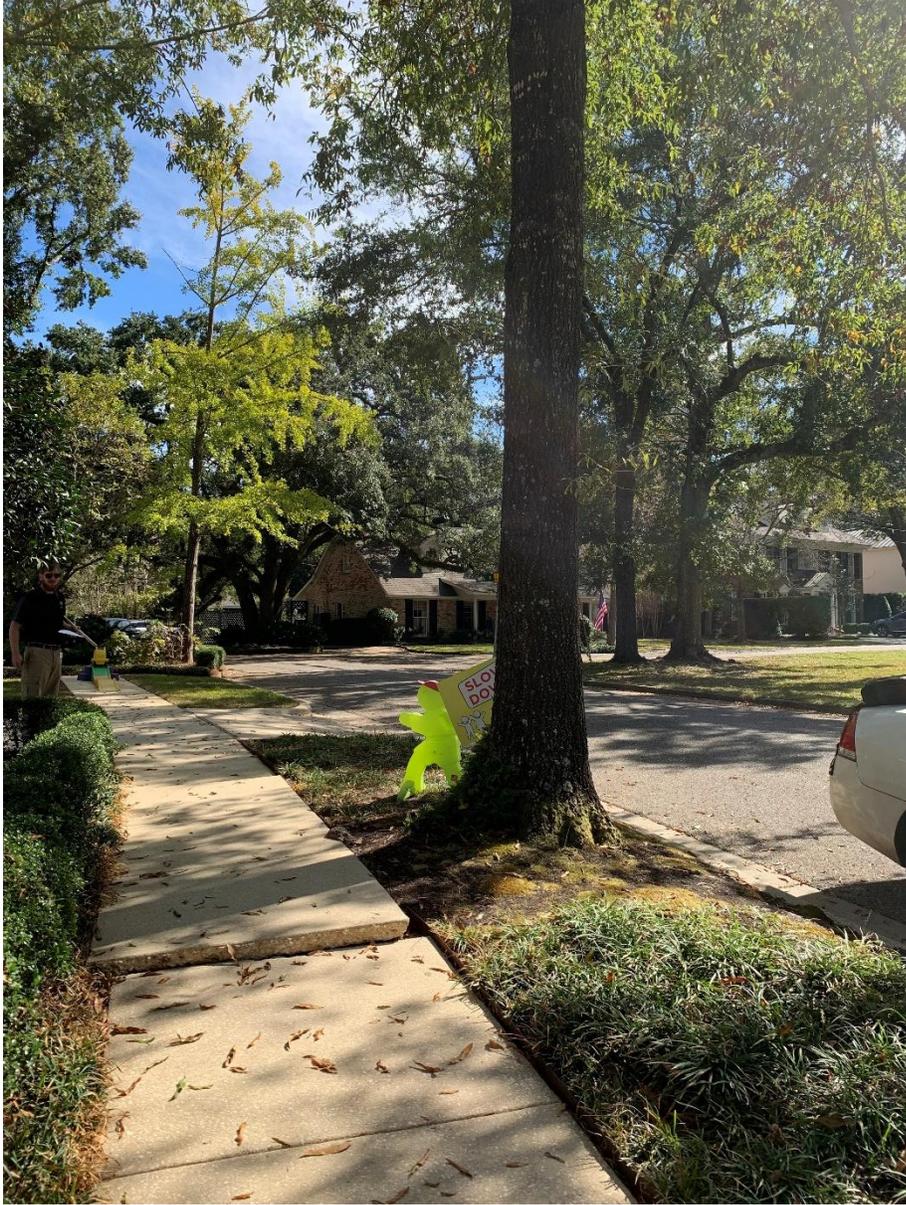
Tree to Right

The overall health of the trees appears to be fair at time of inspection. The 20.5 inch tree to the right has some signs of stress in the canopy. Some light tip dieback, lichens present in upper canopy, and some deadwood was observed. Additionally, the canopy was overall slightly thinner. Lack of greenspace and possible old root damage is suspected, as there is a lot of hardscape (horseshoe shaped driveway and sidewalk) around this tree. The 16 inch oak to the left appeared to be less stressed, but showed some signs of stress. The canopy appeared slightly thinned and some lichens were present in the upper canopy. Neither tree showed signs that indicated them to be at risk of eminent failure at time of inspection.

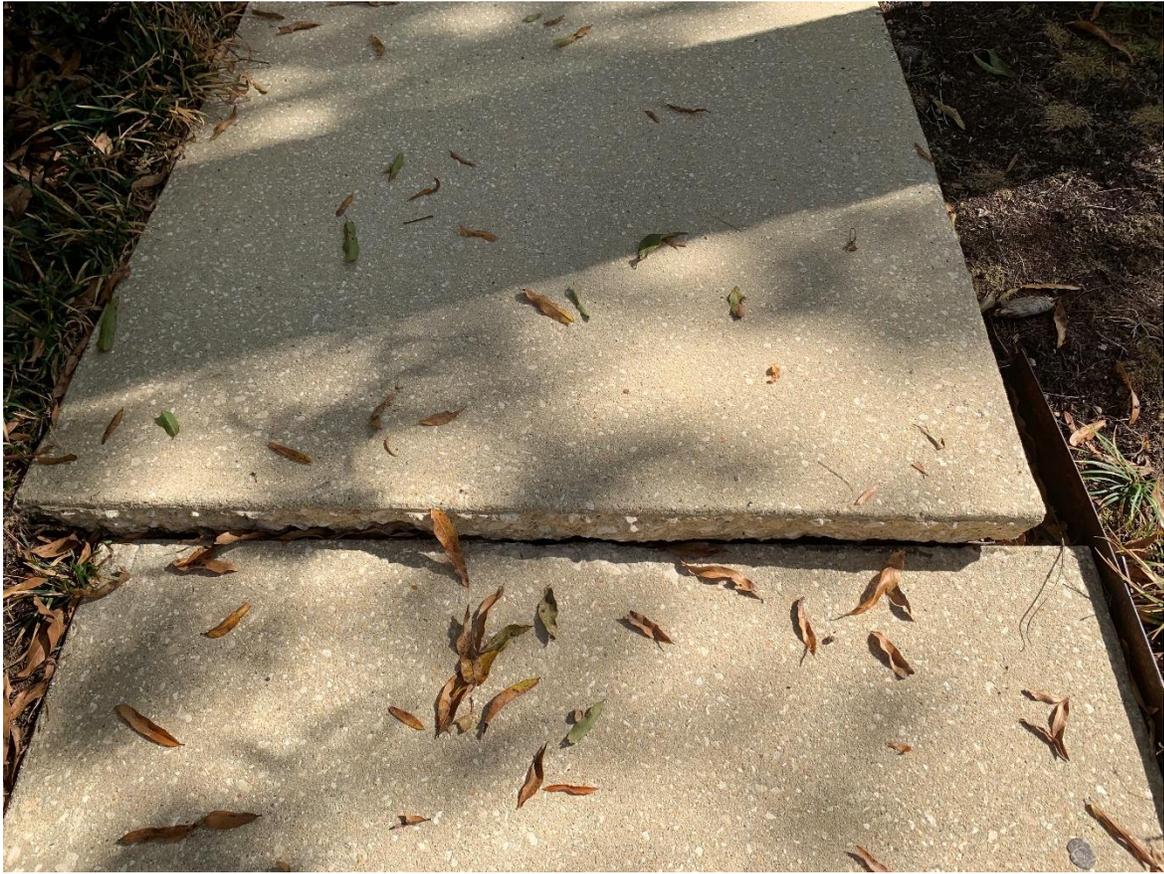
Sidewalk Damage

The 20.5 inch willow oak to the right has buckled the sidewalk. Without pulling the sidewalk panel it can't be determined if the root causing the buckle can be removed without negatively impacting the structural integrity of the tree.

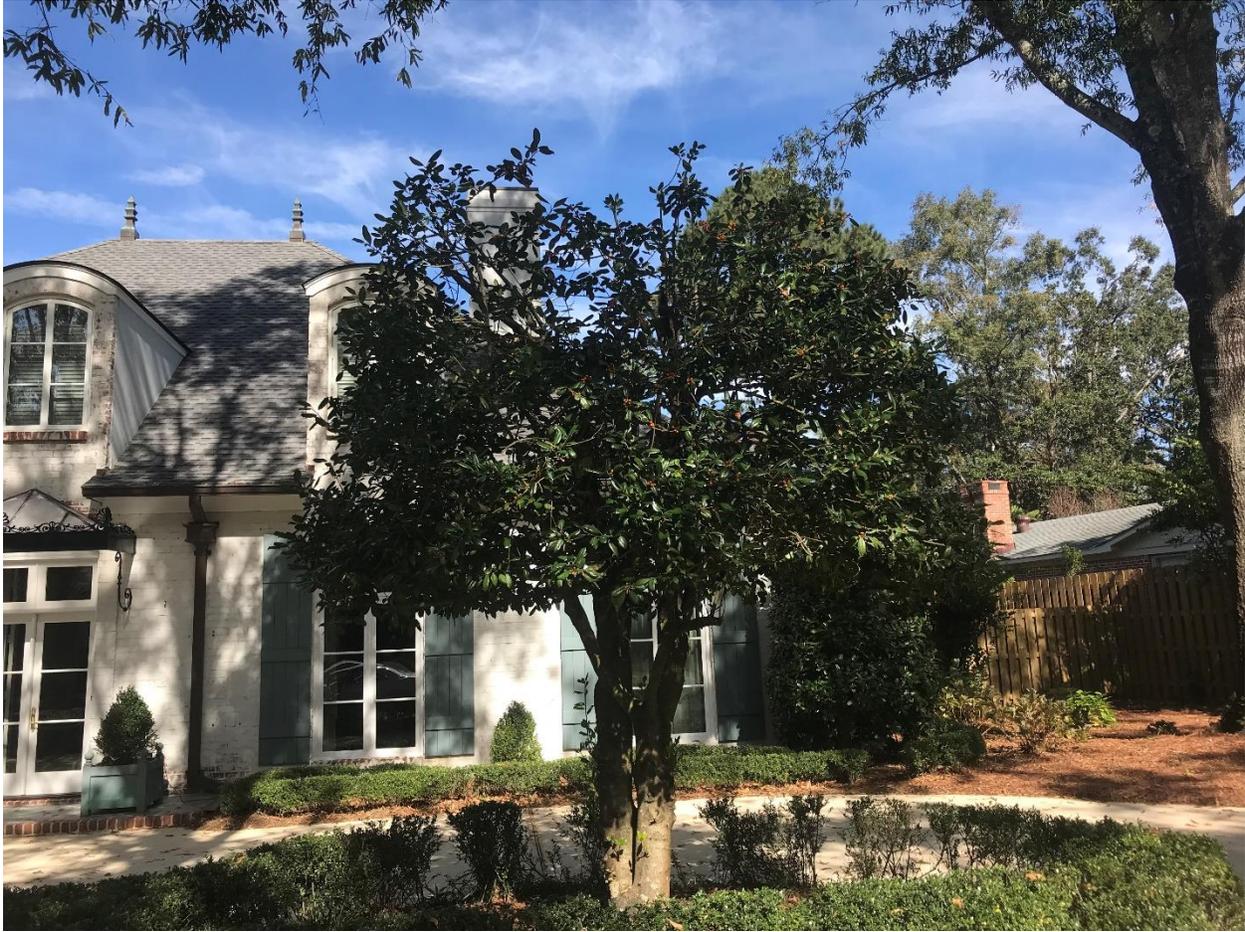
Shaded Holly

The resident is concerned about the trees starting to crowd one another, as well as shading out their other landscaping. At this location there are 3 additional willow oaks that were planted at the same time as the two on right of way, and the trees have grown to the point that their canopies are touching. She wishes to remove the two on right of way to allow the canopy of the ones on private
