Agenda Item #1

Application 2024-13-CA

30 Hannon Avenue

After-the-Fact Approval: Reframe rear addition, fenestration changes, and install drop siding.

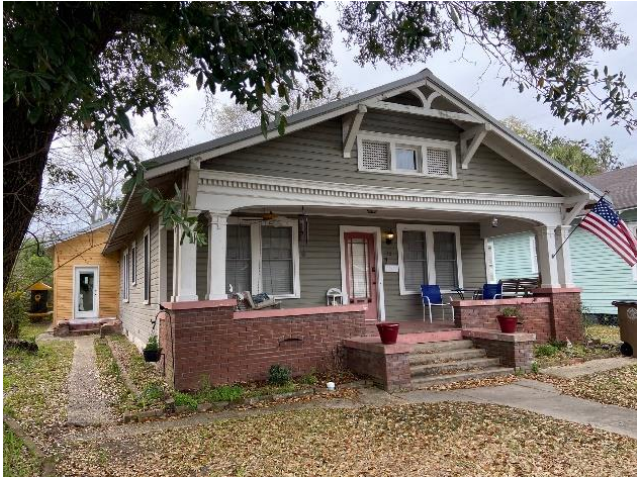
1. East façade

According to the *Guidelines*, replacement doors should align with the historic character of the building. Although a divided light or panel door would arguably be a more appropriate style, the single light replacement door on the east elevation of the addition (see Photo 3) is not located on a primary façade and somewhat echoes the prairie style divided light entry door on the main façade. However, vinyl is not listed as an acceptable material for historic buildings. Further, the sliding glass door on the north elevation is not compatible with the historic character of the property or district. (5.15)

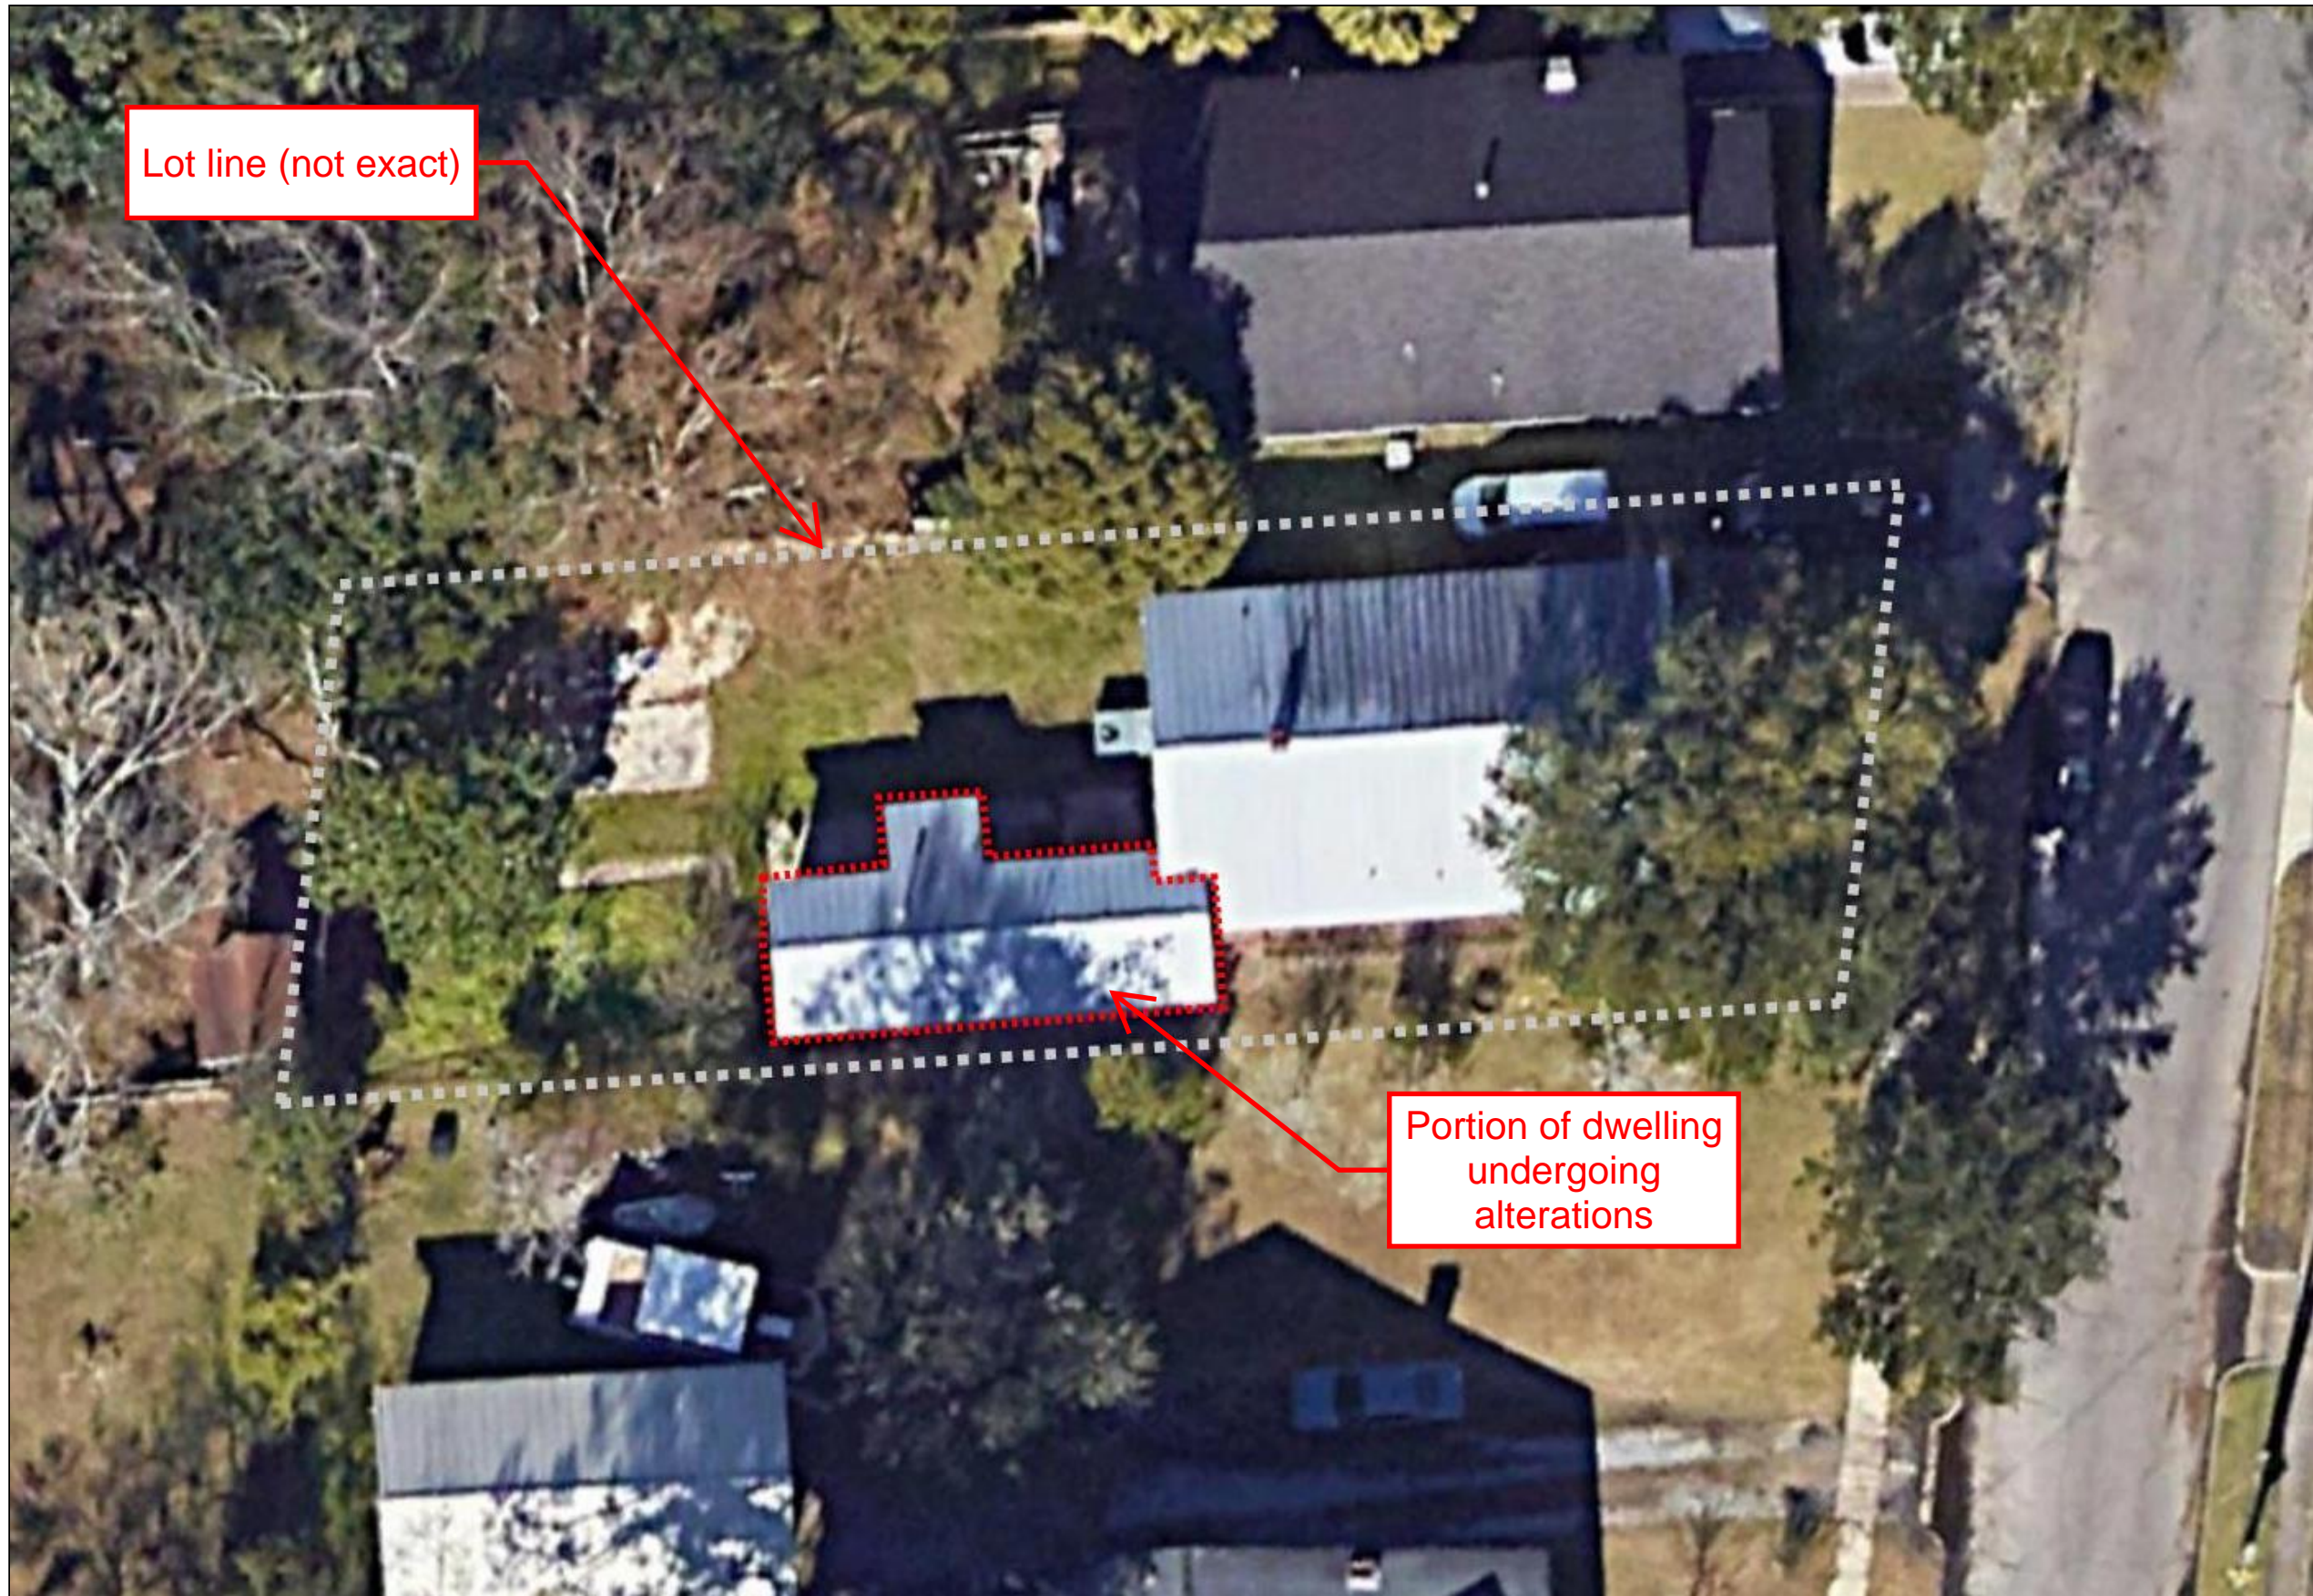
Site plan showing location of ongoing work - 30 Hannon Avenue

30 Hannon Avenue is a contributing resource within the Old Dauphin Way Historic District. The application under review seeks after-the-fact approval for siding replacement and various fenestration alterations to a rear addition.

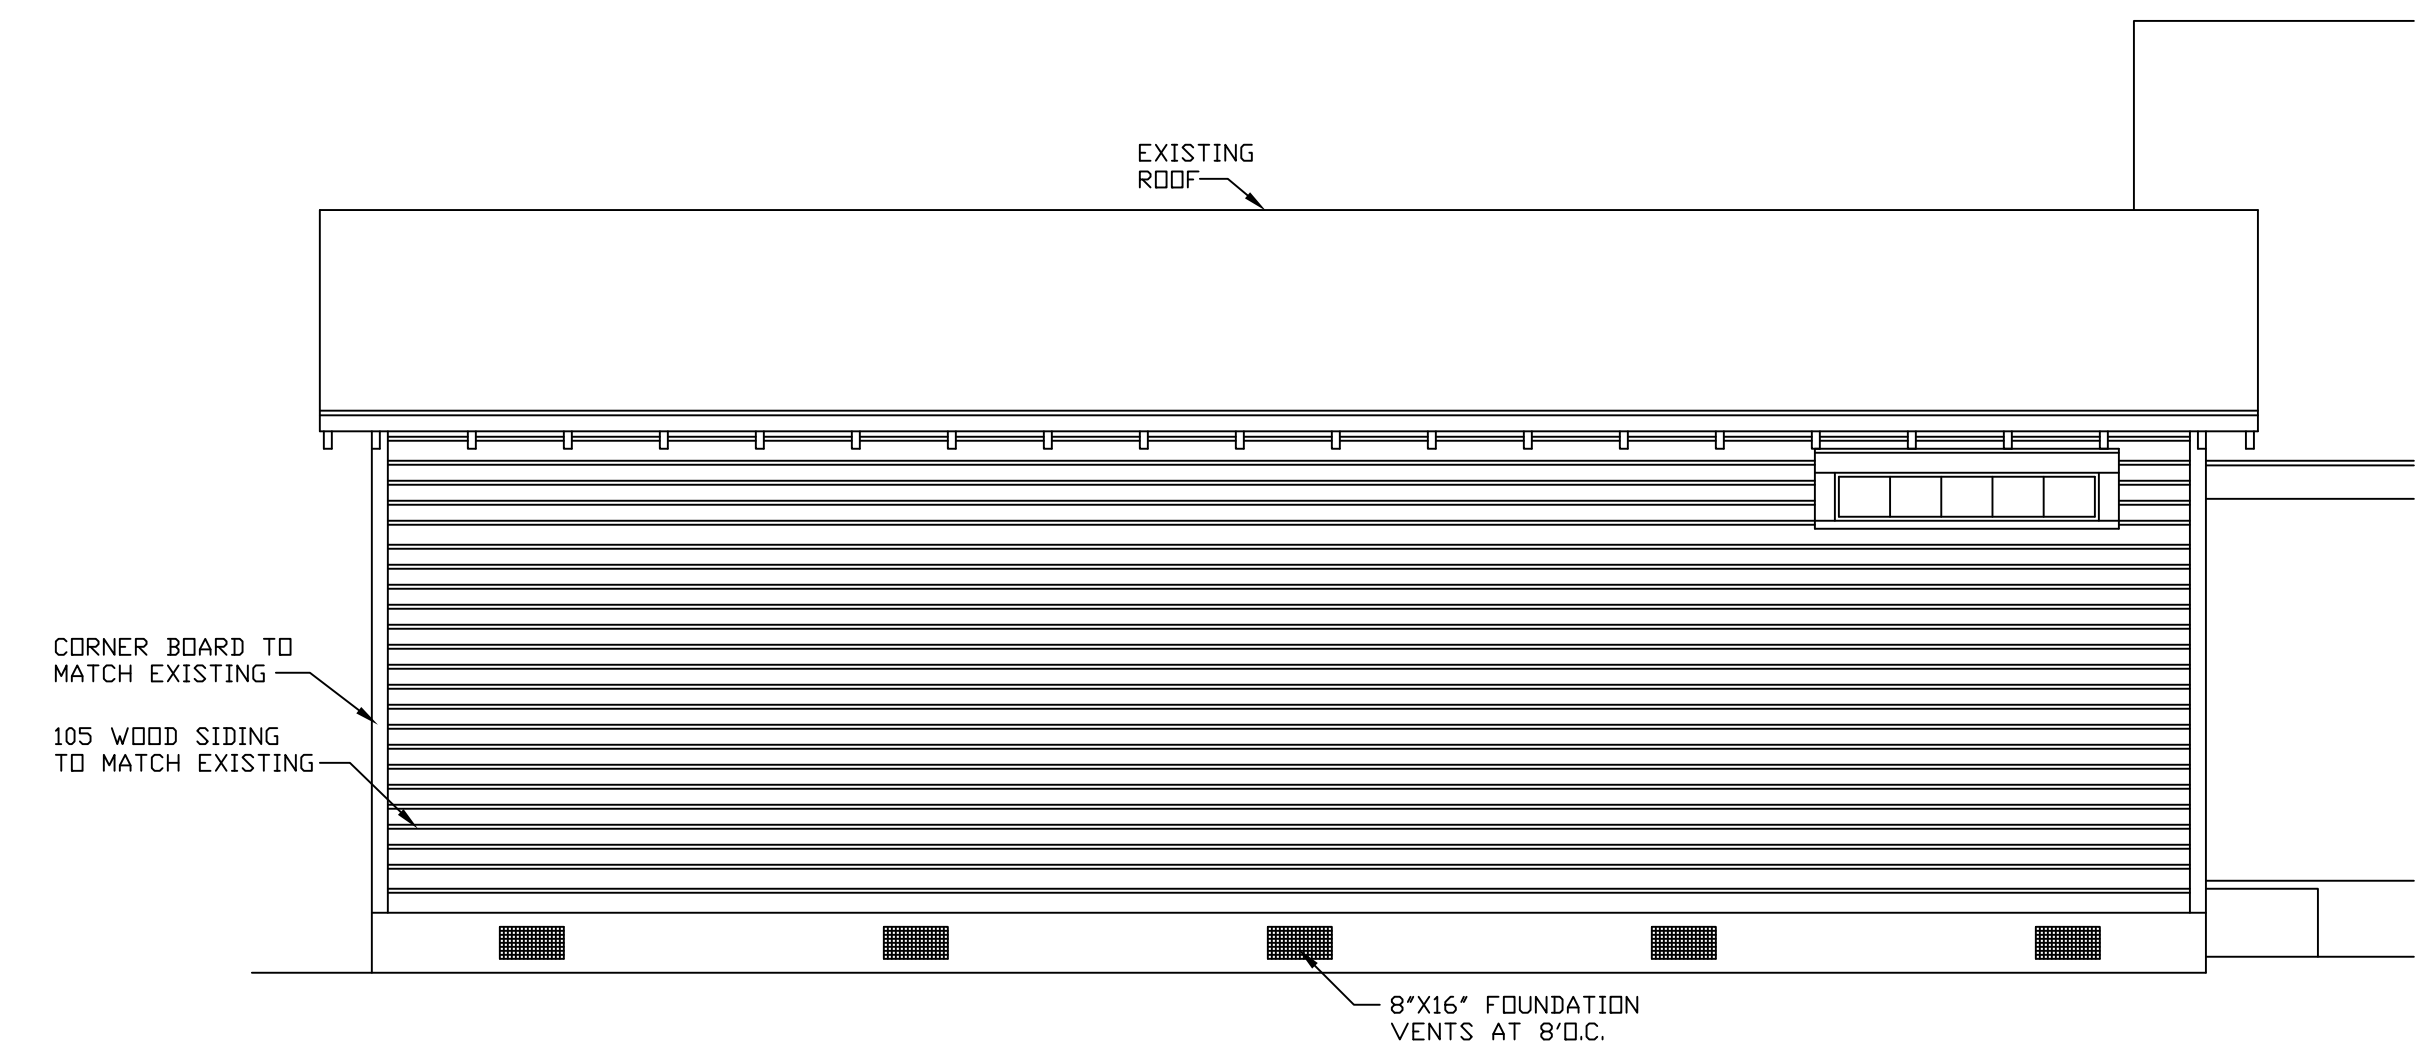
LEFT SIDE EXTERIOR ELEVATION

The *Guidelines* state that intact historic windows should be retained and repaired, preserving elements such as light configuration, frames, sashes, muntins, etc. In cases where windows are not repairable, new windows should match the existing as per location, framing, and light configuration. Due to the fenestration changes having been completed prior to obtaining a COA, no window survey was completed. According to the applicant, the original windows are no longer extant. Therefore, their condition at the time of removal is unknown. The replacement windows do not comply with the *Guidelines'* directive to match the existing location, framing, and light configuration of the original windows. The removal of all windows on the south elevation, leaving a blank side

wall with one small, high-wall window in the east corner is not an appropriate alteration. The removal of a traditional fenestration pattern and the established solid-to-void ratio creates an unsuitable contemporary expression on a historic elevation. Likewise, the north elevation, though less visible from the street, has been inappropriately rehabilitated using a contemporary fenestration arrangement such as the pairing of narrow one-over-one windows and the installation of a horizontal sliding glass door. In addition, vinyl is not an approved material for Mobile's historic districts. (5.20-5.22)

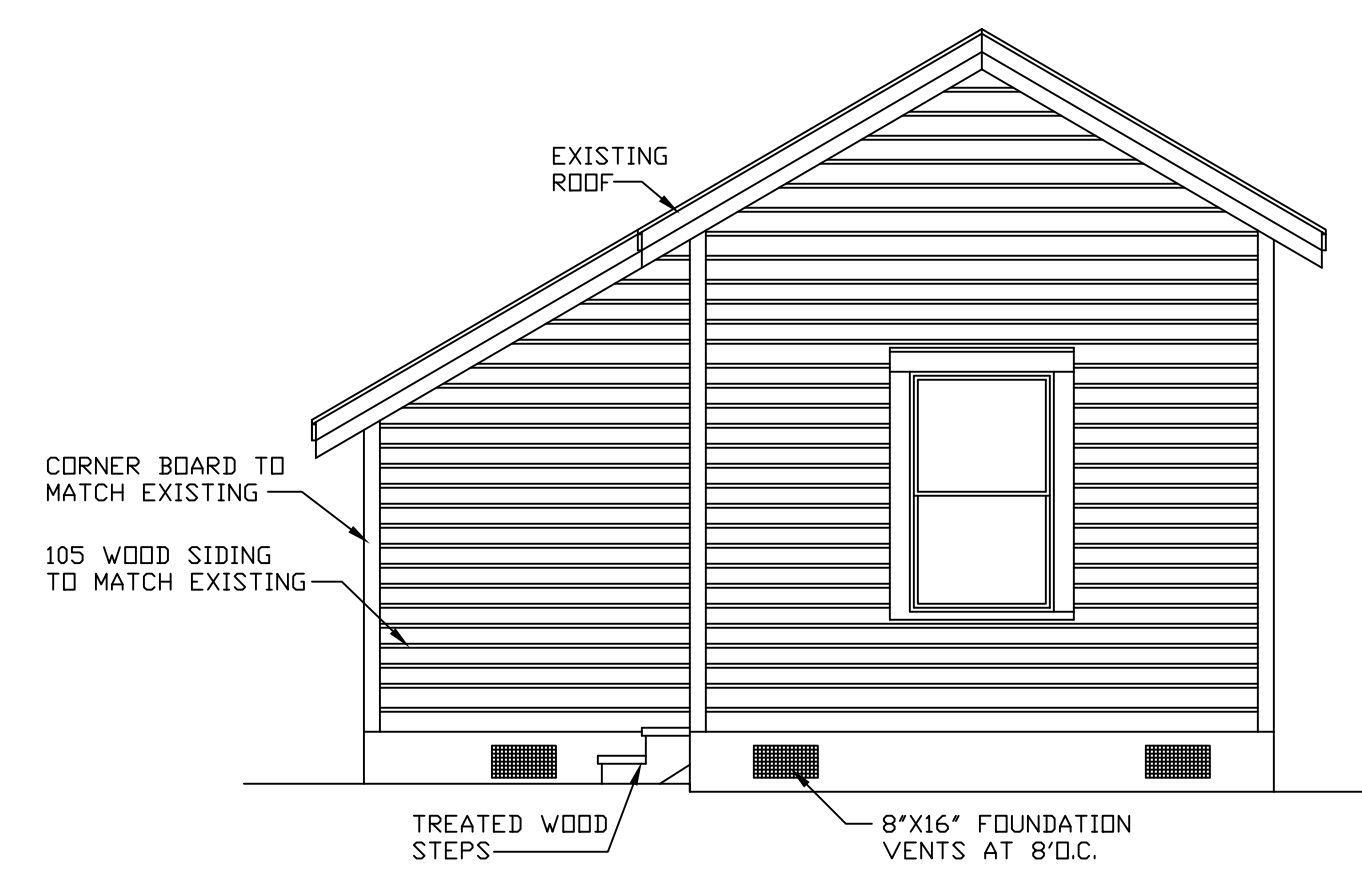
REAR EXTERIOR ELEVATION

The new 6" replacement wood siding that was installed on the rear addition follows the *Guidelines'* call for replacement materials on non-primary elevations to match the original material in composition, scale, and finish. (5.7)
