Agenda Item #9

Application 2026-11-CA

Location:
153 S. Catherine Street

Summary of Request:
Replace thirteen existing wood windows with vinyl sash windows.

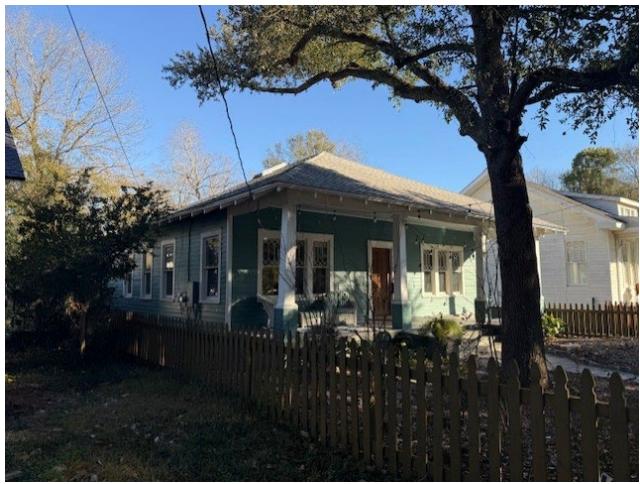
2. North and west elevations facing SE

Having reviewed the applicant's window survey, Historic Development Staff was not able to conclude that the existing windows are beyond repair. It appears that the lower window sashes on the two three-over-one windows along the north elevation do not close completely. Glazing putty could be removed and replaced with new to stabilize any loose glass panes and prevent air leakage. The applicant has stated concerns and operable challenges with most existing windows due to the fact that they have been painted shut and do not currently have a locking mechanism. Removing the layers of paint and installing a lock on the lower sash may be possible. Additionally, an interior or exterior storm window can be installed to increase energy efficiency and insulation.
