Agenda Item #5

Application 2026-18-CA

After-the-fact replacement of existing wood front entry door with new wood entry door

Old Dauphin Way Historic District

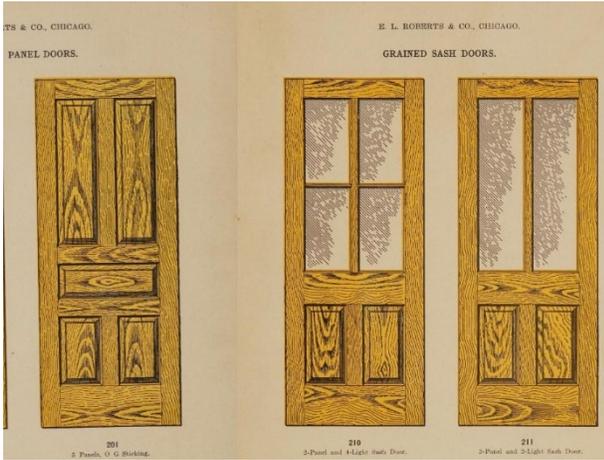
7. Door with a two-over-two light set above two vertical panels in E. L. Roberts & Co. Catalogue (1903)

If an original door has deteriorated to the point that repair is impossible, the *Guidelines* require that a replacement door reflect the age and style of the subject property. Paneled wood doors with glass lights were common in the period between 1900 and 1910. However, the specific configuration of the replacement door – a two-over-two light above a single rectangular panel – would have been atypical when the house was constructed in 1903. At that time, the most common lighted door configurations featured one large light or two paired lights over a variety of wood panel configurations. Doors with two-over-two lights set above two or three wood panels were commercially available, but they are rarely depicted as front entry doors in the house design books of the period. This door type was uncommon and primarily used for accessory structures, such as ice houses. Staff were able to find one house design catalogue from 1900 that shows a front entry door with a two-over-two light. Instead of a single wood panel, the light is set above three horizontal panels, similar to the configuration of the door removed from the subject property.

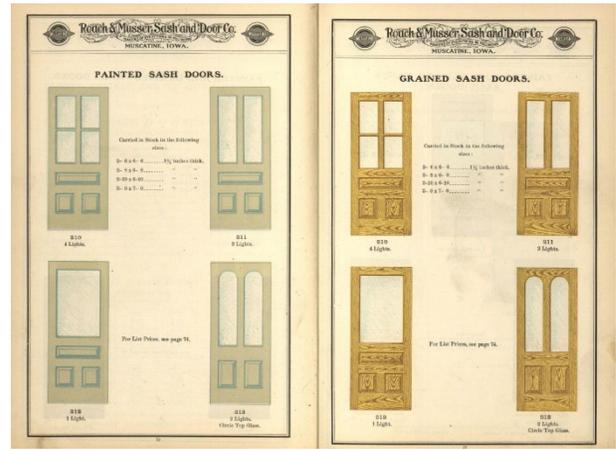
8. Door with a two-over-two light set above three unequal panels in Roach and Musser Sash and Door Co. Catalogue (1905)

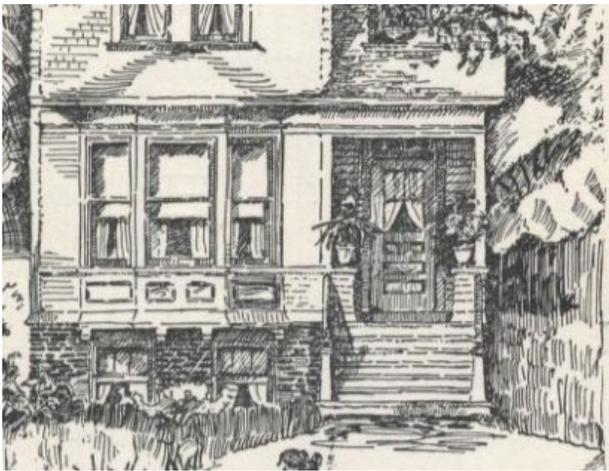
9. Door with a two-over-two light set above three horizontal panels in *Modern Homes* (S. B. Reed, 1900)

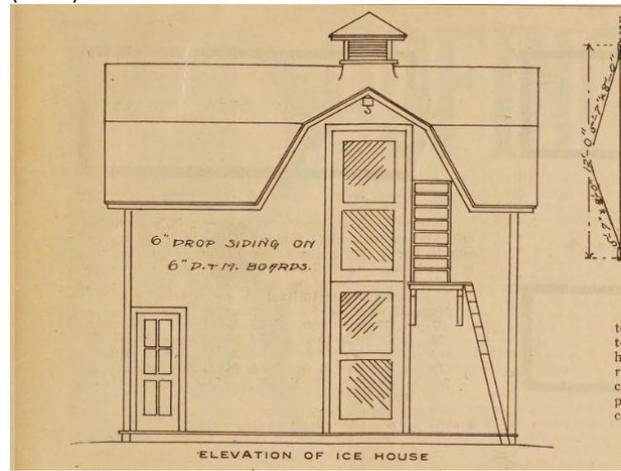
10. Door with a two-over-two light set above two vertical panels pictured on a design for an icehouse in Gordon-Van Tine Co. catalogue (1908)
