## Agenda Item #2

### Application 2025-30-CA

1159 Old Shell Road

After-the-fact window and column replacement on façade; Paint applied to brick porch wall

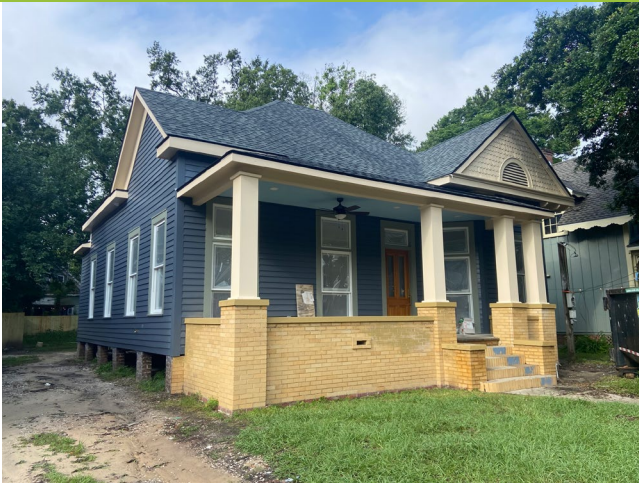
1. View of subject property, looking SW

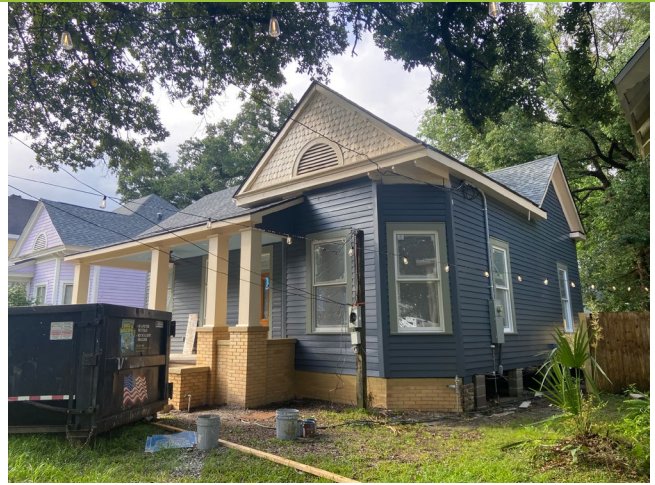
2. View of property, looking SE

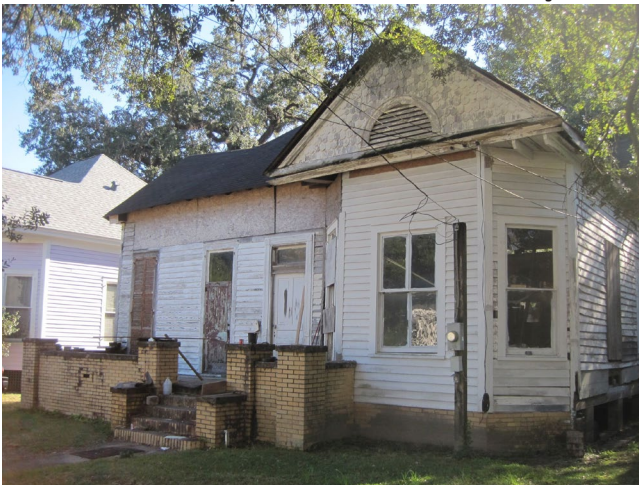
5. View of property prior to rehabilitation

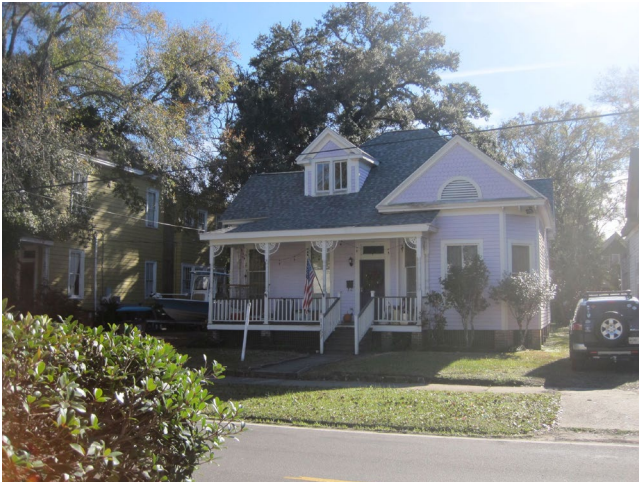
**9. View of neighbor twin property at 1157 Old Shell Road.**

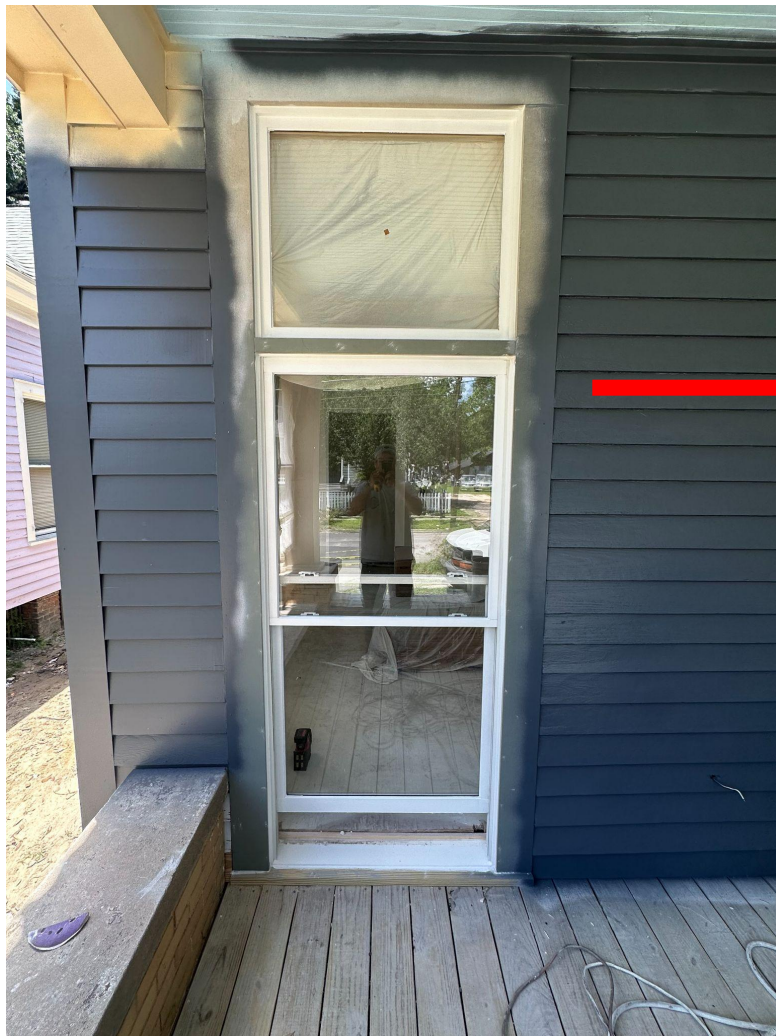
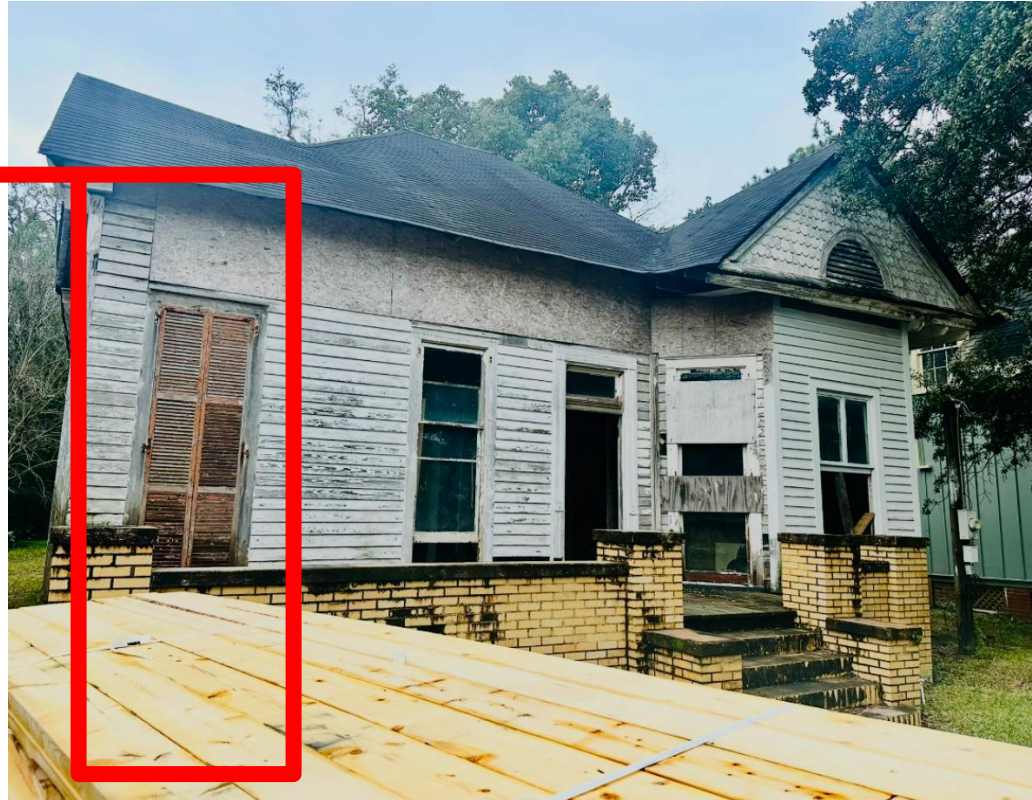
North Elevation, Left Window– Replace window

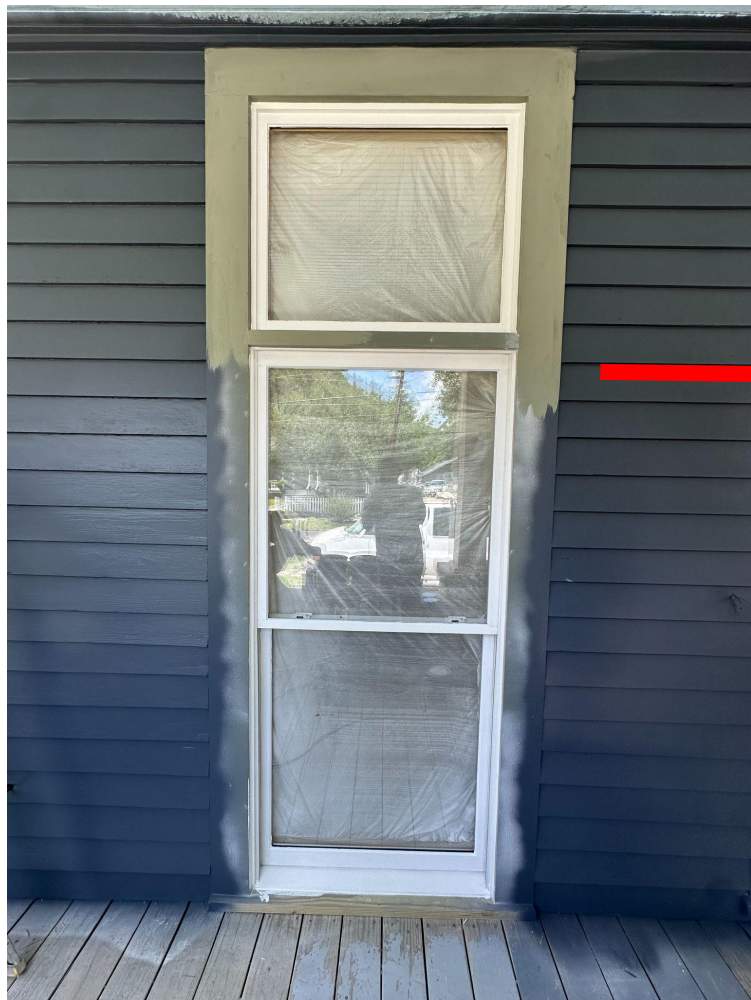
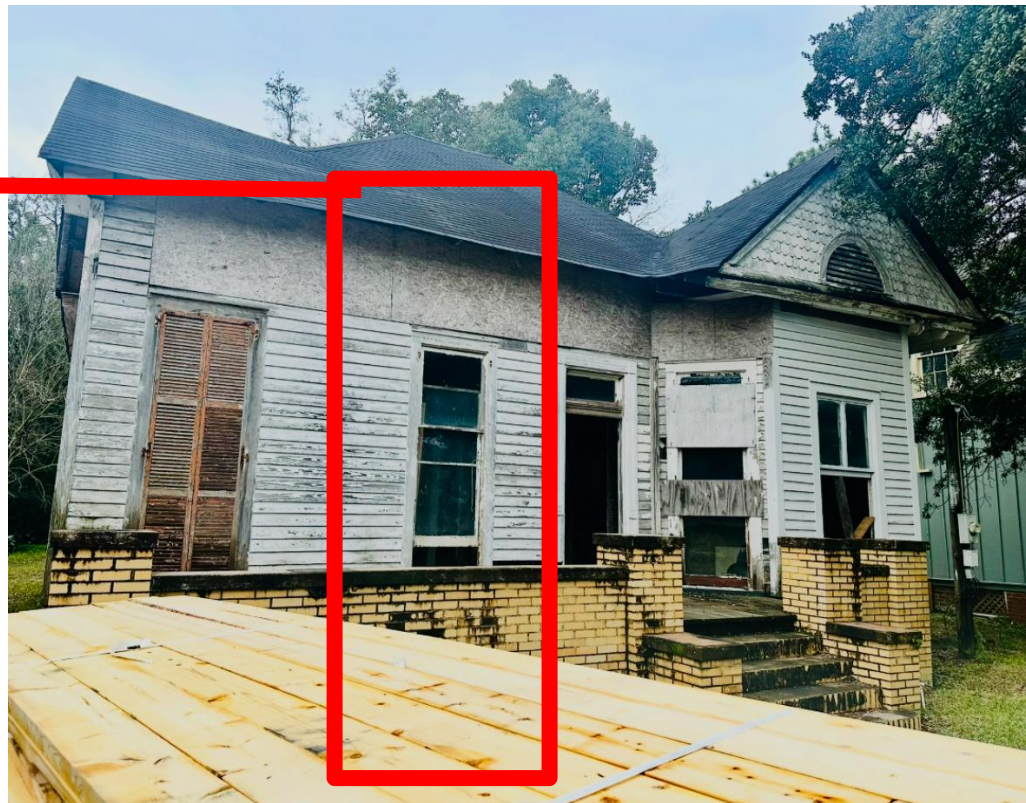
North Elevation, Middle Window– Replace window

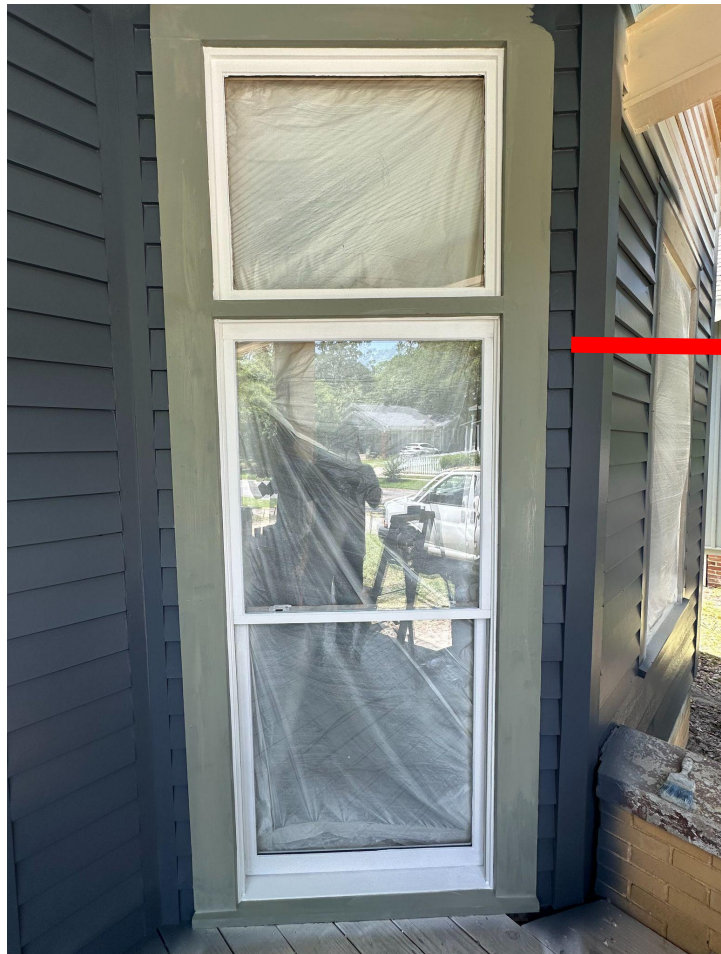
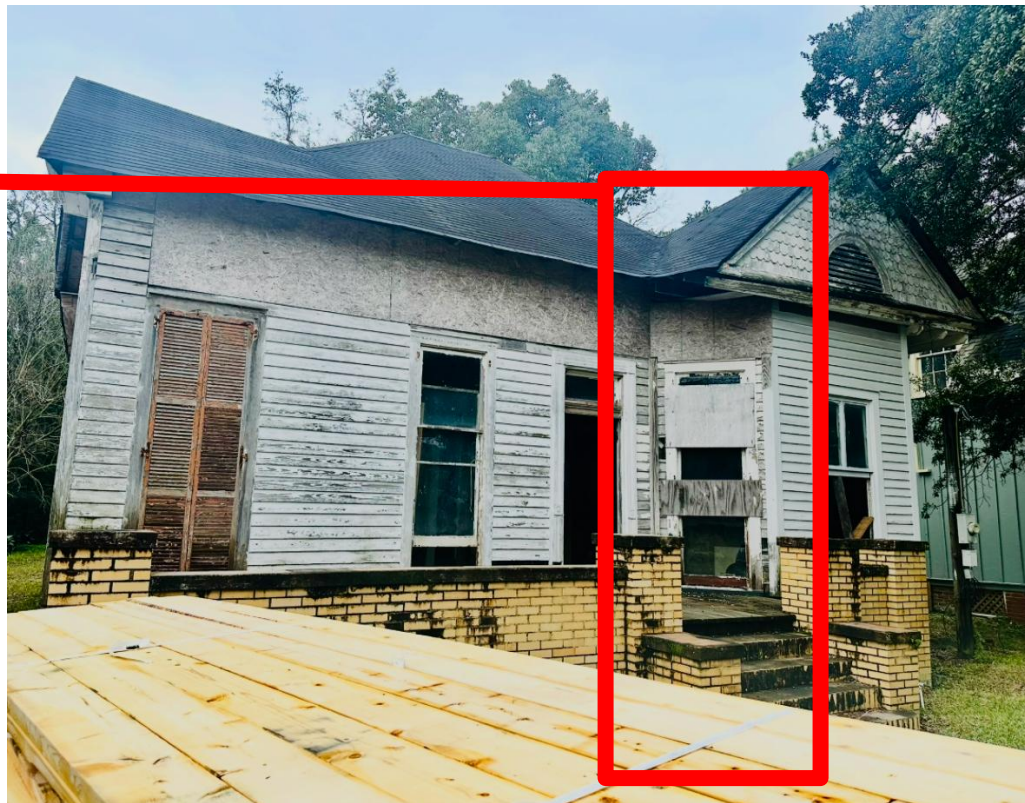
North Elevation, Right Window– Replace window

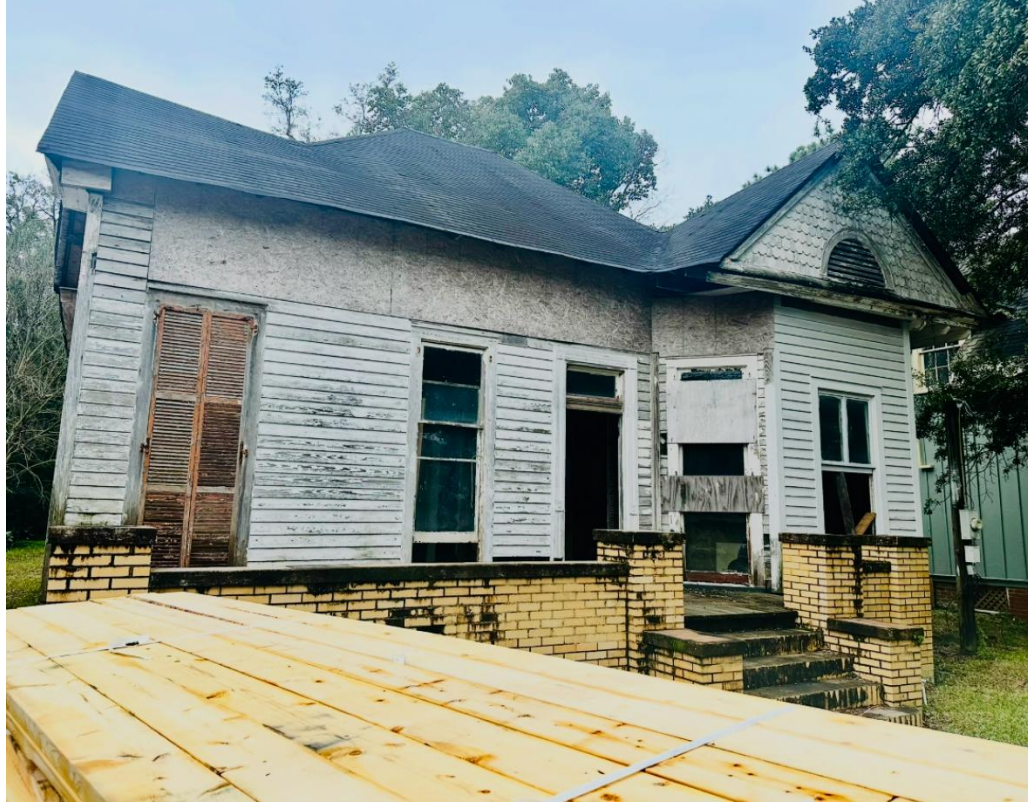
# Original porch at time of purchase
